# Investigation Report into November 2019 Derwent Floods in Derby City

Derby City Council

Project number: 60675186

15th September 2022

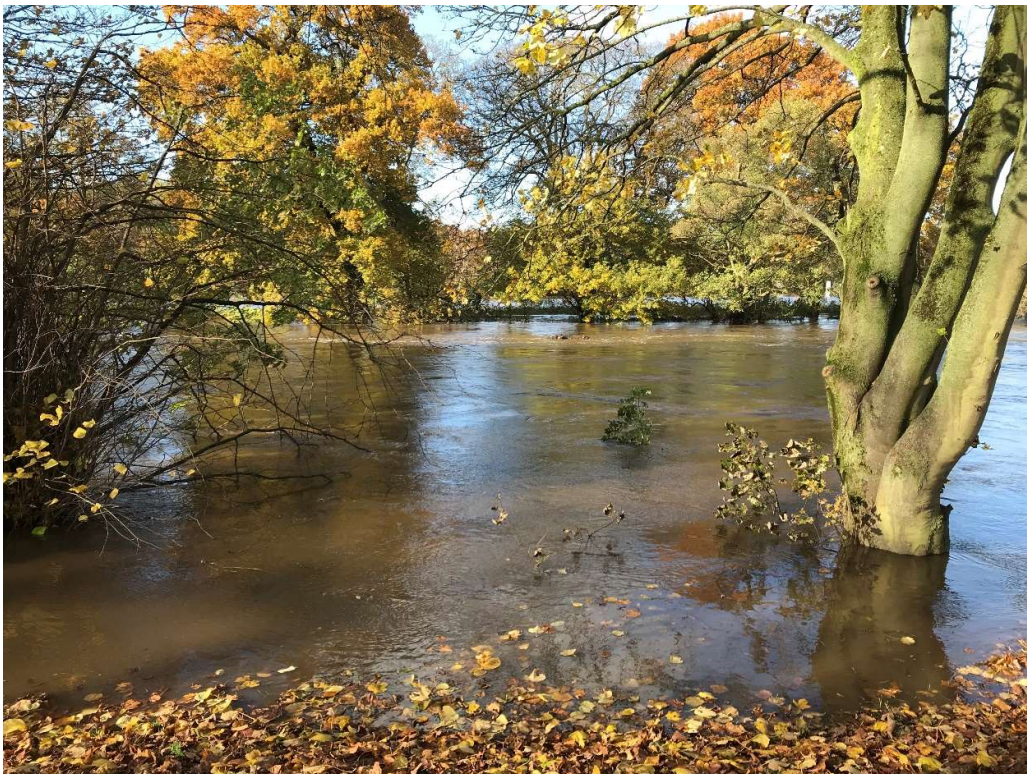
Figure 5-12: Photo showing flooding in Darley Fields (12:20 8<sup>th</sup> November 2019)

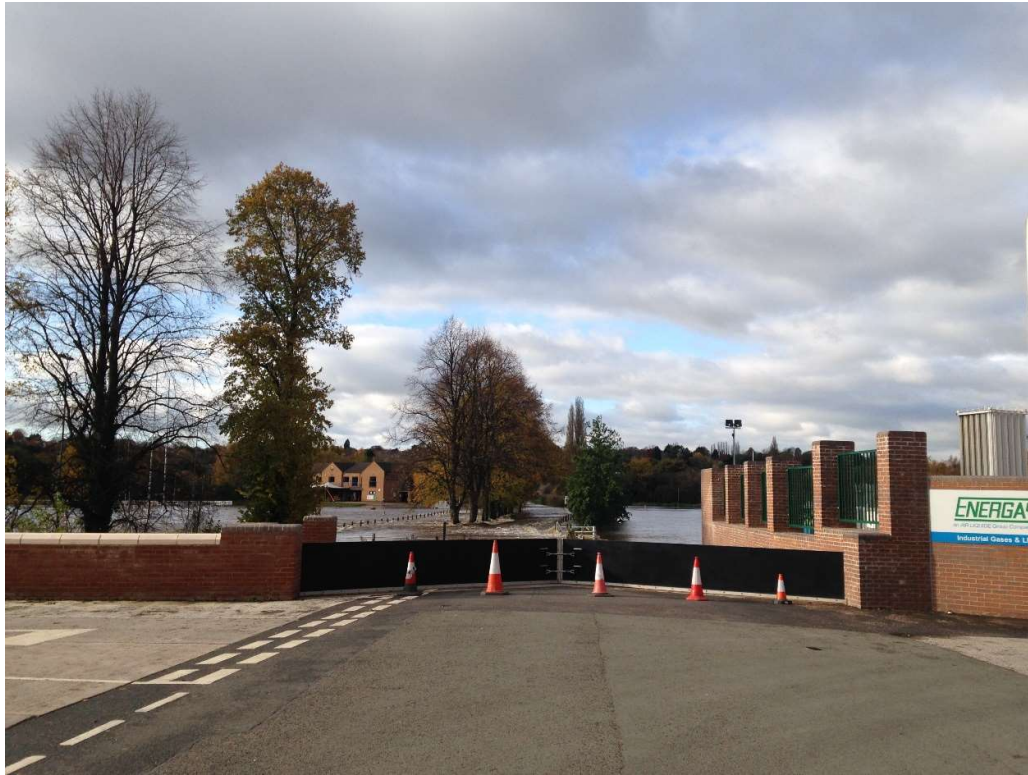
Prior to this flood event, as part of the OCOR scheme<sup>12</sup> (Derby's flood alleviation project, led by DCiC in partnership with the EA), the road at Haslams Lane had been regraded and a flood gate installed (Figure 5-14). During the event the flood gate on Haslams Lane was closed at approximately 2 pm on 8<sup>th</sup> of November and reopened the following morning.

**Figure 5-14: Photo showing flood gate on Haslams Lane closed during the flood event (13:12 8<sup>th</sup> November 2019)**

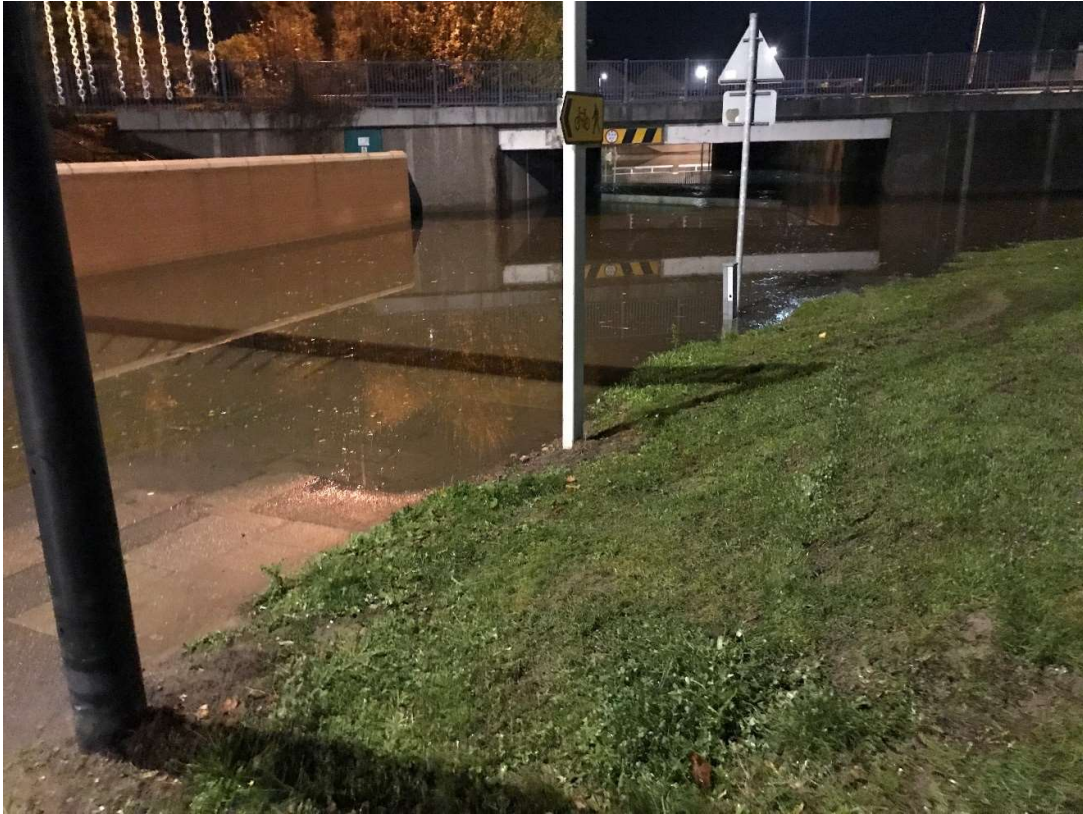
Prior to this flood event as part of the OCOR scheme<sup>12</sup> to reduce the impact of St Marys bridge on river flow, an exceedance channel along Sowter Road was created, see Figure 5-19. The exceedance channel was designed to have flood waters overtop the bank and enter the channel north of the bridge allowing flows to bypass the constriction of St Marys Bridge and re-enter the channel south of the bridge, with flood water being stored under the underpass on Sowter Road. However, due to the levels of the constructed exceedance channel south of the bridge, the flood waters entered the exceedance channel from the south before collecting in the underpass, Figure 5-20 and Figure 5-21.

Figure 5-20: Flooding in Sowter Road underpass (22:57 8<sup>th</sup> November 2019)

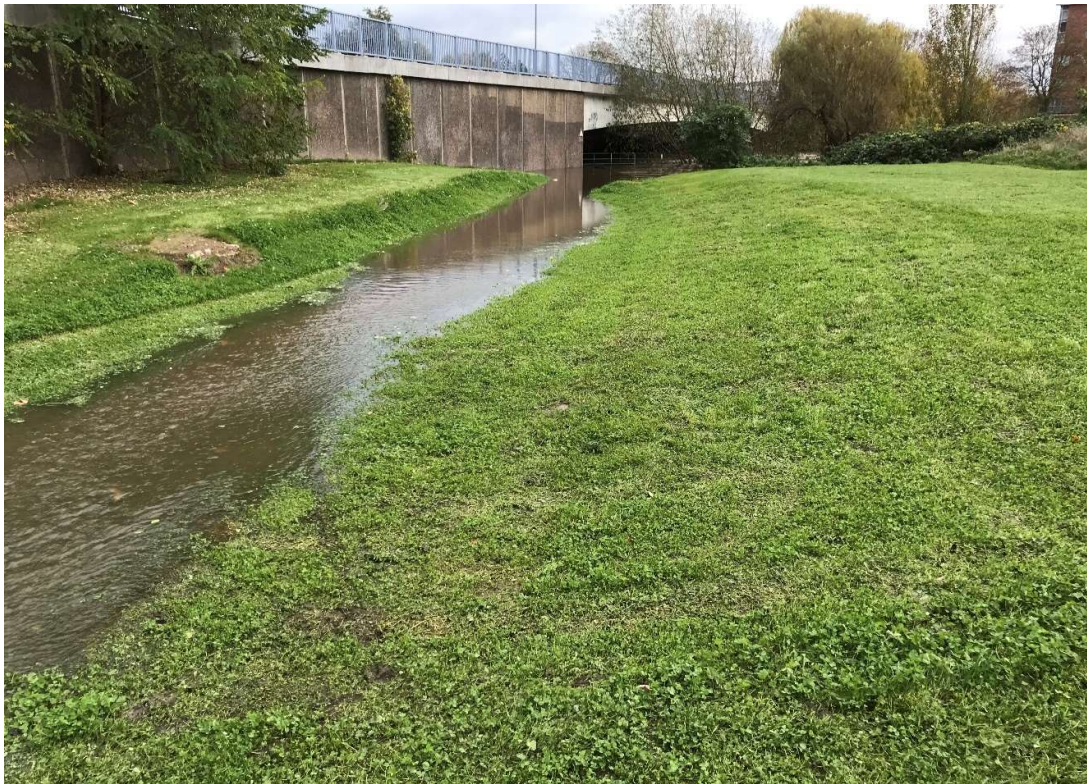
Figure 5-21: Exceedance channel South of Causey Bridge (13:14 8<sup>th</sup> November 2019)

Since November 2019, DCiC have taken corrective action to ensure the exceedance channel will function as designed. The levels of the exceedance channel to the south of the bridge have been altered to match with the designed levels to reduce the chance of flood waters entering the exceedance channel from the south, see Figure 5-22.

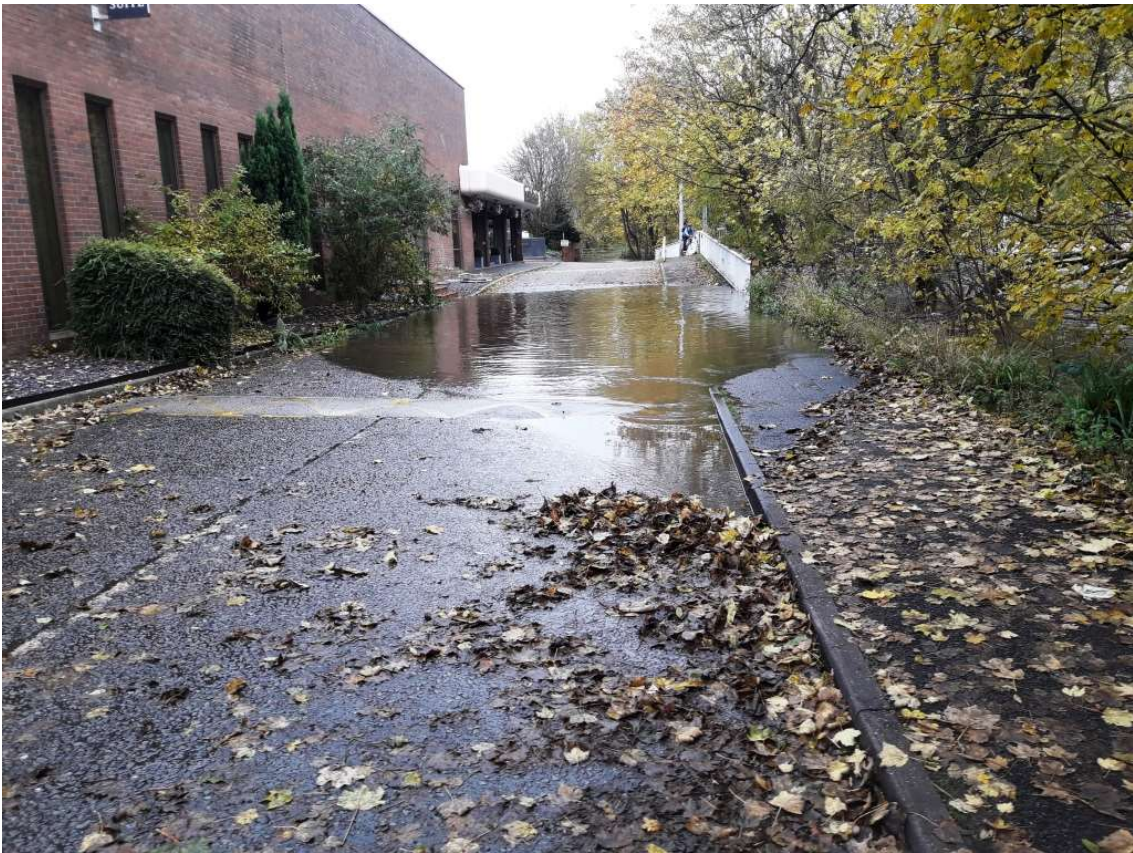
The flooding that occurred along the industrial area of Meadow Lane was likely caused by the river overtopping its banks, starting by the footbridge, which acted as a constriction on the river flows. As identified by the EA's fluvial flood map, this area has a high risk of fluvial flooding (see Figure 5-26). As a result of the flooding one of the commercial properties was evacuated. The overtopping of the riverbank likely resulted in flooding of the road (see Figure 5-27).with flood depths of approximately 150mm to 200mm near the bridge by 2:30pm on 8<sup>th</sup> of November, 2019. From the site walkover it is understood that internal flooding at four of the commercial properties was experienced during the same event at this location.

Figure 5-27: Flooding on Meadow Lane from overtopping of riverbank prior to the peak (13:58 8<sup>th</sup> November 2019)

As part of the OCOR Scheme<sup>12</sup> it is proposed to build flood defences in this area in the second phase (Package 2) of the project.

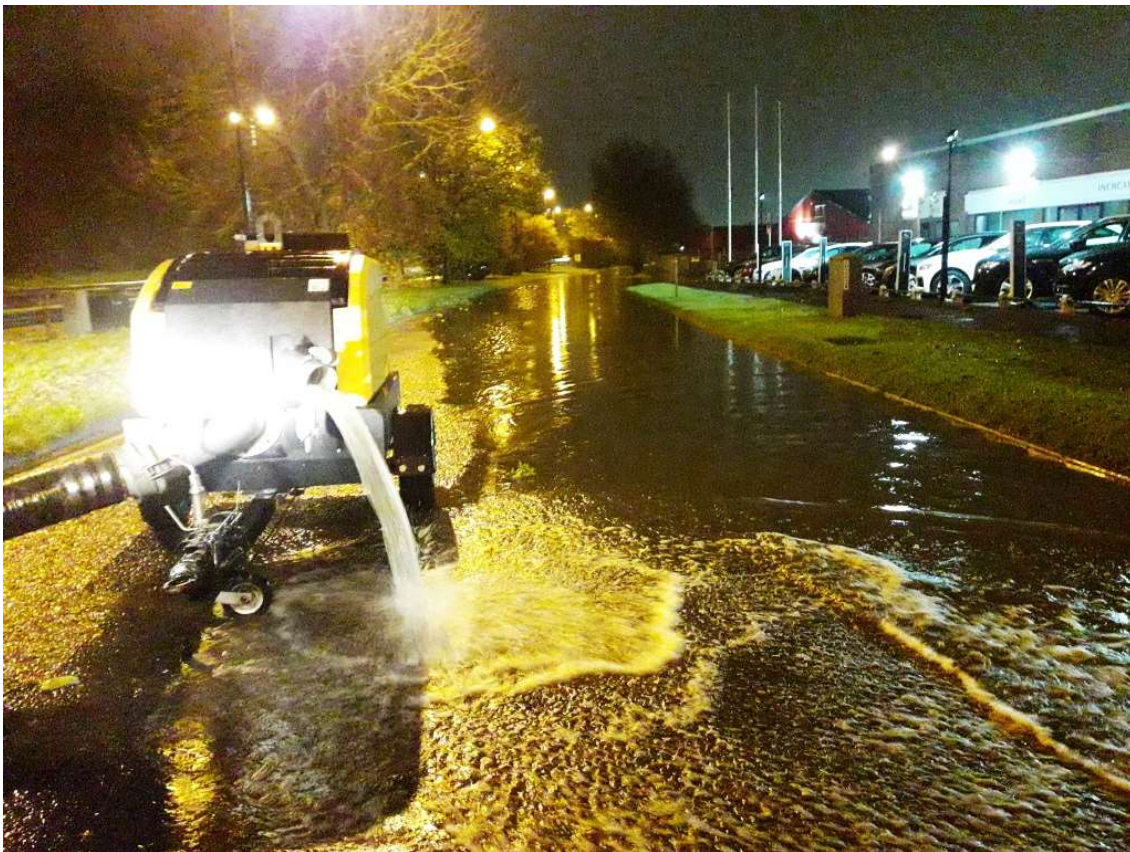
The flooding in the Chaddesden Sidings area resulted in flooding of the A52 and Chequers Road (see Figure 5-32) and internal flooding to several commercial properties along Chequers Road up to a depth of 1.5 m. The A52 which runs east - west to the north of this area was closed from 21:45 on 8<sup>th</sup> November and reopened on 9<sup>th</sup> November. Chequers Road was also closed at 07:41 on 9<sup>th</sup> November due to flooding within the carriageway. The flooding within Chaddesden Sidings is thought to have had three sources, flooding from the south of the railway embankment, failure of the Downing Road pumping station and flooding from the STW surface water sewer backing up.

**Figure 5-32: Pumping in Chaddesden Sidings after flooding (18:39 9th November 2019)**

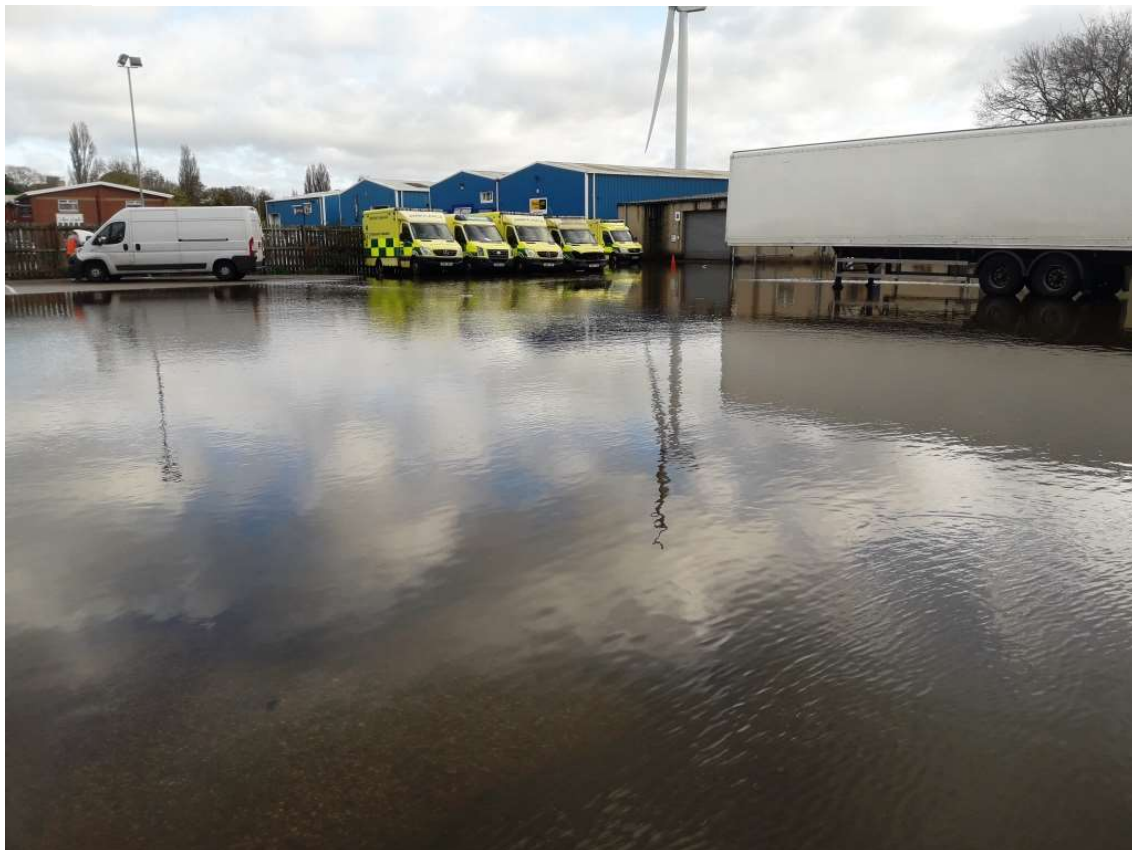
Figure 5-37 shows a second outfall into the river north of the ditch outfall, for a surface water drainage system. Due to the high river levels during the event the surface water system was also unable to discharge and so pluvial flows backed up along the pipe. This resulted in internal flooding of one commercial property on Raynesway as a drain located within the property flooded, see Figure 5-39.

Figure 5-39: Flooding at commercial property on Raynesway (11:09 8<sup>th</sup> November 2019)
