Derby City Council

Flood Investigation Report

Bishops Drive, Oakwood 19th July 2014

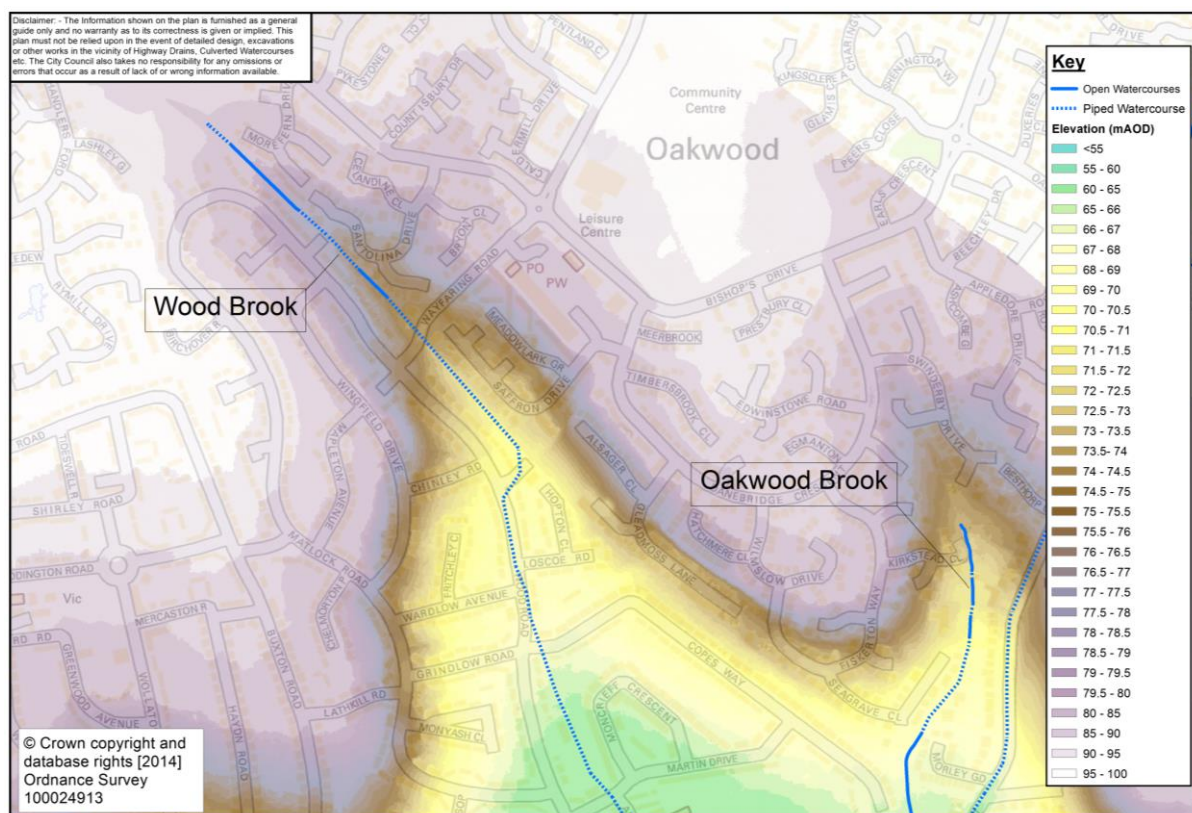
Figure 3: Local Topography of the Investigation Site

Figure 3 illustrates the local topography of the investigation site. The map illustrates two distinct topographical valleys aligned by the Wood Brook and the Oakwood Brook. Both brooks are illustrated on Figure 3 including their piped lengths. Naturally therefore, it is likely that generally surface water on paved and green surfaces, including any sewer exceedence, will propagate towards the base of these valleys to join one of the two brooks. As such, those streets, highways and properties situated to the base of these valleys adjacent to the watercourse are likely to be more susceptible to either being located within a flow path or in an area of surface water accumulation during a storm event. In particular this is likely to be the case for Morefern Drive, Santolina Drive, Saffron Drive and Columbine Close which are all located in close vicinity to the base of the Wood Brook catchment valley. Inspection of the Environment Agency’s Risk of Flooding from Surface Water dataset¹ appears to illustrate this likelihood.

Figure 3 shows that elevation of land generally slopes towards the two local brook courses in the area, namely Wood Brook and Oakwood Brook. Generally across the area slope of land is generally towards the Chaddesden brook in the south. Analysis of sewer records has revealed that the public surface water sewer system serving the worst affected areas of the investigation site (Bishops Drive, Morefern Drive, Columbine Close, Santolina Drive and Saffron Drive) also serves a very large urban catchment encompassing the majority of Oakwood, as described in Section 2.1.

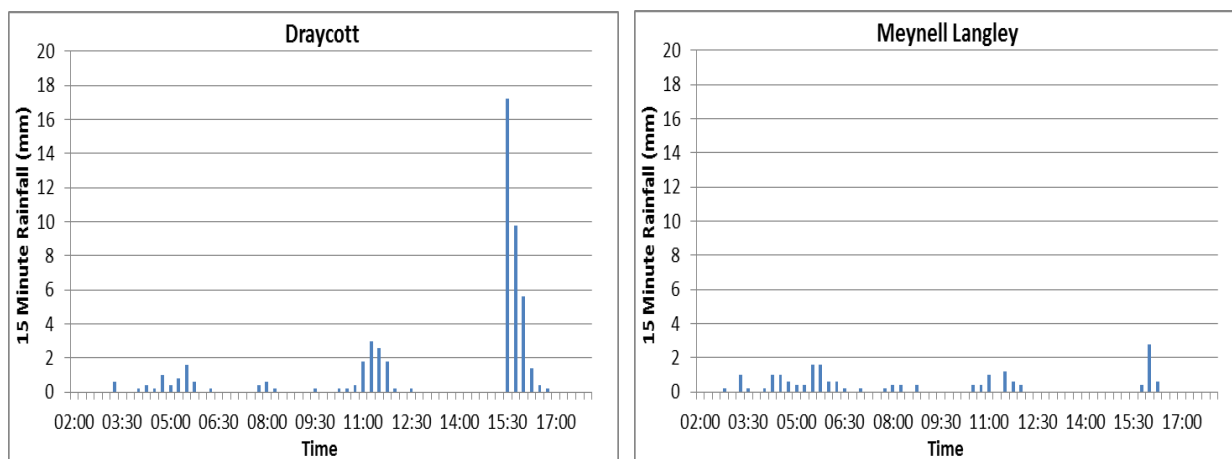
Figure 6: Comparison of 15 minute rainfall intervals on 19th July 2014 recorded at rain gauges at Draycott (8km south east of Oakwood) and Meynell Langley (9km west of Oakwood) (Data Source: Environment Agency)

Analysis of the rainfall data at Draycott has indicated that the 15 minute rainfall event where 17.2mm of rain fell is estimated to be up to a 1 in 50 year return period (1.67% annual probability) event for this duration. The storm resulted in a significant volume of surface water generated from paved areas and later public open green spaces rapidly entering local drainage systems.

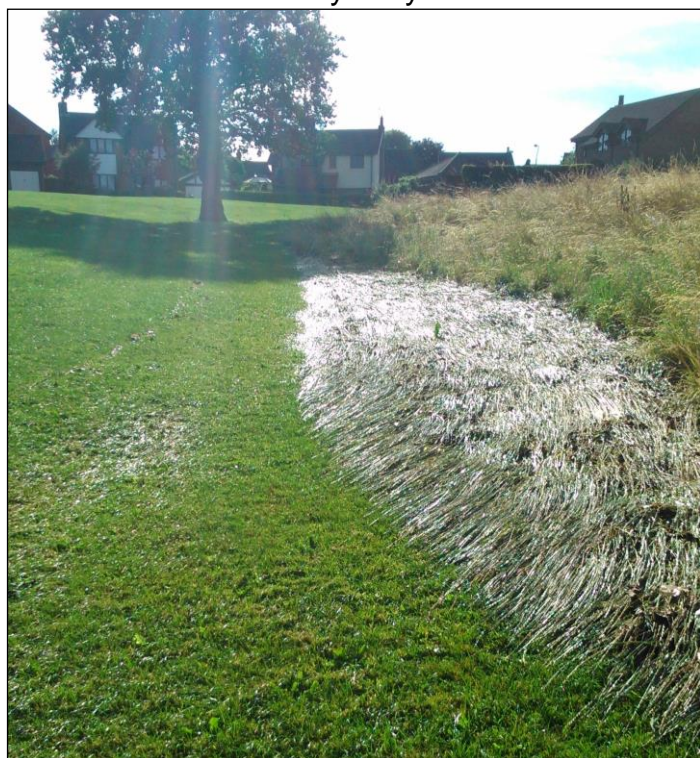
Figure 8: Slope of Chandlers Ford Recreation Ground from Chandlers Ford towards Morefern Drive. Flattened vegetation illustrates the flow of water over the land.

originating directly from the recreation ground and travelled towards the boundary of properties on Morefern Drive and the recreation ground.

It is believed that the excess volume of surface water at this point which could not enter the Wood Brook through limited capacity spilled under the boundary fences of gardens and entered at least one property internally. Anecdotal information indicates that the Wood Brook at this point may have been affected by the presence of detritus resulting from improper disposal of loose materials by individuals into the watercourse.

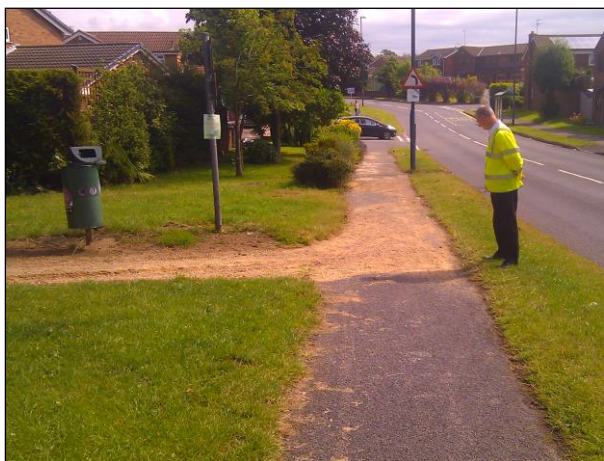
In addition to the surface water sourced from the highway, it can be observed that much of the Bishops Drive Recreation Ground drains via natural topography towards Bishops Drive and to the junction with Earls Crescent. This could be observed by the inflow of soil and sediment from the recreation ground onto Bishops Drive as illustrated in Figure 9. It was also observed shortly after the event by DCC officers as well as from reports from residents that foul water flooding was experienced in this area of Bishops Drive, although there is no evidence available to suggest this affected internal living areas of properties. Figure 10 illustrates foul water flooding from the Severn Trent Water foul system shortly after the event.

Figure 9: Wash of soil from Bishops Drive Recreation Ground onto Bishops Drive indicates the flow of surface water from the recreation ground during the event.

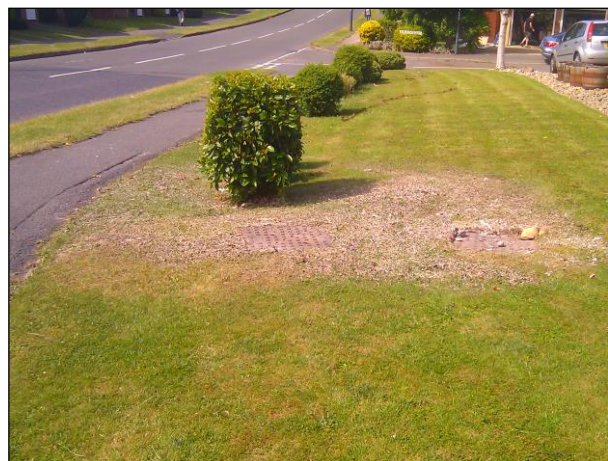
Figure 10: Evidence of foul water flooding near to Earls Crescent during the event, pictured two days after the storm event.

Reports have indicated that there was foul water flooding in the investigation area during the event on 19th July 2014. This included a report of internal foul water flooding on Springwood Close where pressure in the system forced water back up into the ground floor toilet of the property. Records indicate that the area is drained by separate foul and surface water systems, with the advantage being that this should remove the likelihood of inundation of foul systems with surface water during extreme rainfall events. As the runoff from the rainfall event appears to have entered and flooded some foul water sewers in the area, there is the possibility that misconnections exist whereby surface water is inadvertently piped into a foul water pipe. Severn Trent Water, as the water and sewerage undertaker for the area, has the responsibility for managing flood risk from the waste water system.

Severn Trent Water should investigate any incidences of foul water flooding reported to them in the area for this event on behalf of the residents affected.

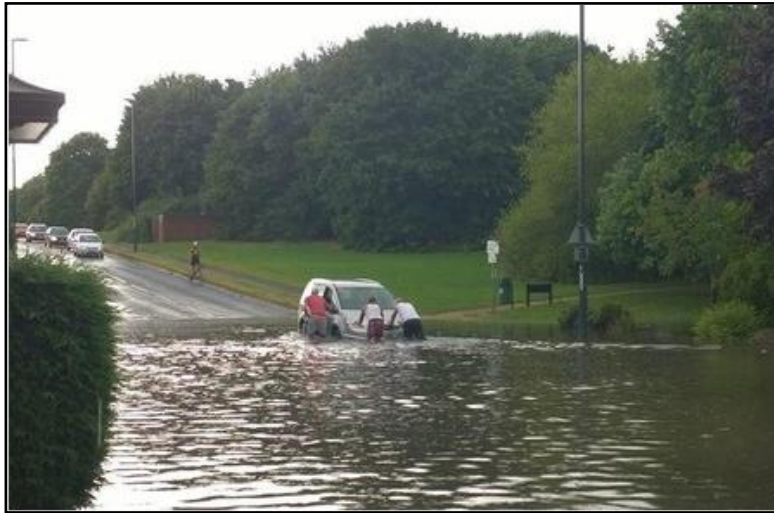
Aside from the streets described above where Bishops Drive has either acted as a source or conduit to surface water runoff, Bishops Drive was the receptor of significant highway flooding near to the junctions with Earls Crescent. It is also believed that up to ten properties in this area of Bishops Drive were flooded internally by surface water, but this to date unconfirmed.

This junction of Bishops Drive and Earls Crescent is a local topographical low point and is identified in Figure 3 above as being at the head of the Oakwood Brook valley (although Oakwood Brook rises further to the south of this point). For this reason, surface water has the tendency to flow towards this junction and to the south if it is not directed elsewhere by surface water drainage systems. As such, during the storm event on the 19th July 2014, surface water resulting in over-capacity of the local sewer system propagated towards this area causing the identified surface water flooding.

Figure 11: Resident's photo of the flooding of Bishops Drive at the Earls Crescent junction on 19th July 2014 (Source: Derby Telegraph)
