# Section 19 Report

## Markeaton

Derby City Council

09 December 2014

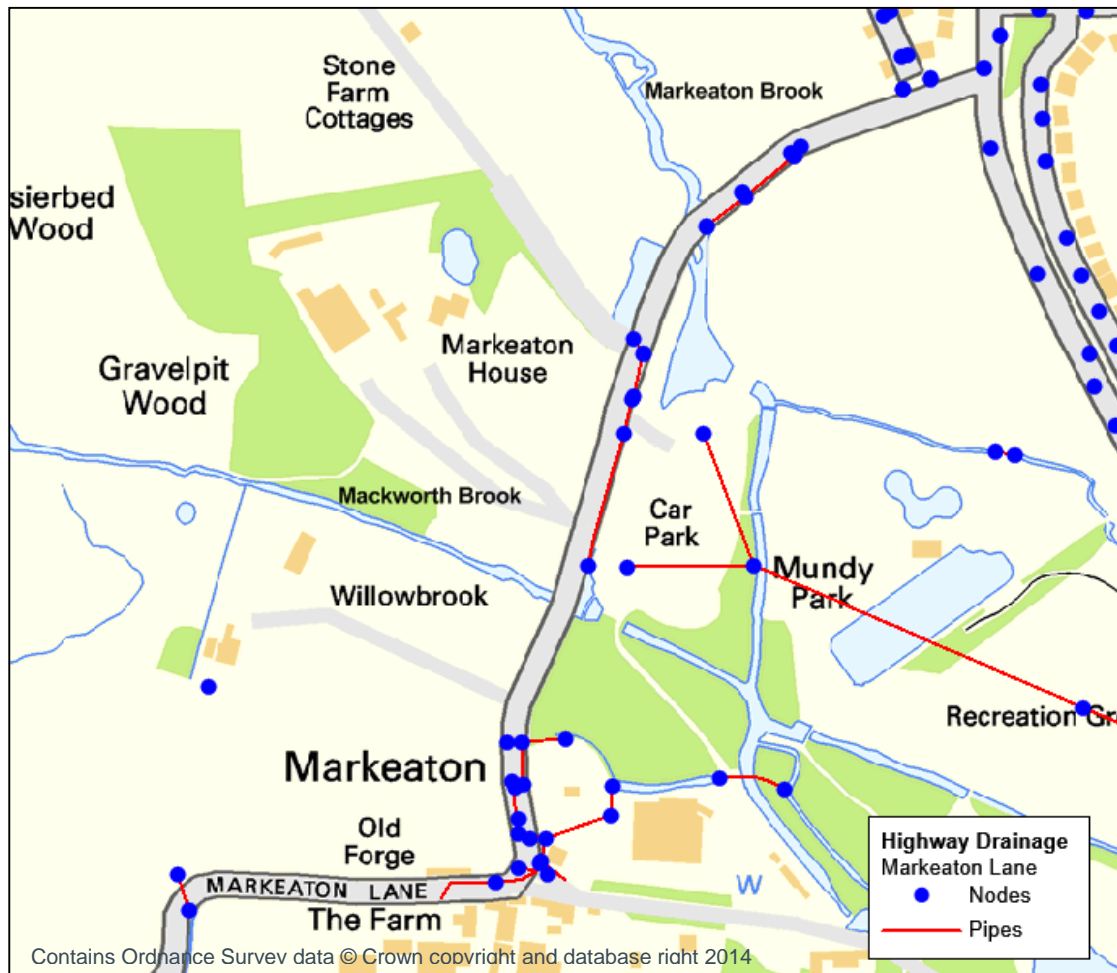
Figure 2-1 Existing drainage along Markeaton Lane

Markeaton Lane has an existing drainage system in place. A model schematic of this drainage systems is shown in Figure 2-1, whereby pipes reflect the pipe network and culverts, and the nodes represent the inlet and outlets to this system. The drainage system schematic, Figure 2-1, shows that surface water on Markeaton Lane in Markeaton enters the ditch located between the village of Markeaton and Mackworth

Brook. The schematic also shows a separate system to the west of Markeaton that discharges into Mackworth Brook upstream of the study area.

The current drainage in Markeaton is reliant on free discharge to the ditch located between the village of Markeaton and Mackworth Brook. The outfall from this ditch is limited to prevent flooding to numerous downstream properties. There is potential to improve the drainage system within this area, as discussed in the Markeaton Brook and Mackworth Brook technical note (Atkins, 2014). These improvement proposals are for schemes such as redirection of the drainage system to enter the Flood Relief Culvert, which is considered by DCC to have sufficient capacity to receive this additional runoff. However a scheme to redirect the surface water drainage would be highly costly and unlikely to be considered economically feasible.

The second area where potential drainage improvements could be considered is within the existing drainage system in Markeaton, which is currently limited owing to the outfall to the ditch located between the village of Markeaton and Mackworth Brook. There is potential that the drainage system could be improved, although it is considered unlikely that a system to provide significantly higher capacity would be cost beneficial.

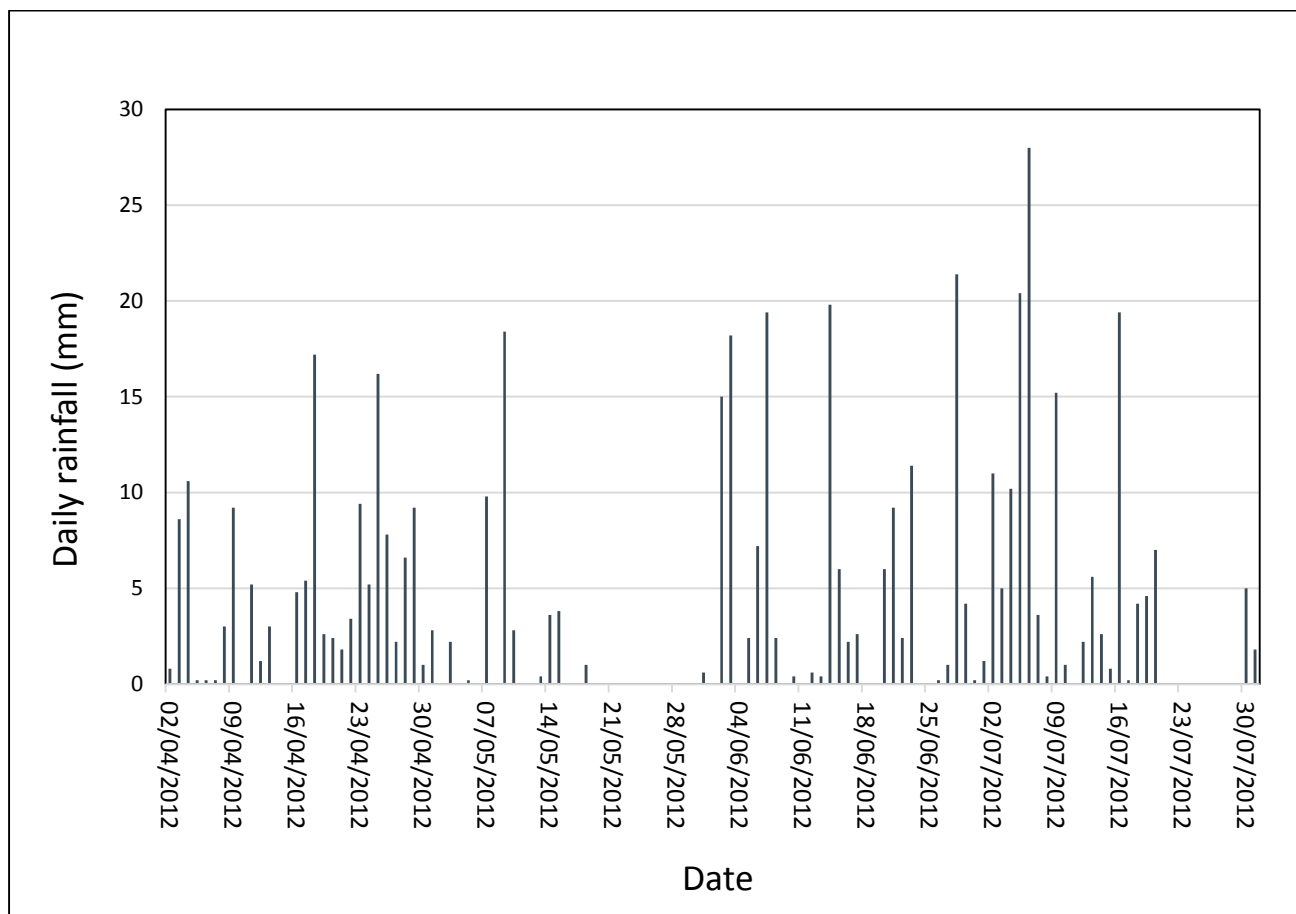
**Figure 4-1 Daily rainfall totals at the Meynell Langley gauge**

The rainfall severity analysis indicates that a storm occurred within the catchment on the 28<sup>th</sup> June, which based on the data available for closest gauge, has been estimated to have an annual probability of greater than 1 in 7. There are no records of flooding occurring on or immediately after this June event. It is also evident that rainfall continued between this storm and the event that occurred on the 6<sup>th</sup> July. This supports the theory that the ground became saturated at the end of June 2012, potentially during the rainfall on 28<sup>th</sup> June 2012 and that continued rainfall between this date and early July caused the ground to remain saturated.

Based on the information supplied from the three rain gauges it is considered that the rainfall event that potentially caused the flooding on the 6<sup>th</sup> July is more frequent than the 1 in 15 annual probability event. A storm with a 1 in 15 annual probability is not considered extreme under normal conditions such as when a proportion of the rainfall can infiltrate the ground. However as a result of earlier storms and continued rainfall until the 6<sup>th</sup> July storm, the ground had become and remained saturated resulting in minimal infiltration during
