Darley Abbey Bridge

Heritage Statement Baseline Understanding & Geoarchaeological Assessment

authors: Mel Morris & Kristina Krawiec (dated 14/10/2025 – v6)

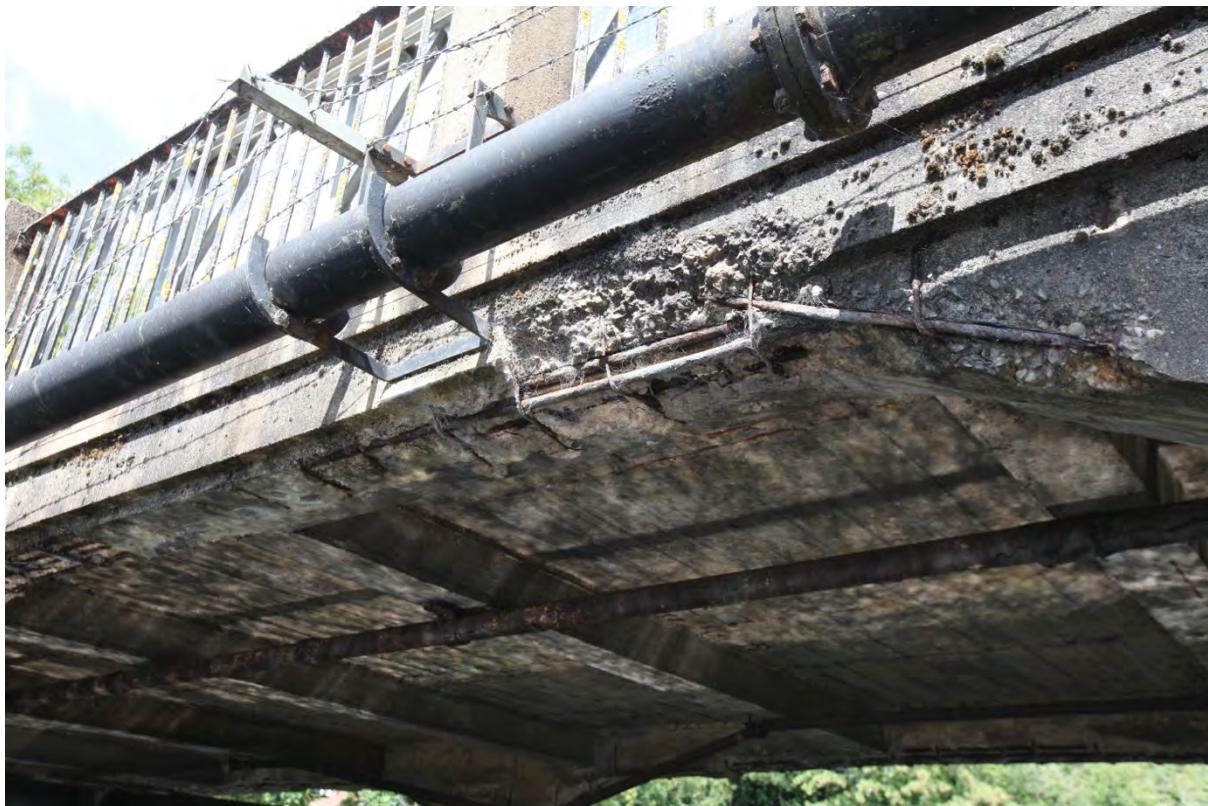
Fig.28 View of downstream face with corroded rebar and spalled concrete, sewer pipe to the side and gas pipe to the soffit (8.8.25)

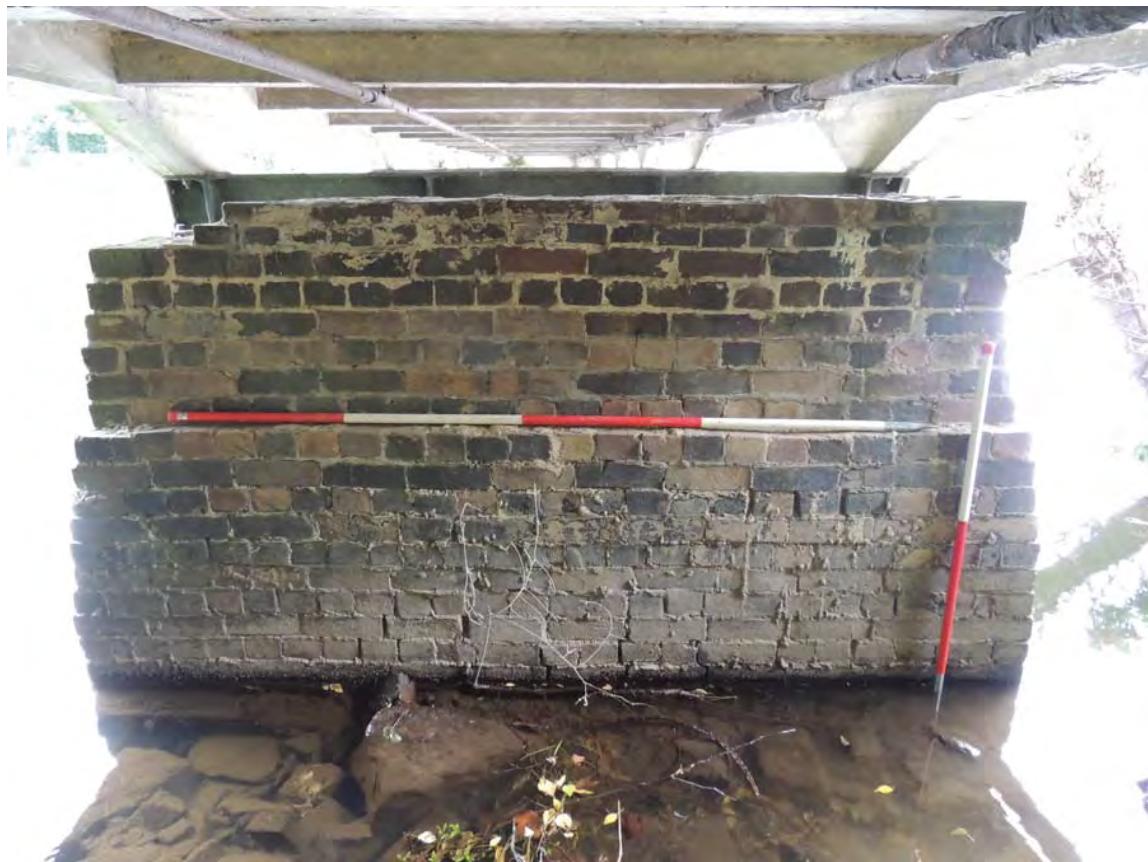
Fig.29 Brick pier photographed in 2013 by LP Archaeology, now missing.

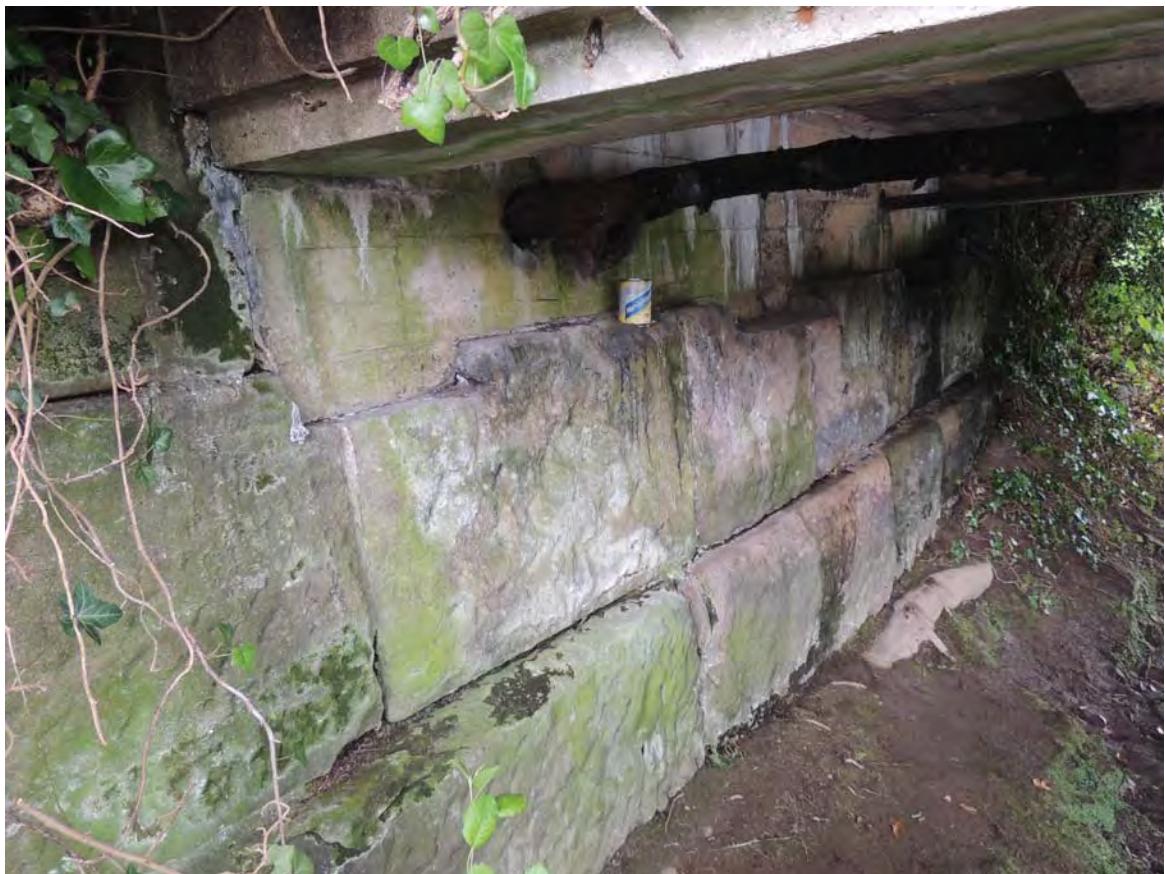
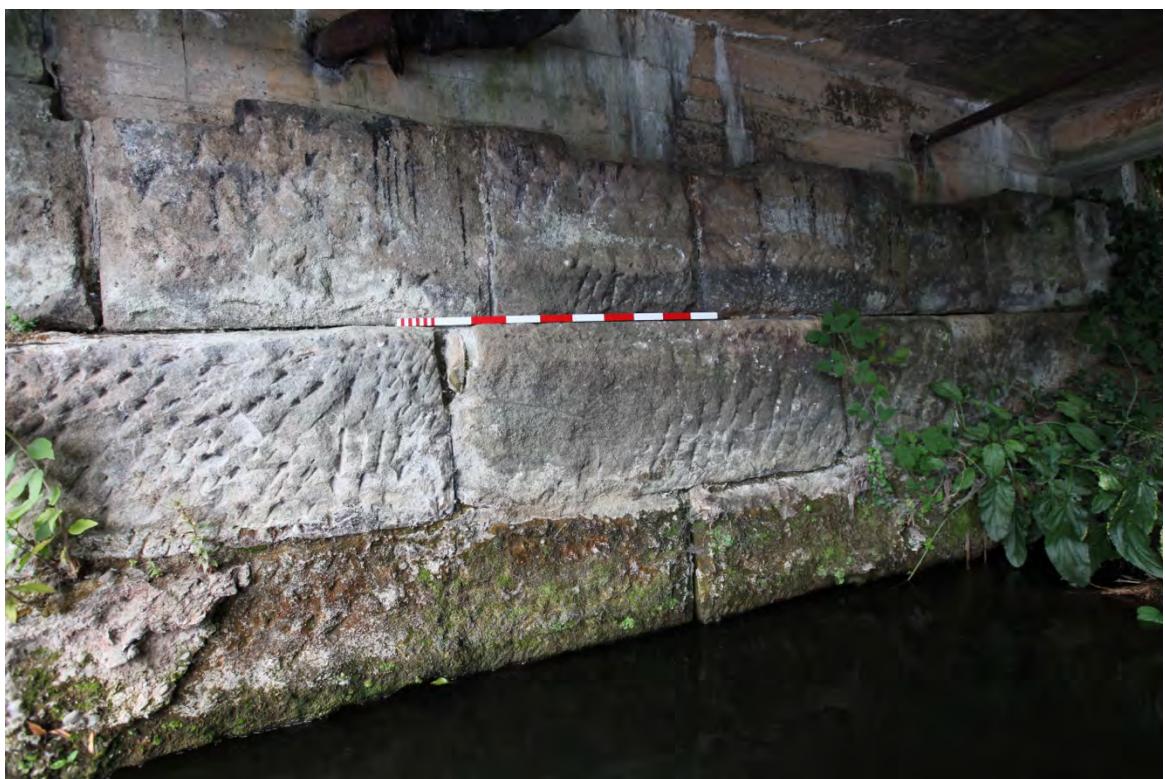
Figs.30 & 31 Revetment wall to west abutment photographed in 2013 by LP Archaeology. Compare this with the same wall in 2025 (below).

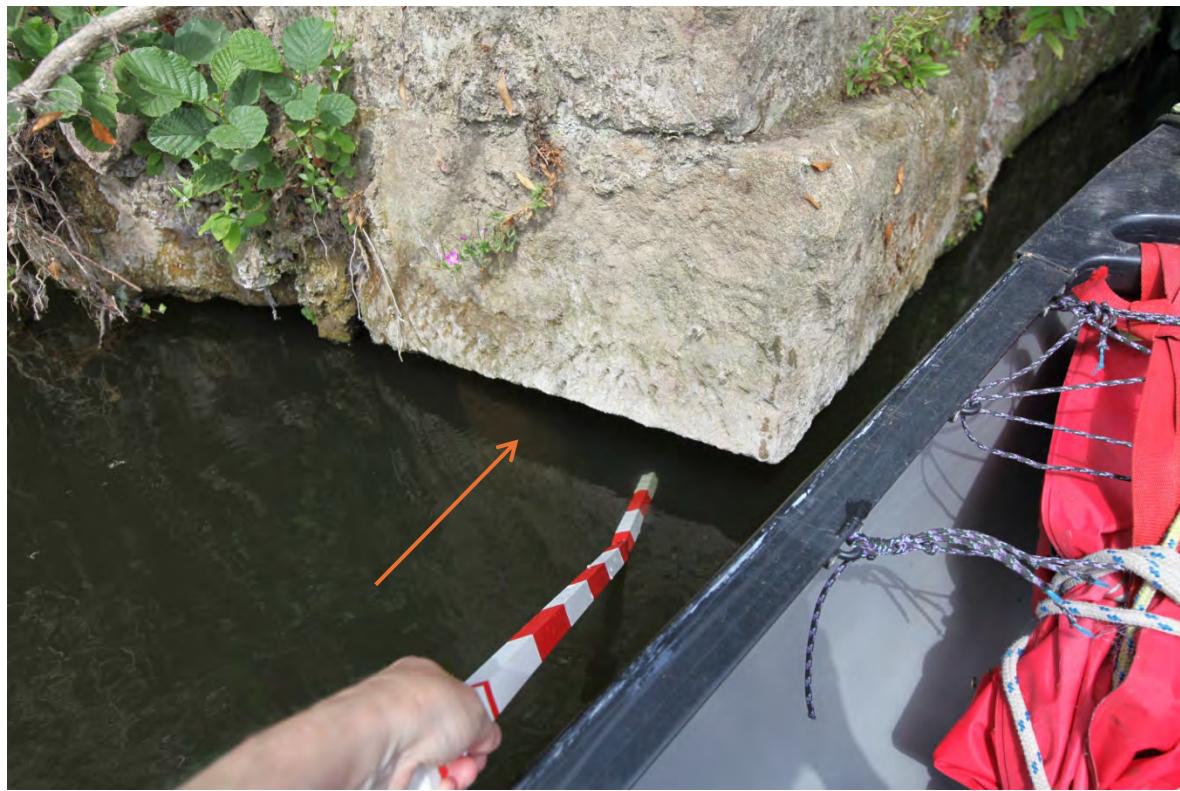
Fig.32 Undercut to right abutment of 1.5 metres, with pile arrowed (8.8.2025).

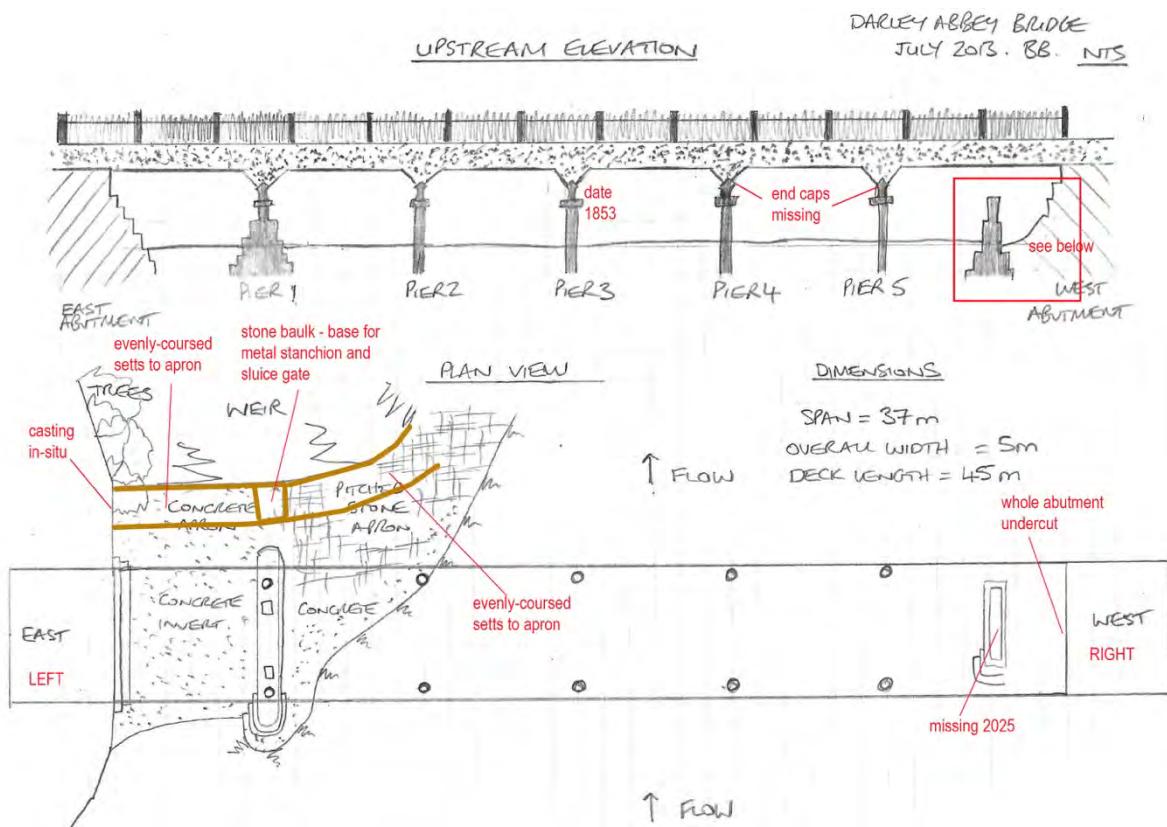
Fig.33 2013 Divers sketch annotated 2025.

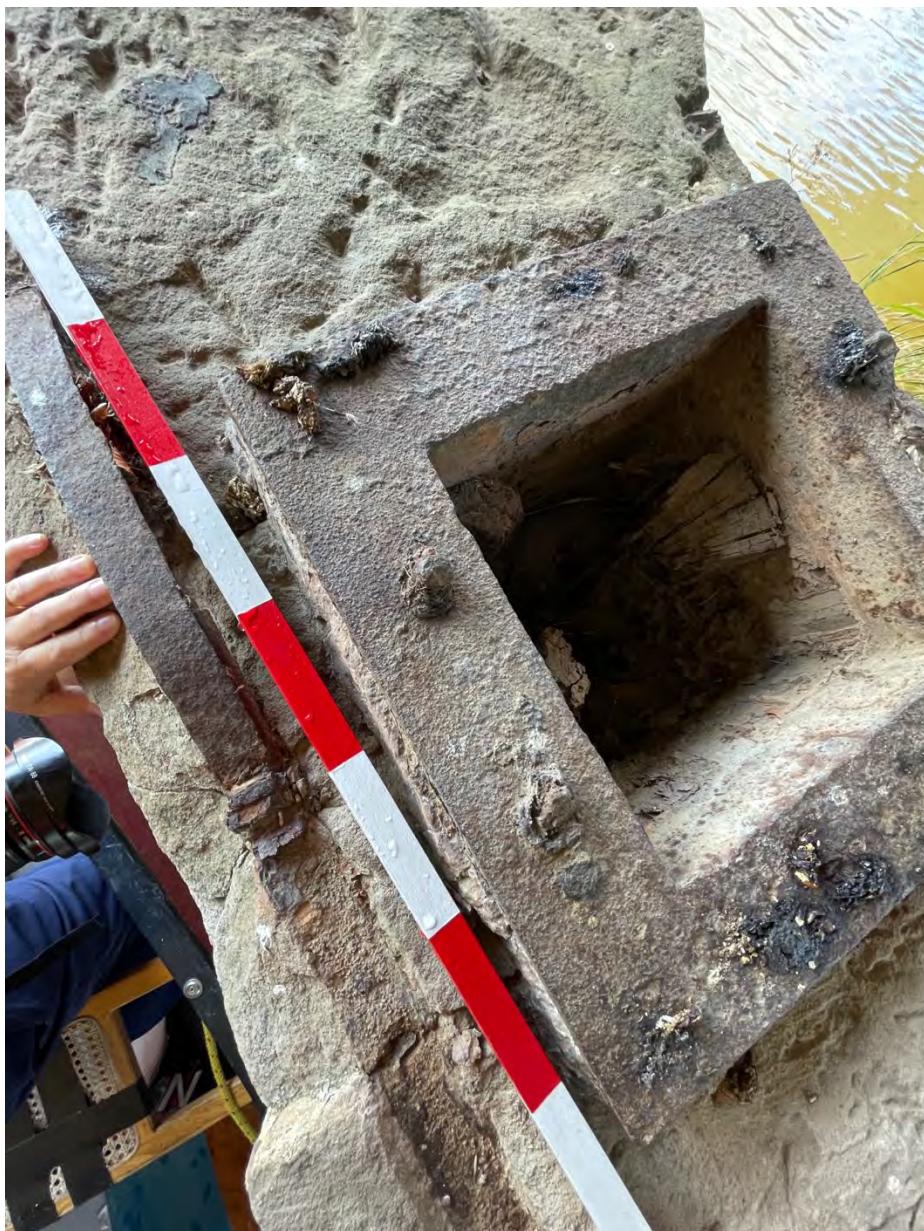
Fig.38 Cast-iron square collar with inset casting surrounding a timber post (parts of which are visible) let into the upper face of the stone pier and bolted to the upper face with 4 corroded bolts. The outer edge of the collar measures approximately 500 x 500mm. Off-set is a wrought-iron cramp 350mm long inset into the stone at the joint between two large masonry blocks and another channel cut for a wrought iron cramp which is missing. The stone appear to have delaminated at the outer edge, where it is fractured and a weak spot – 8.8.2025.

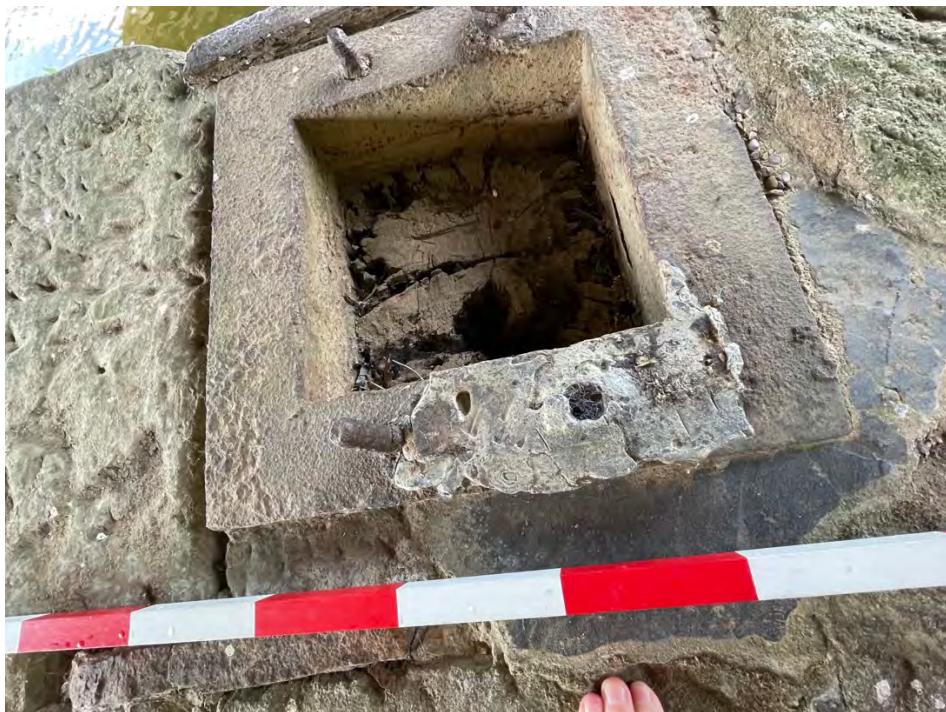
Fig.39 Stone pier with second cast-iron square collar, slightly smaller, approximately 400mm x 400mm. Four corroded bolts to the upper face, one with a surviving threaded nut. Inset timber post with heartwood. Wrought-iron masonry cramps are visible (bottom left of image and top) – 8.8.2025.

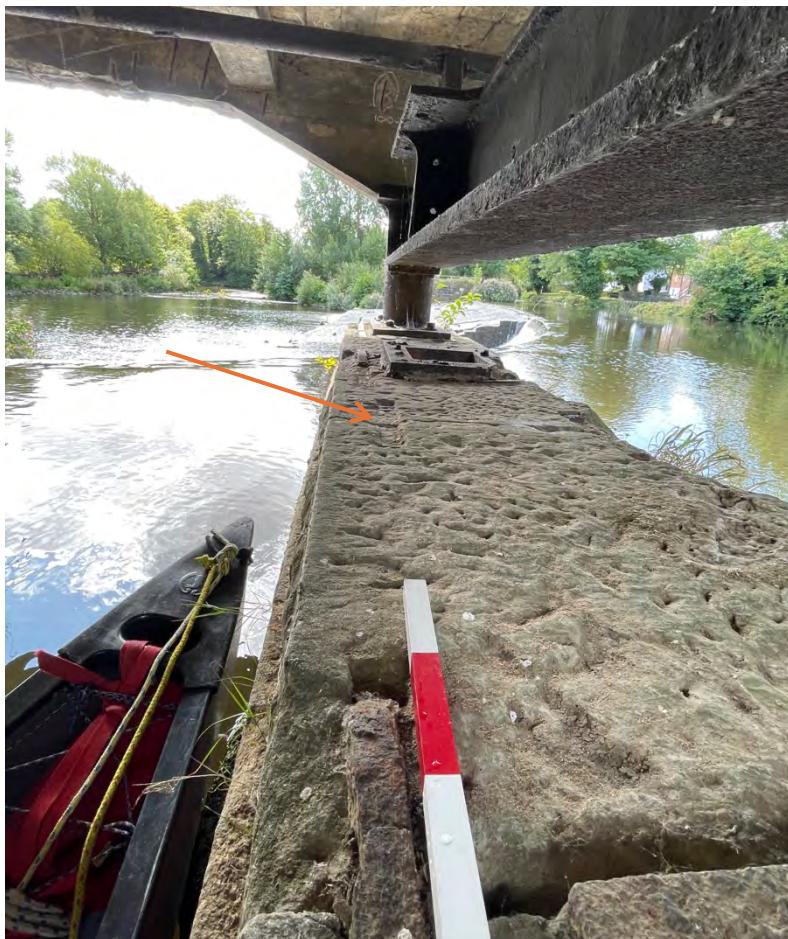
Fig.40 Stone pier with masonry upper face. Some wrought-iron masonry cramps are missing but the channel remains (arrowed) – 8.8.2025.

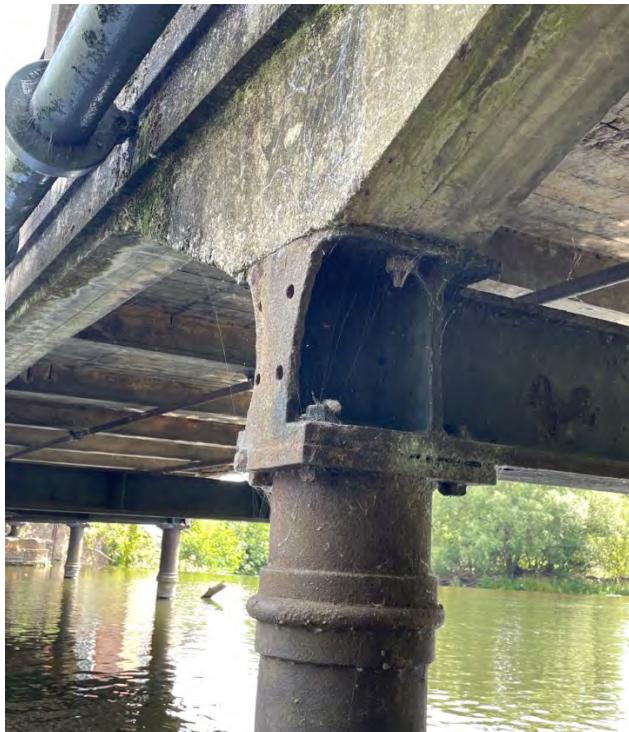
Fig.41 Tapered end of cast-iron beam, with four holes for dowels. The end cap is missing to this beam - 8.8.2025.

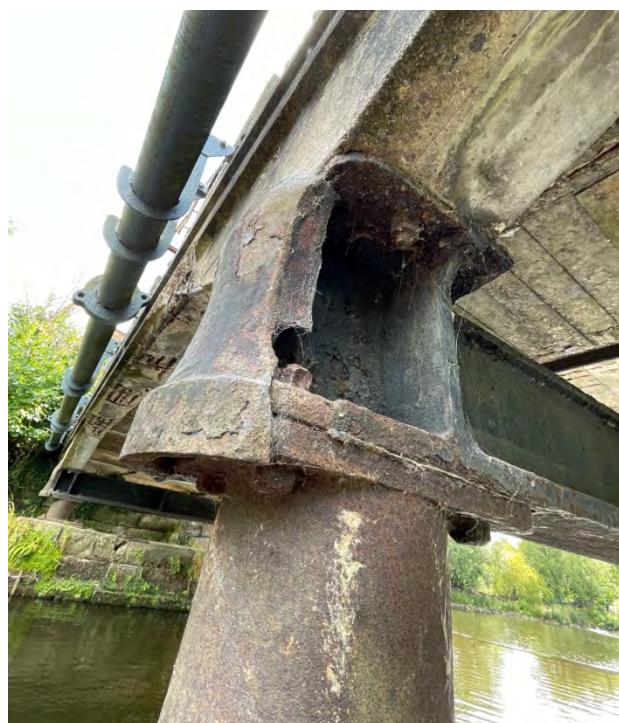
Fig.42 Castings for the beam and post meet with a flat joint which is part covered by the bell-shaped end cap. Here there is some local corrosion which has exposed one of the bolts - 8.8.2025.

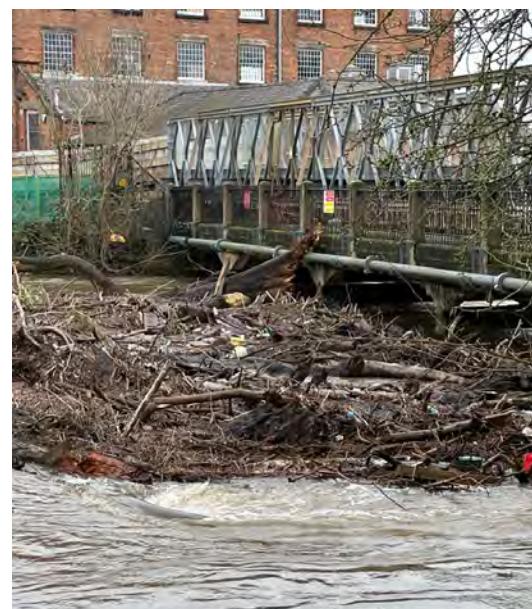
Fig.48 Debris build-up against bridge following during 2024 floods (image – Derby City Council engineers).
