Derby Retail Study

Zone 2 – Littleover Accessibility & Infrastructure Appraisal

Curtins Ref: TPNO66625-CUR-00-XX-RP-TP-00002

Issue Date: 13 May 2019

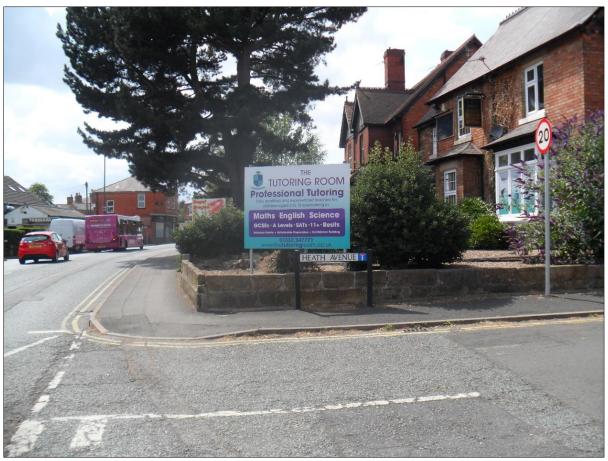
3.2.1 The local speed limit on A5250 Burton Road and majority of surrounding roads is 30mph, some local residential roads connecting with Burton Road have a speed restriction of 20mph in place as shown in **Figure 3.1**.

Figure 3.1 20mph Speed Limit on Heath Avenue (residential road)

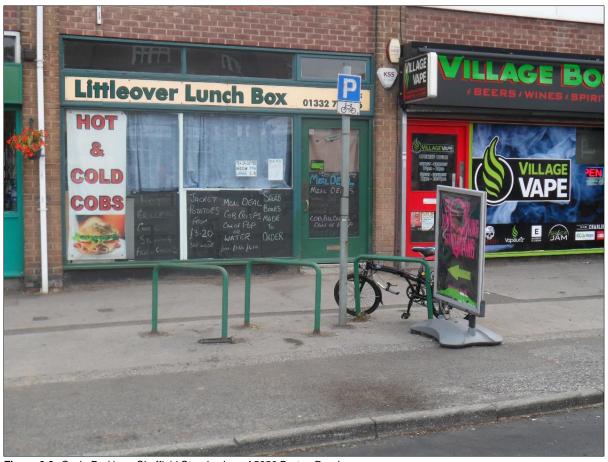
3.4.2 There is cycle parking for up to 18 bikes within the main shopping area, along A5250 Burton Road. The cycle parking location is in a convenient and safe position, conveniently located along the main frontage of the shops and is overlooked. **Figure 3.2** shows Sheffield cycle parking stands outside a sandwich shop, along the A5250 Burton Road.

Figure 3.2 Cycle Parking - Sheffield Stands along A5250 Burton Road

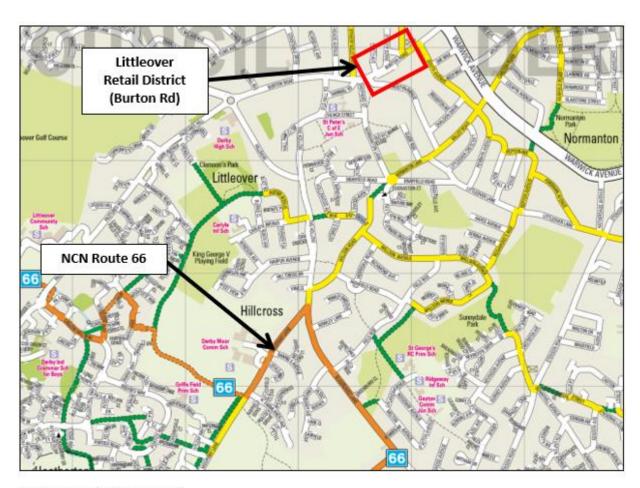
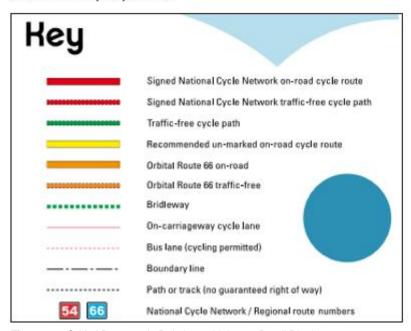
falls within the Derby City Council's recommended unmarked on road cycle route shown in **Figure 3.3**. National Cycle Network (NCN) Route 66 lies approximately 1 km south-west of the retail area.

3.4.3 Figure 3.3 shows the Orbital Route 66 and its location in relation to Littleover Retail District.

Figure 3.3 Orbital Route 66 in Relation to Littleover Retail District

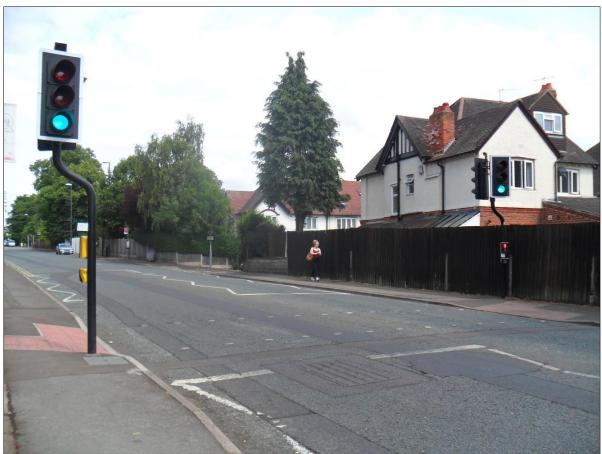
3.6.2 There is a pelican crossing facility with dropped kerbs and tactile paving on Burton Road, near The Half Moon Pub, shown in **Figure 3.4**. There is also another pelican crossing facility with dropped kerbs and tactile paving, linking Burton Road with the main shopping area, outside the Pharmacy. Both crossing facilities are appropriately located to enable safe crossing of Burton Road and provide access to surrounding bus stops. Both crossings are well maintained and are in good condition.

Figure 3.4 Pelican Crossing on A5250 Burton Road

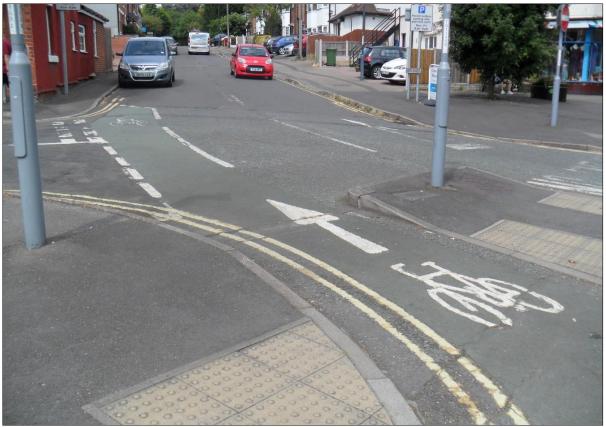
3.6.6 Footways have been provided in appropriate locations and they are in good condition, with dropped kerbs. Two-way access for cyclists onto North Street, which is a one-way street for vehicles, is shown in **Figure 3.5.**

Figure 3.5 Cycle Access on North Street

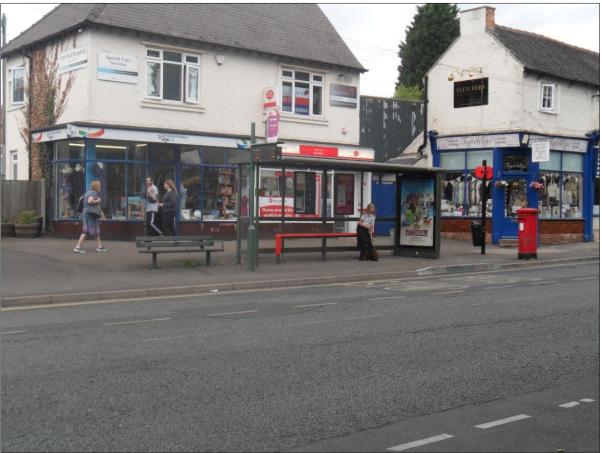
4.1.1 There are two bus stops on A5250 Burton Road. The northeast bound services are accessible via a bus stop outside The Half Moon Inn and South west bound services are available via the bus stop outside the Iceland food store in the main shopping area. Both bus stops have a shelter with seating, timetable and real time information, raised kerb and a bus cage within the carriageway.

Figure 4.1 North-bound bus stop on A5250 Burton Road

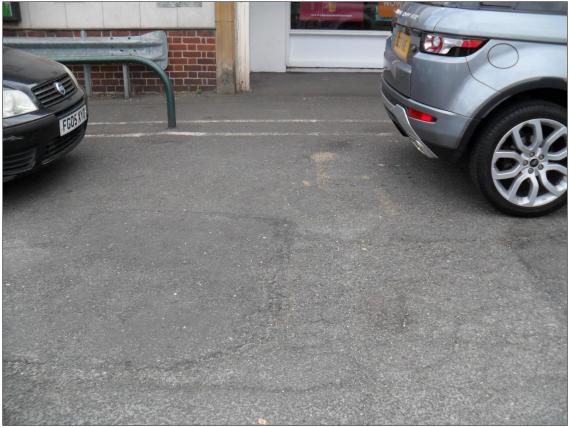
- 5.1.2 There are approximately 20 standard parking bays, three disabled bays and one parent & child parking bays provided within the shopping area, along the main frontage of the shops. Some of the disabled bay markings near Thomas Cook, are fading and will need re-painting, as shown in **Figure 5.1.**
- 5.1.3 There is off street parking provision adjacent to the Pharmacy on Burton Road. This parking area does not have formal parking bays marked out and from observations at the time of survey, appeared to accommodate approximately seven vehicles.
- 5.1.4 Parking was observed along Burton Road outside Co-operative Funeral care where approximately 11 vehicles could be accommodated.
- 5.1.5 There are approximately 92 standard, nine disabled and one parent and child car parking bay at The Co-operative food store.

Figure 5.1 Faded Disabled Bay Marking on A5250 Burton Road

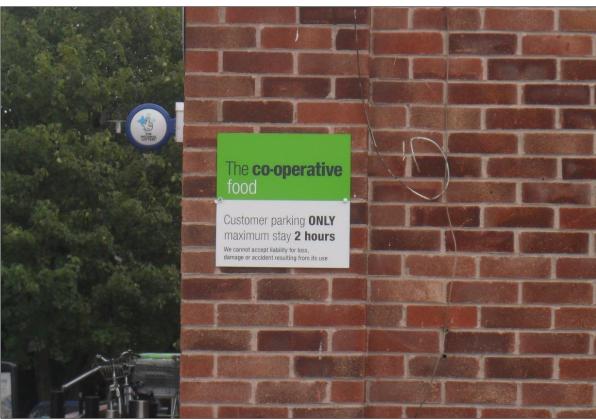
- 5.2.2 Car parking facilities along the shop frontages do not have time or monetary restrictions.
- 5.2.3 Cars occupying the Co-operative food store parking bays have a maximum stay of two hours, as shown in **Figure 5.2**

Figure 5.2 Co-op Car park - Parking Time Restriction

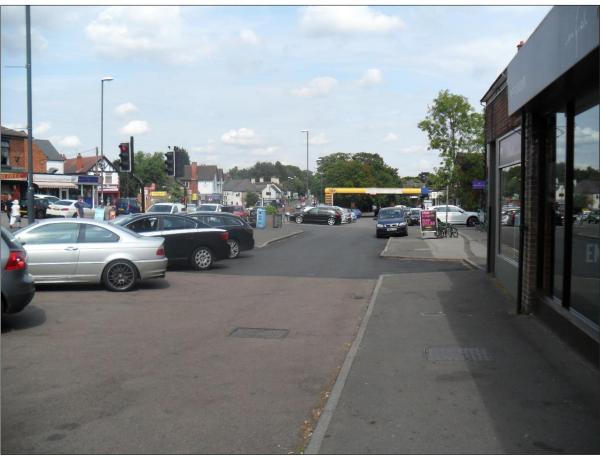
6.1.1 The shopping area is open and spacious, functional and tidy, and planters are introduced within the retail area to improve the attractiveness of the area. **Figure 6.1** shows the parking area outside the main shopping area.

Figure 6.1 Littleover – Shopping Area (A5250 Burton Road)

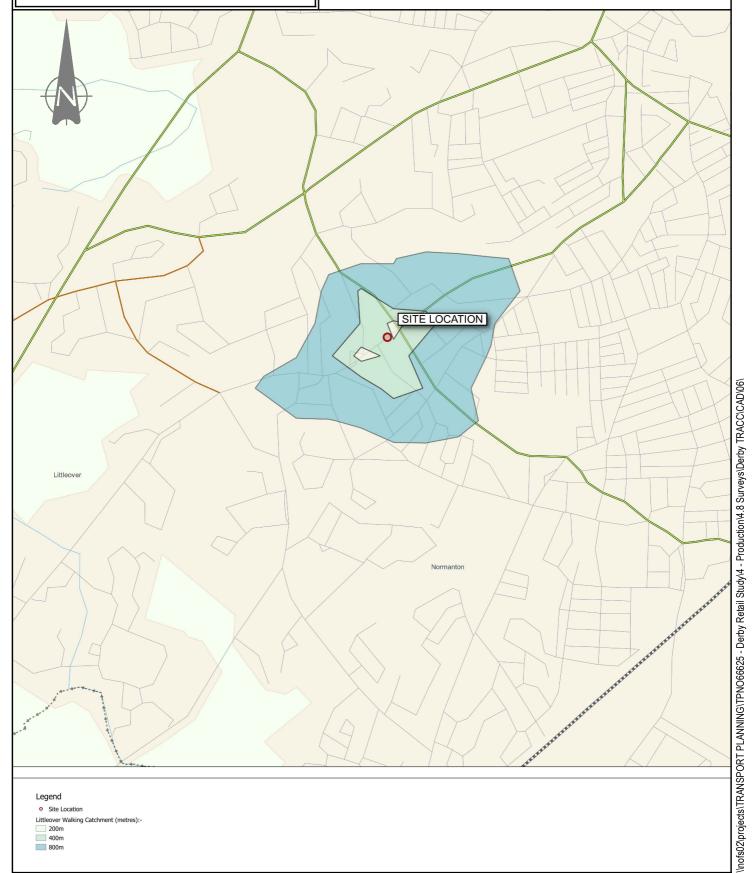
66625 - CUR - 00 - XX - DR -TP - 06004 - P01

- 7.2.4 To assist in summarising the accessibility of the site by foot, an indicative pedestrian catchment plan has been produced. Plan 066625–CUR-00–XX-DR-TP-06004–P01. shows distances of 200m, 400m, and 800m which reflect the 'Preferred Maximum' for retail trips, by the CIHT.

- 7.2.5 The pedestrian catchment plan confirms that the site is situated within walking distance of a number of existing residential areas. The pedestrian catchment plan demonstrates that the much of the retail district's existing catchment area is within 400 metres walking distance of the site. The catchment area also demonstrates that existing public transport opportunities such as local bus stops on A5250 Burton Road are within 800 metres of the retail area, which reflect the 'Preferred Maximum' for commuting trips, by the CIHT. The pedestrian catchment plan confirms that local residents, employees and visitors could access sustainable transport opportunities within the area which could help to reduce future private car use.

- 7.2.6 The 800m pedestrian catchment plan shows that Littleover Retail District is accessible by the majority of Littleover residents, within the preferred maximum walking distance for trips on foot.

ACCESSIBILITY WALKING CATCHMENT

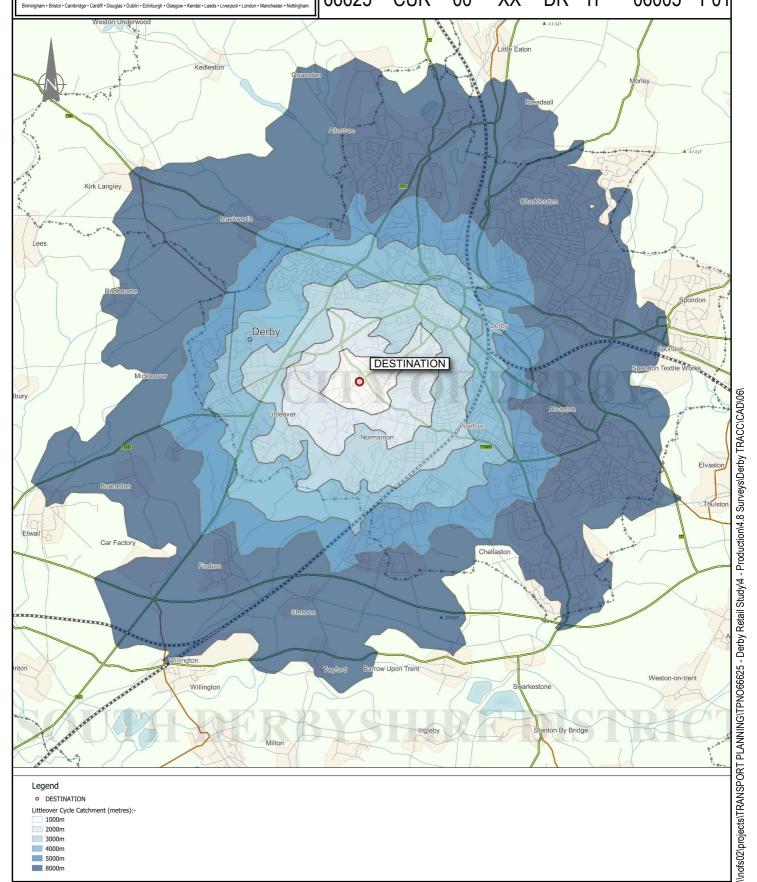
66625 - CUR - 00 - XX - DR -TP - 06005 - P01

- 7.3.1 In order to assist in assessing the accessibility of the site by cycle, Plan 066625–CUR-00–XX-DR-TP-06005–P01 presents an eight-kilometre cycle catchment for the site. The eight-kilometre cycling distance refers to a recommendation by Cycling England in the document 'Integrating Cycling into Development Proposals' (2009).
- 7.3.2 The catchment extends as far as Quarndon in the north, Spondon to the east, Twyford in the south and Burnaston to the west.
- 7.3.3 National Cycle Network (NCN) Route 66 lies approximately 1 km south-west of the retail area. Local roads within the surrounding area are relatively flat and are therefore considered to be suitable for cycling.

ACCESSIBILITY
CYCLE CATCHMENT

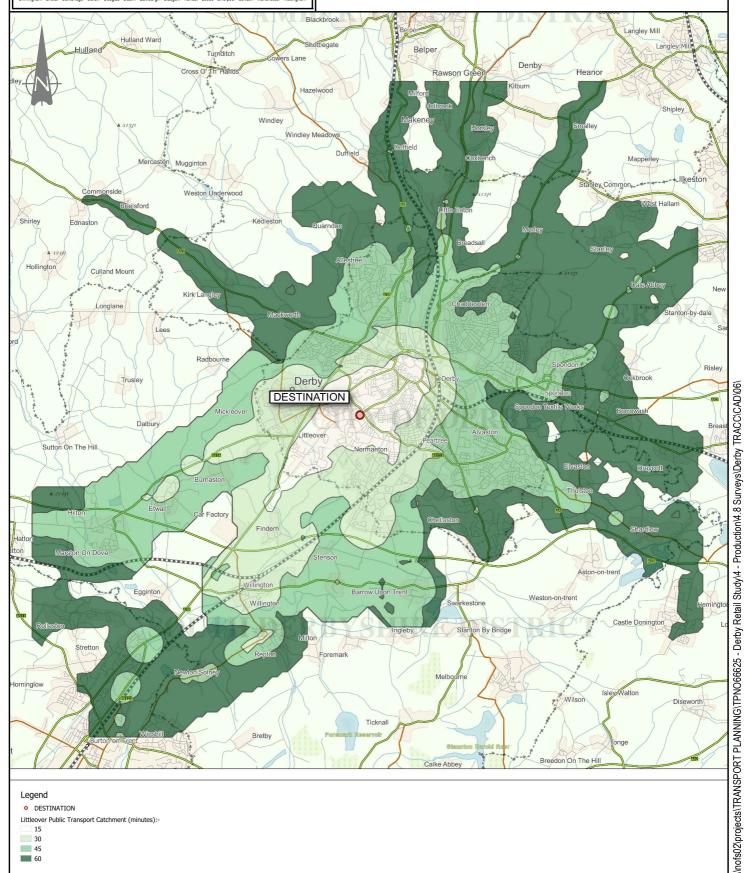
XX - DR -TP -06006 - P01 66625 -

- 7.4.1 Plan 066625–CUR-00-XX-DR-TP-06006–P01 demonstrates those areas accessible via public transport within 15, 30, 45 and 60 minutes journey from the site. Accessibility by bus and rail are considered in further detail within the subsections below.
- 7.4.2 There are two bus stops on A5250 Burton Road (within close proximity to the shopping area), for north and south bound services. Both bus stops have a flag, pole, shelter, seat, timetable, raised kerb and bus cage within the carriageway.

ACCESSIBILITY PUBLIC TRANSPORT CATCHMENT
