Derby Retail Study

Zone 4 – Mickleover

Accessibility & Infrastructure

Curtins Ref: TPNO66625-CUR-00-XX-RP-TP-00004

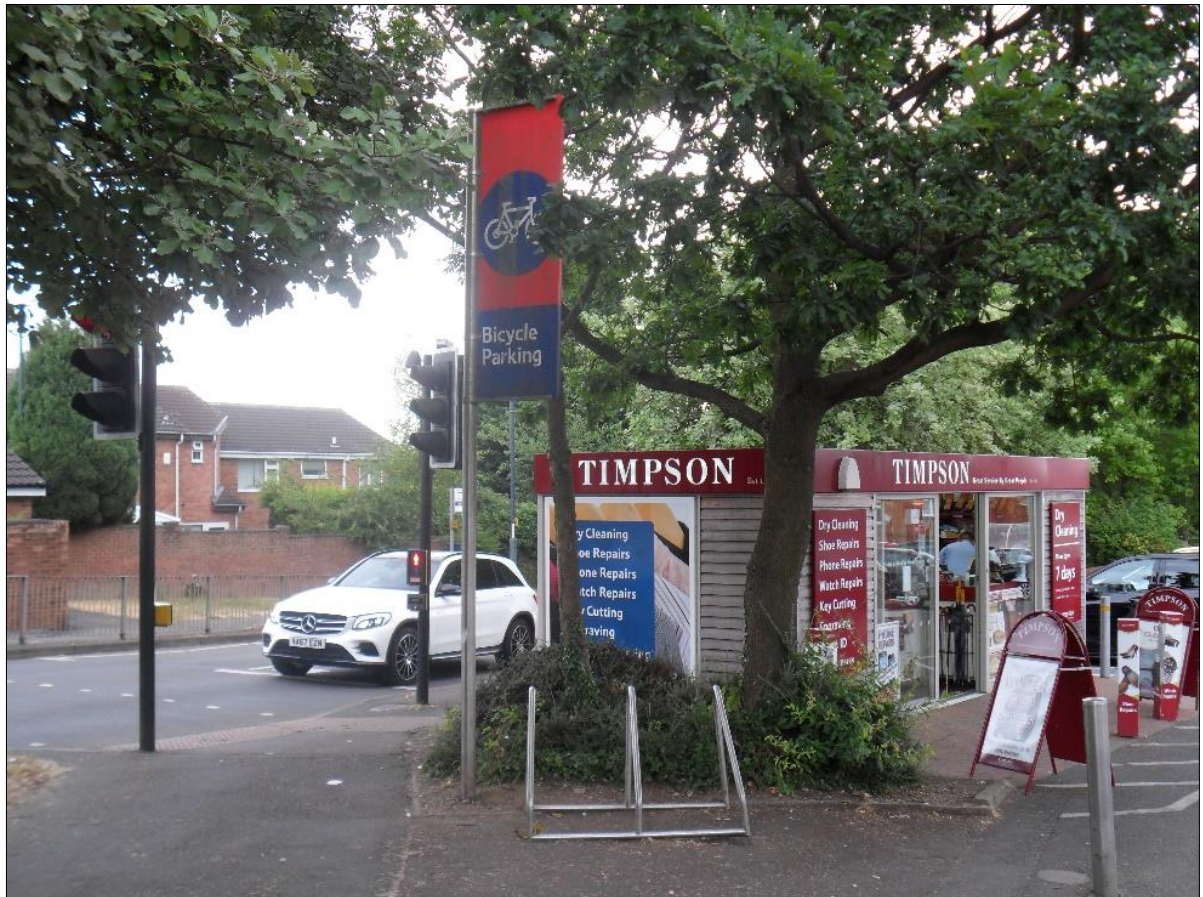
Figure 3.3 Cycle Parking outside Tesco

- 3.4.4 There is cycle parking provision for up to six bikes outside the Tesco store, as shown in **Figure 3.5**.

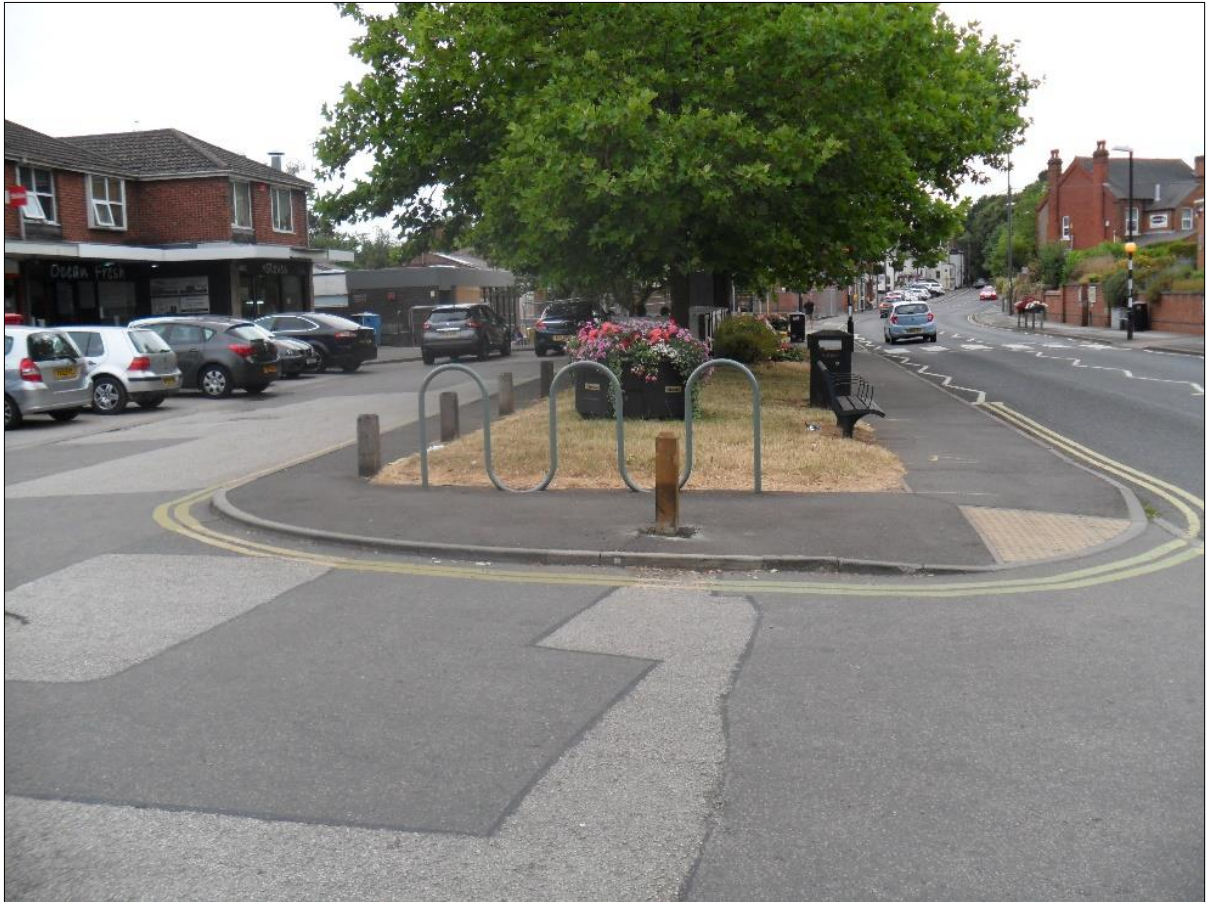
Figure 3.4 Cycle parking at Uttoxeter Rd shopping front

- 3.4.5 There is parking for up to six bikes at the row of shops along Uttoxeter Rd, shown in **Figure 3.6**. The cycle parking location is conveniently located outside the shops and is overlooked during the daytime although the position of the stands has been stationed on the edge of the 2.0m footway, which results in cycles being either parked on the grass or within the footways. The location of the bollard within the footway adjacent to the cycle stands leaves approximately 1.5m width of footway without any cycles present. Once cyclists use this facility the width of the footway will narrow further making the retail area less accessible to footway users, especially the mobility impaired and those with pushchairs.

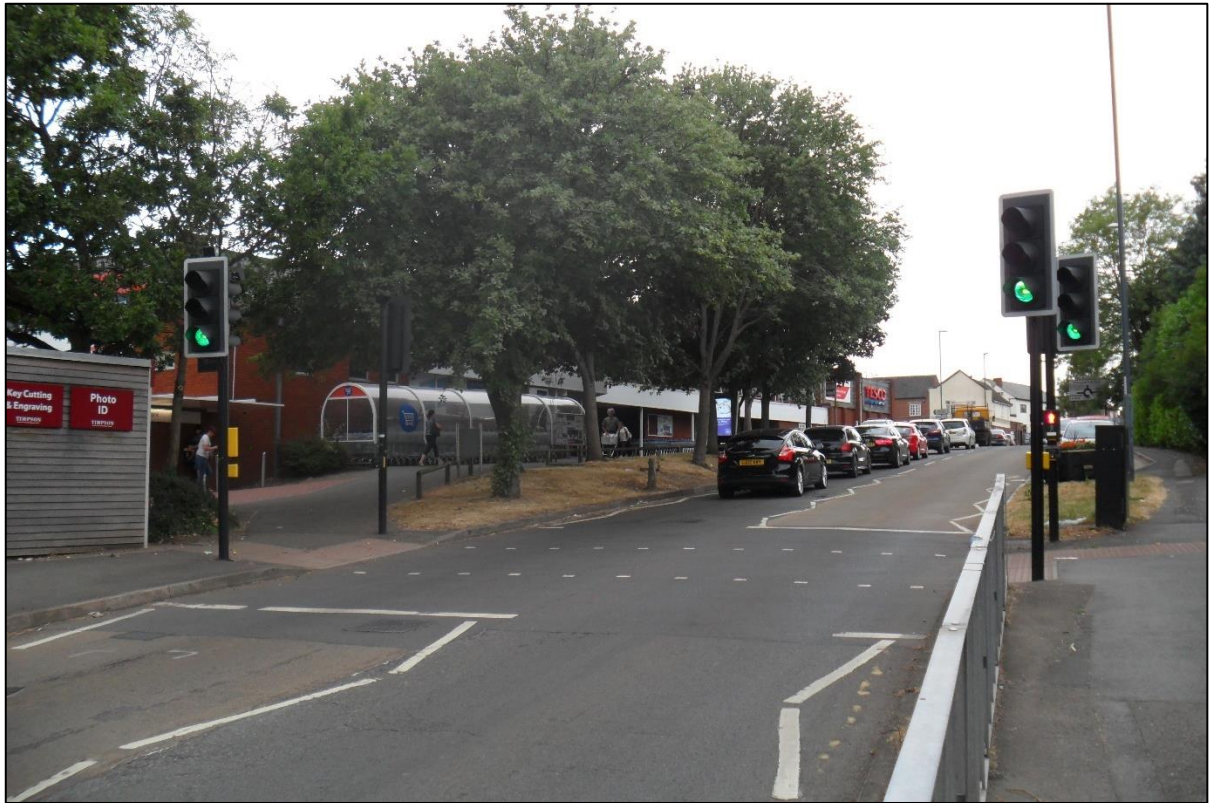
Figure 3.5 Pelican Crossing on Kipling Drive

- 3.6.2 There is a pelican crossing facility with dropped kerbs and tactile paving, linking Kipling Drive to the south of the shopping area, particularly convenient for people going to shop at Tesco, shown in **Figure 3.1**. Surrounding the site there are appropriately located dropped kerbs which also enable crossing of local roads and provide access to surrounding bus stops.

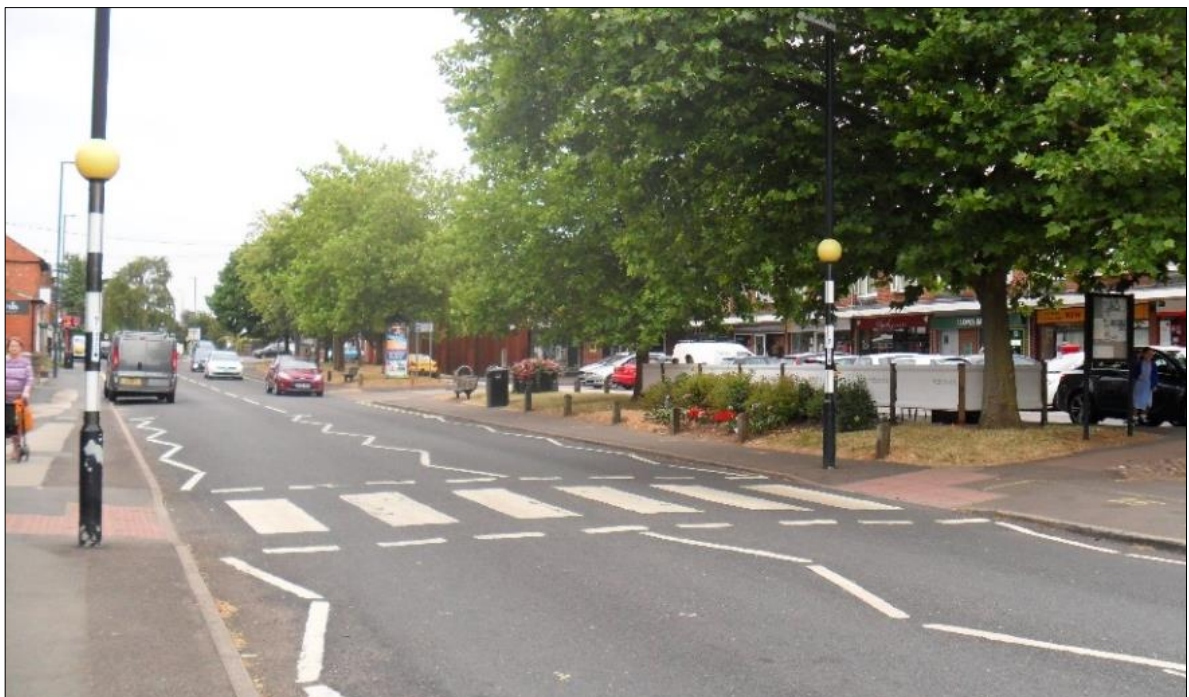
Figure 3.6 Zebra Crossing on Uttoxeter Rd

- 3.6.3 There is a zebra crossing facility with dropped kerbs and tactile paving, providing controlled pedestrian access across Uttoxeter Road to the shopping area, as shown in **Figure 3.2**.

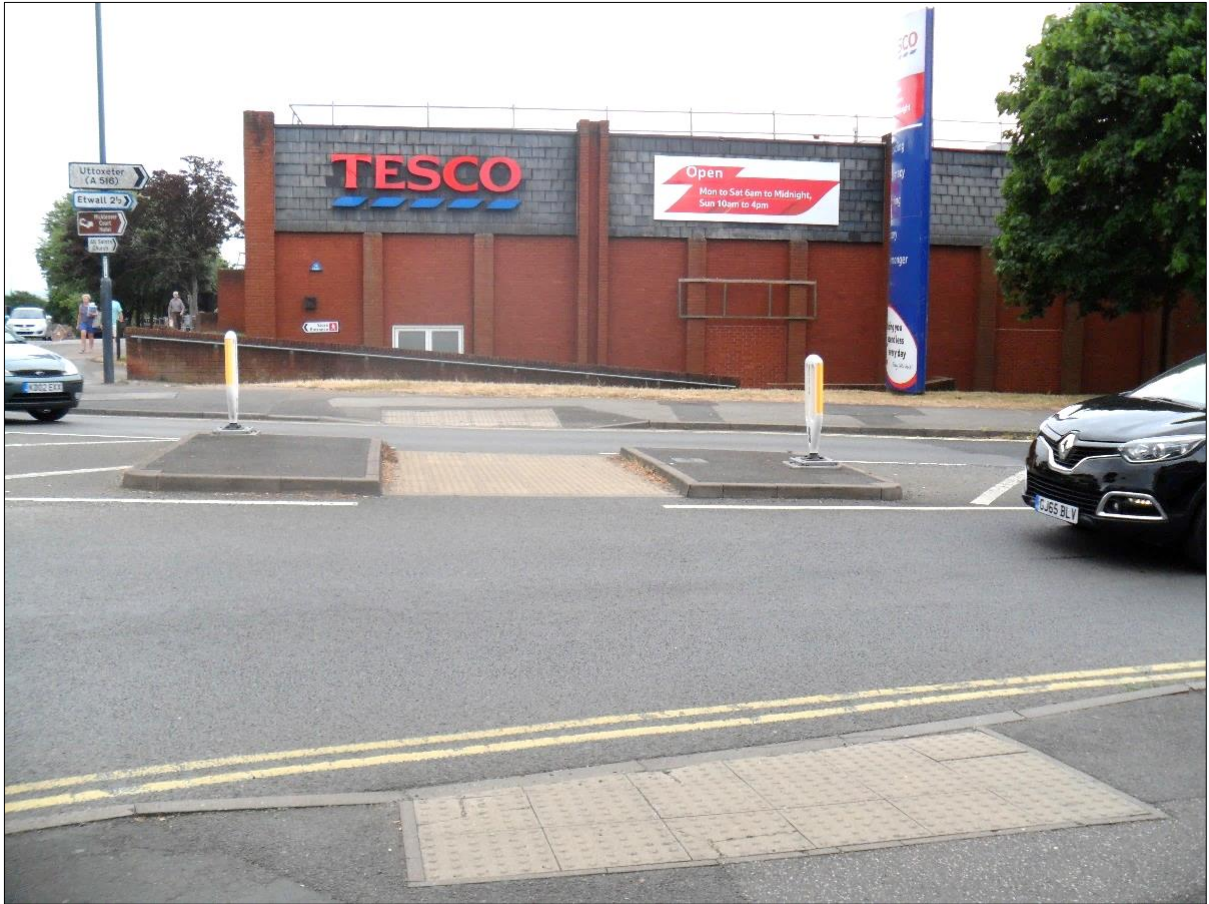
Figure 3.7 Uncontrolled Pedestrian Crossing on Uttoxeter Rd

- 3.6.7 There are uncontrolled pedestrian crossings with dropped kerbs and tactile paving, at each arm of the roundabout junction at B5020 Uttoxeter Rd / Kipling Drive / Uttoxeter Road / B5020 Station Road providing links across the junction, shown in **Figure 3.3**. Pedestrians have to wait at the crossing for long periods before an opportunity to cross the road is realised, as observed during the time of the survey.

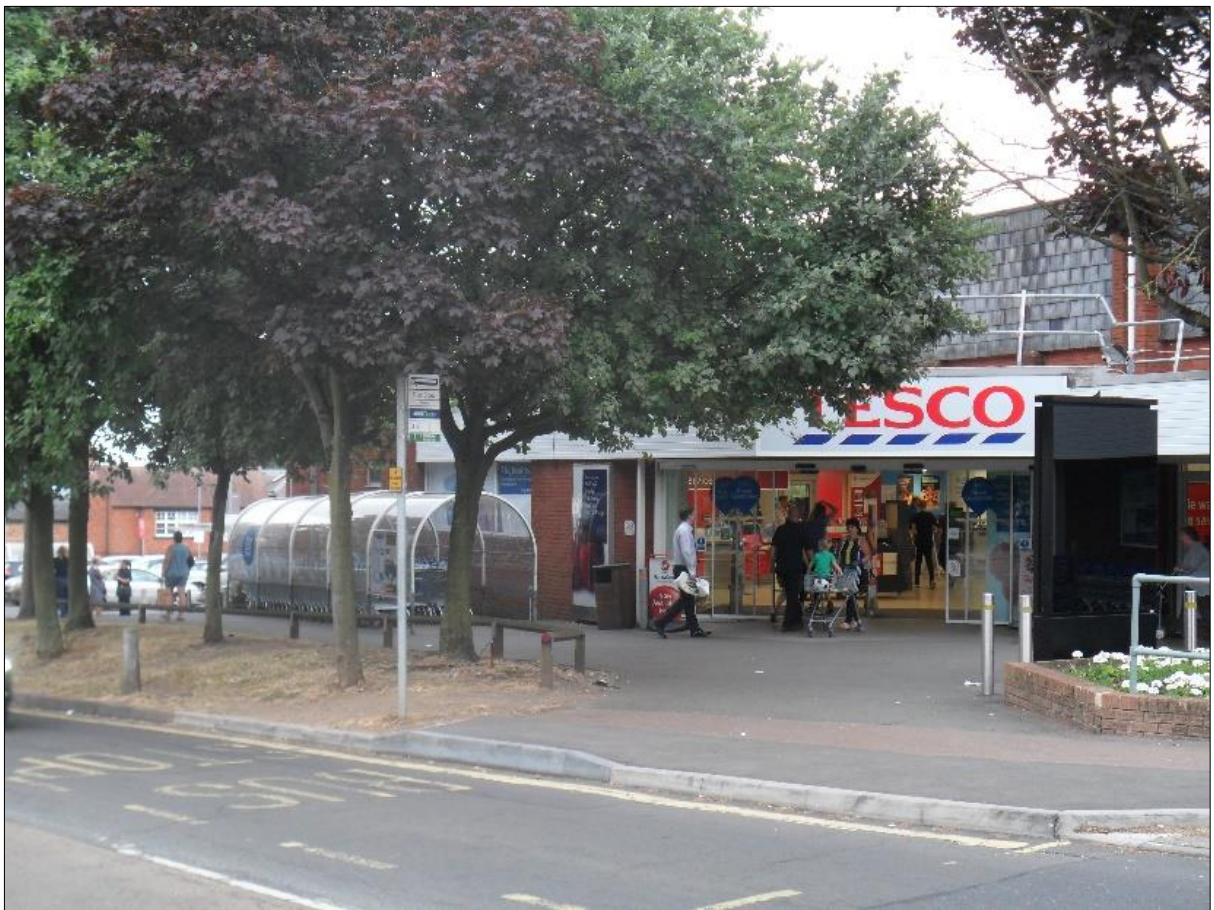
Figure 4.1 Northbound Bus Stop on Kipling Drive

- 4.1.1 There are two bus stops on Kipling Drive (within close proximity to the Tesco) for north & south bound services which have a flag, pole, raised kerb and bus cage within the carriageway, the southbound stop has a service timetable, but the northbound stop has no timetables. The northbound bus stop is shown in **Figure 4.1**.

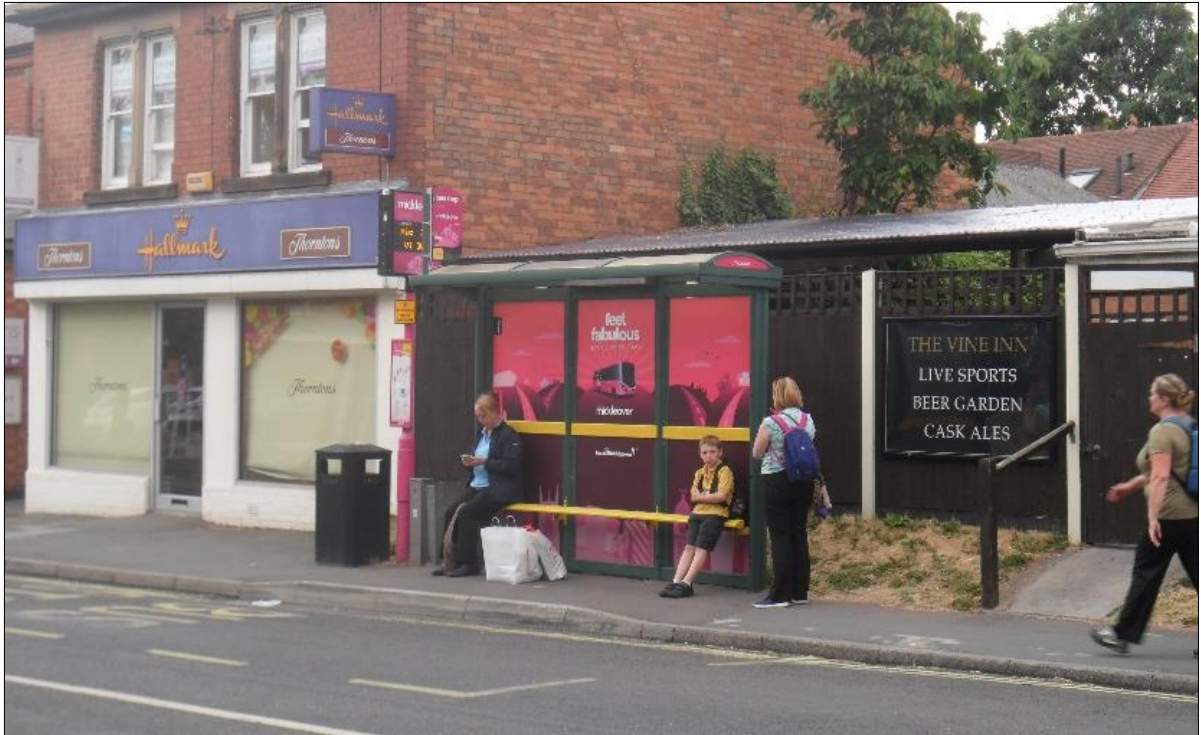
Figure 4.2 Eastbound Bus Stop on Uttoxeter Rd

- 4.1.2 There is one bus stop on Uttoxeter Rd within close proximity to the shopping area which provides a link to eastbound services and facilities include a shelter, seating, raised kerb, service timetable, bus cage within the carriageway and real time bus information as shown in **Figure 4.2**.

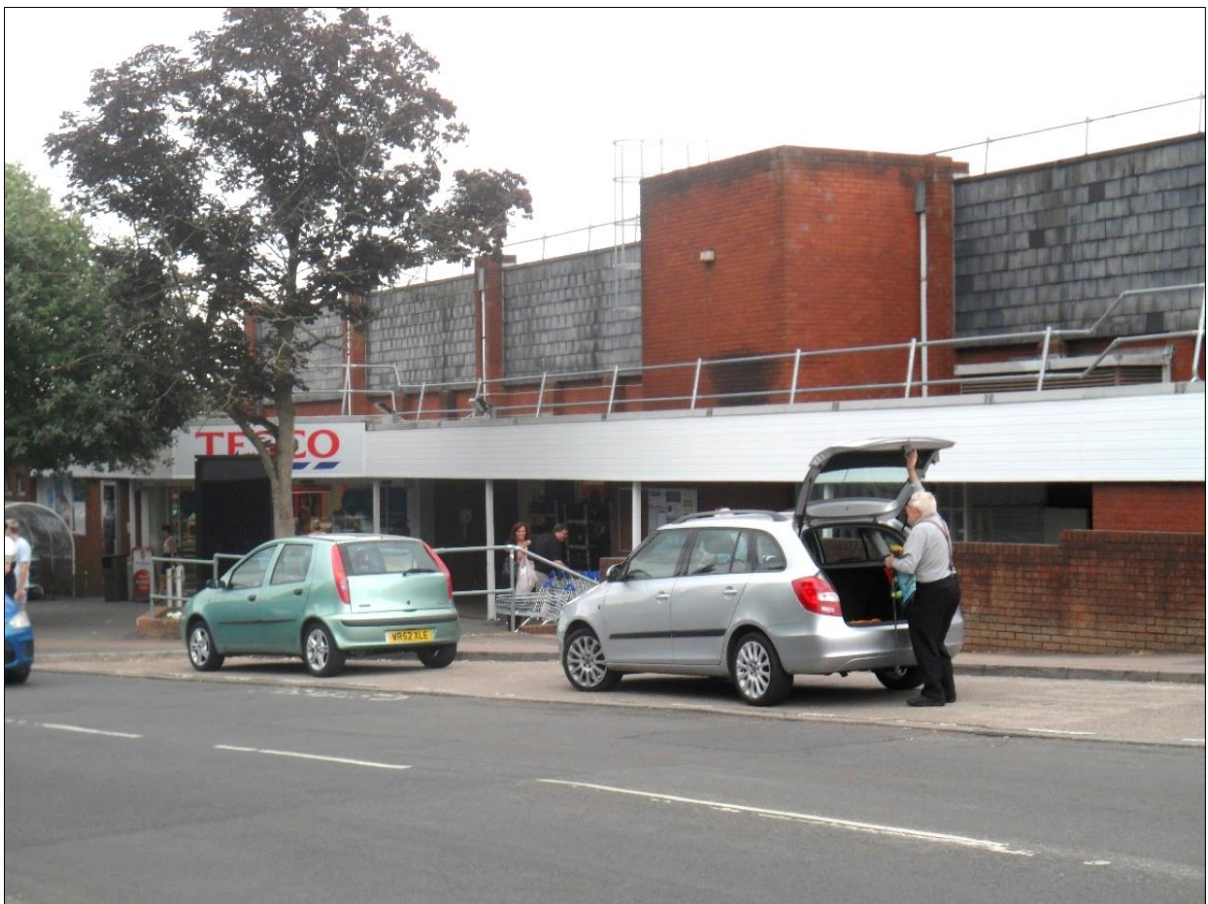
Figure 5.1 Disabled Parking Layby on Kipling Drive

- 5.1.1 There is an on-street parking lay by for disabled users on Kipling Drive, south of the roundabout junction of B5020 Uttoxeter Road / B5020 Station Road / Uttoxeter Road / Kipling Drive and is shown in **Figure 5.1**.
- 5.1.2 The disabled bay can accommodate up to four cars. A second parking layby is provided opposite the disabled parking bay on Kipling Drive, which is for use by all vehicles and can accommodate up to five cars.

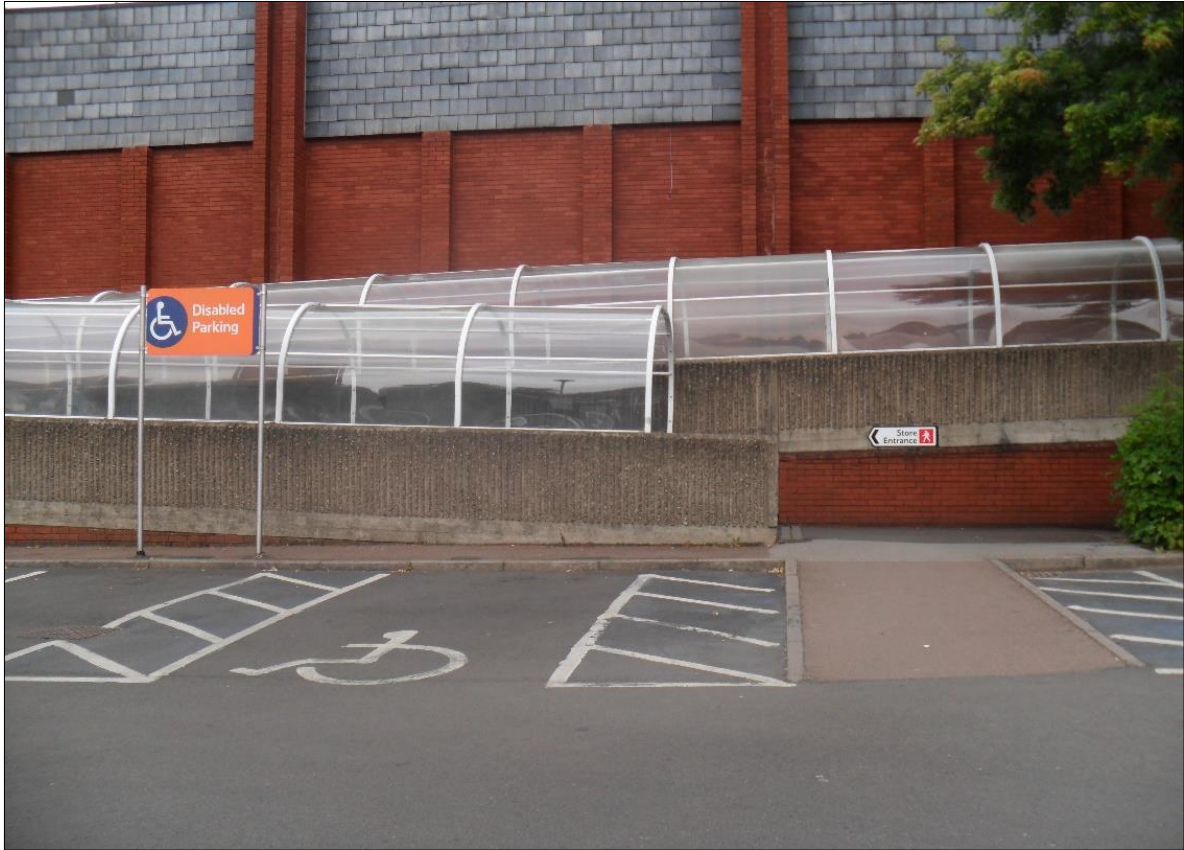
Figure 5.2 Disabled Parking Bay in Tesco Car Park

5.1.4 **Figure 5.3** shows a disabled parking bay in the Tesco car park, conveniently located next to an access ramp.

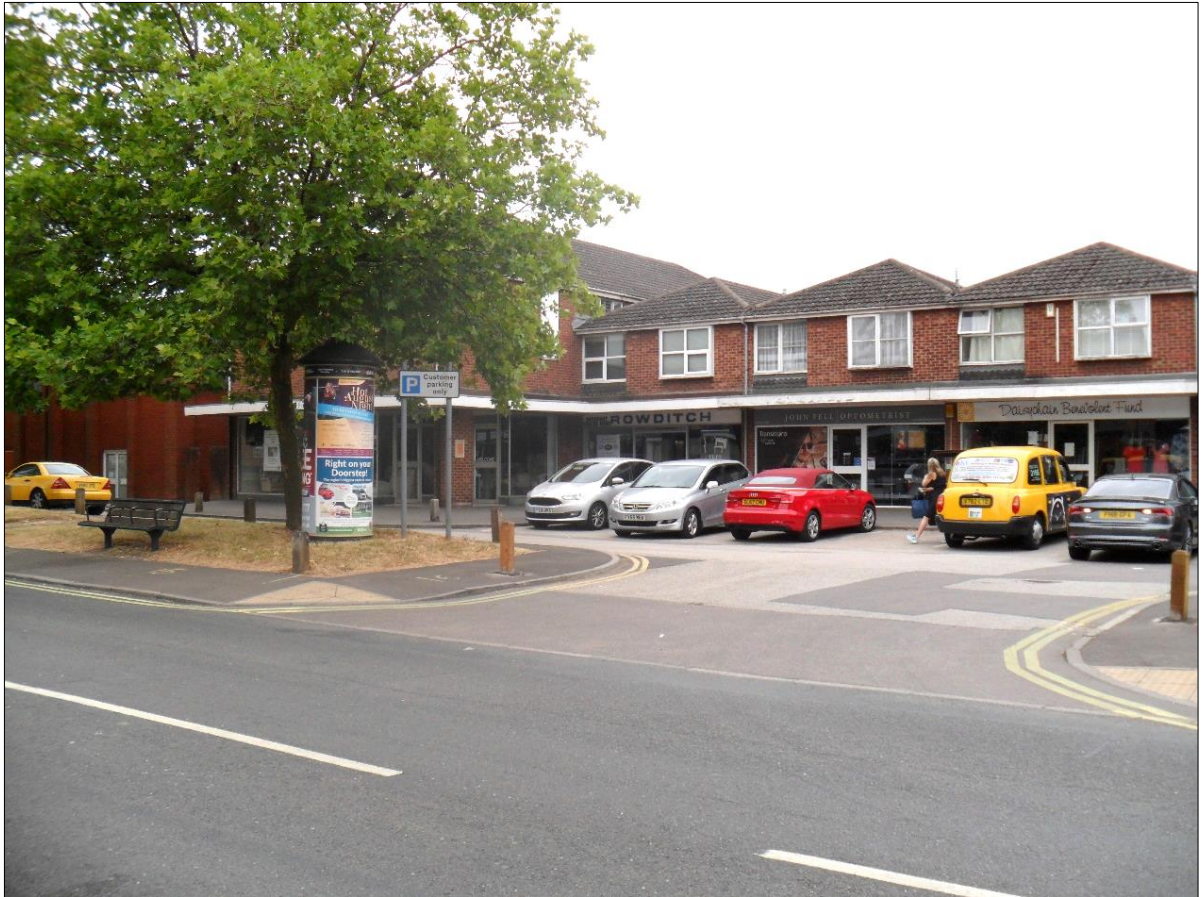
Figure 5.3 Customer Parking area at Utttoxeter Road Retail Centre

5.1.5 There are also two off-street car parking areas provided at the shop frontages along Uttoxeter Rd. One is located to the east of Uttoxeter Road adjacent to the Tesco store, and the other is located further to the west on The Square. The parking area off Uttoxeter Road has 19 standard parking bays and one disabled parking bay, as shown in **Figure 5.2** and the parking area on The Square has 11 standard parking bays, one disabled bay and a parking bay to accommodate up to four vehicles.

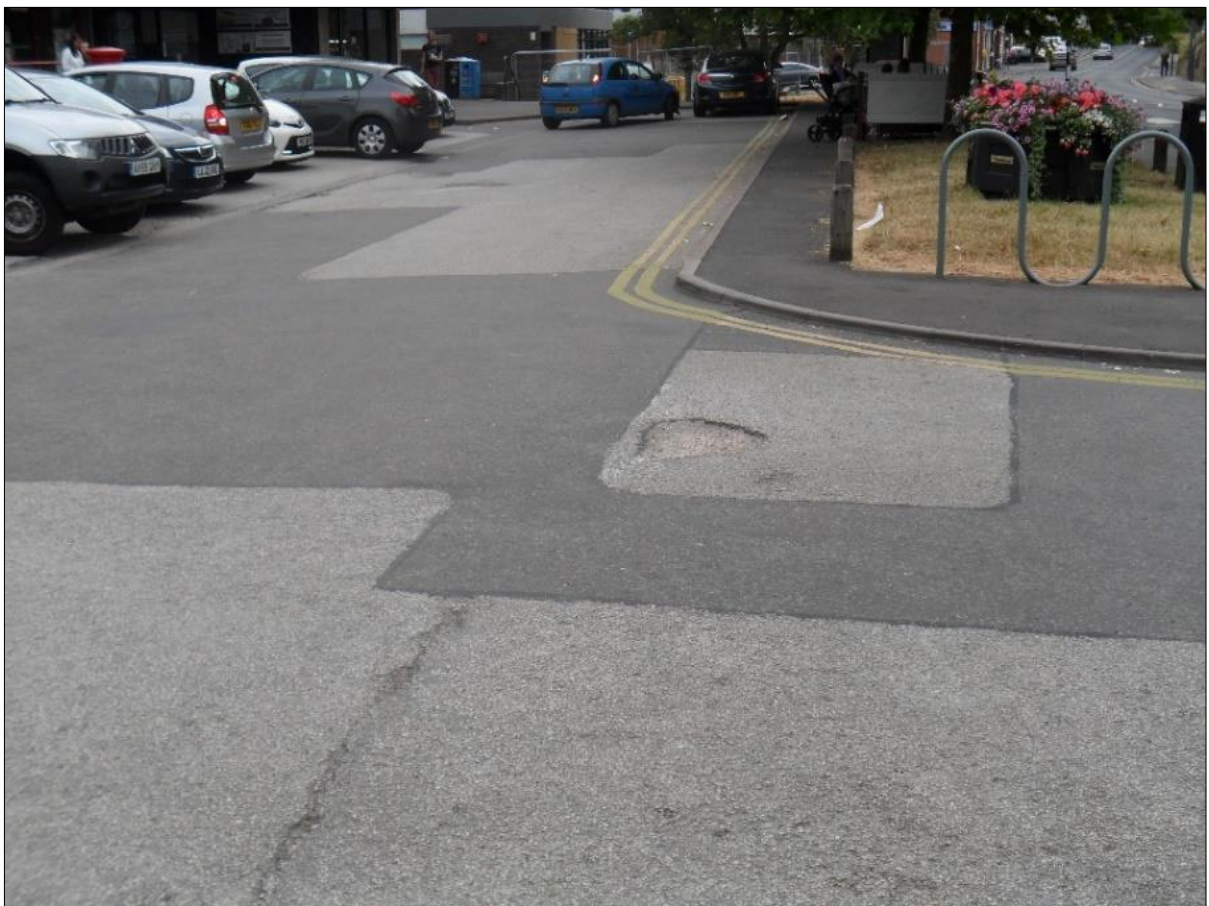
Figure 6.1 Condition of Car Park on Uttoxeter Rd.

- 6.1.1 The shopping area is generally tidy, orderly and functional. The Tesco store area seems well maintained but the shopping areas on Uttoxeter Road require some maintenance. The Uttoxeter Road car park in particular has pot holes in some areas, as shown in **Figure 6.1**

- 6.8.1 The general condition and maintenance of the car park and shopping area at the Tesco store is good. Lighting and is provided and the area is well maintained. The retail area on Uttoxeter Rd needs requires attention, particularly the car park off Uttoxeter Road adjacent to the Tesco store as shown in Figure 6.1 & 6.2.

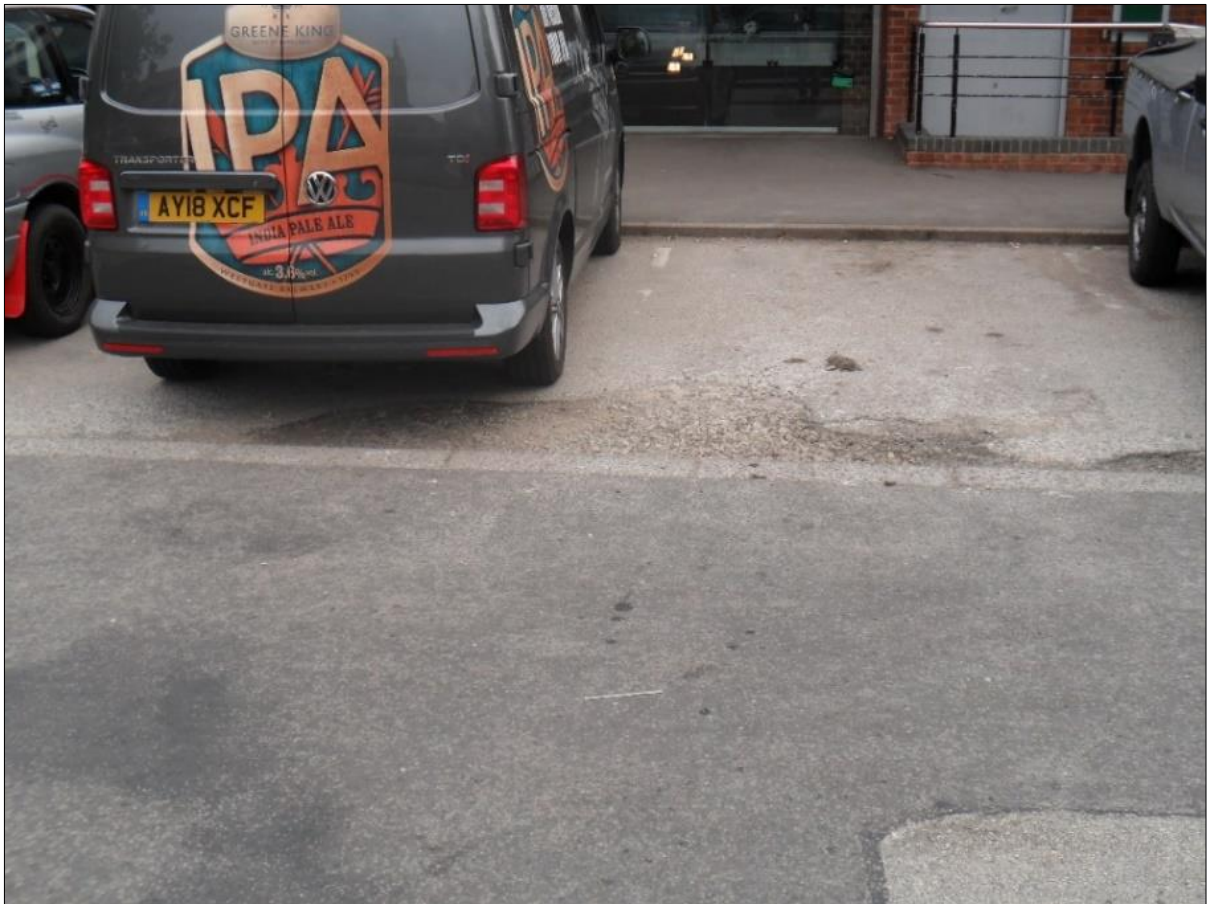
Figure 6.2 Uneven surface in car park on Uttoxeter Road

- 6.1.2 **Figure 6.2** also shows the poor condition of the customer parking area on Uttoxeter Road. The surface is cracked and uneven, and road markings have worn away. The broken surface is a potential trip hazard for users of the car park, specifically those with mobility issues.
