# Derby Retail Study

## Zone 13 – Mackworth Accessibility & Infrastructure Appraisal

Curtins Ref: TPNO66625-CUR-00-XX-RP-AIA-00013

Issue Date: 13 May 2019

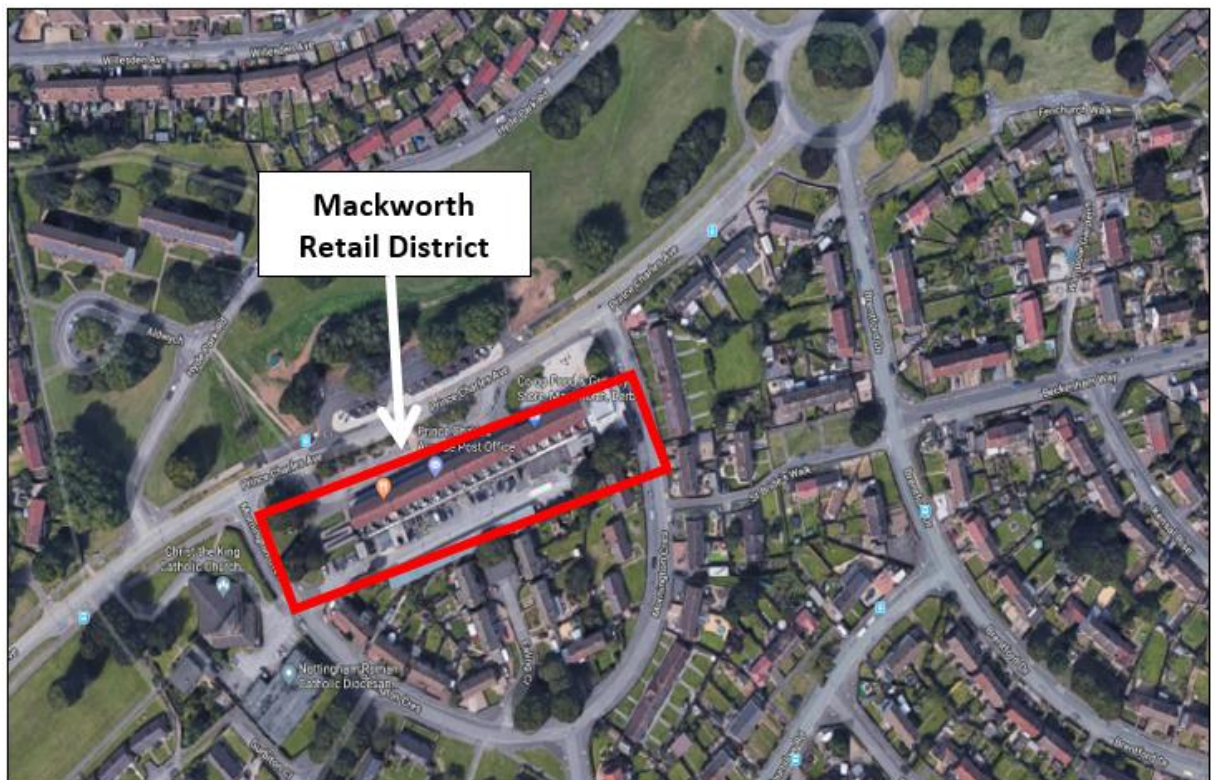
**Figure 2.1** Mackworth District Centre Location Map

- 2.1.1 Mackworth district centre is located along Prince Charles Avenue between the two junctions with Mornington Crescent, in Mackworth, Derby. Mackworth is located west of Derby City Centre, just beyond the boundary formed by the A38 Kingsway.

- 2.1.2 Mackworth district centre serves the Oakwood community, in addition to neighbouring residential areas to the east of Mackworth.
- 2.1.3 The retail district consists mainly of a small retail precinct which also includes a library and a church within its vicinity. The linear retail precinct is fronted by two car parking areas. One being of short stay on street parking bays, and the other a longer stay car park. The retail precinct is surrounded by the residential properties to the east, south and west, whilst open grassed land lies to the north of the site, beyond this is a further area of residential dwellings.

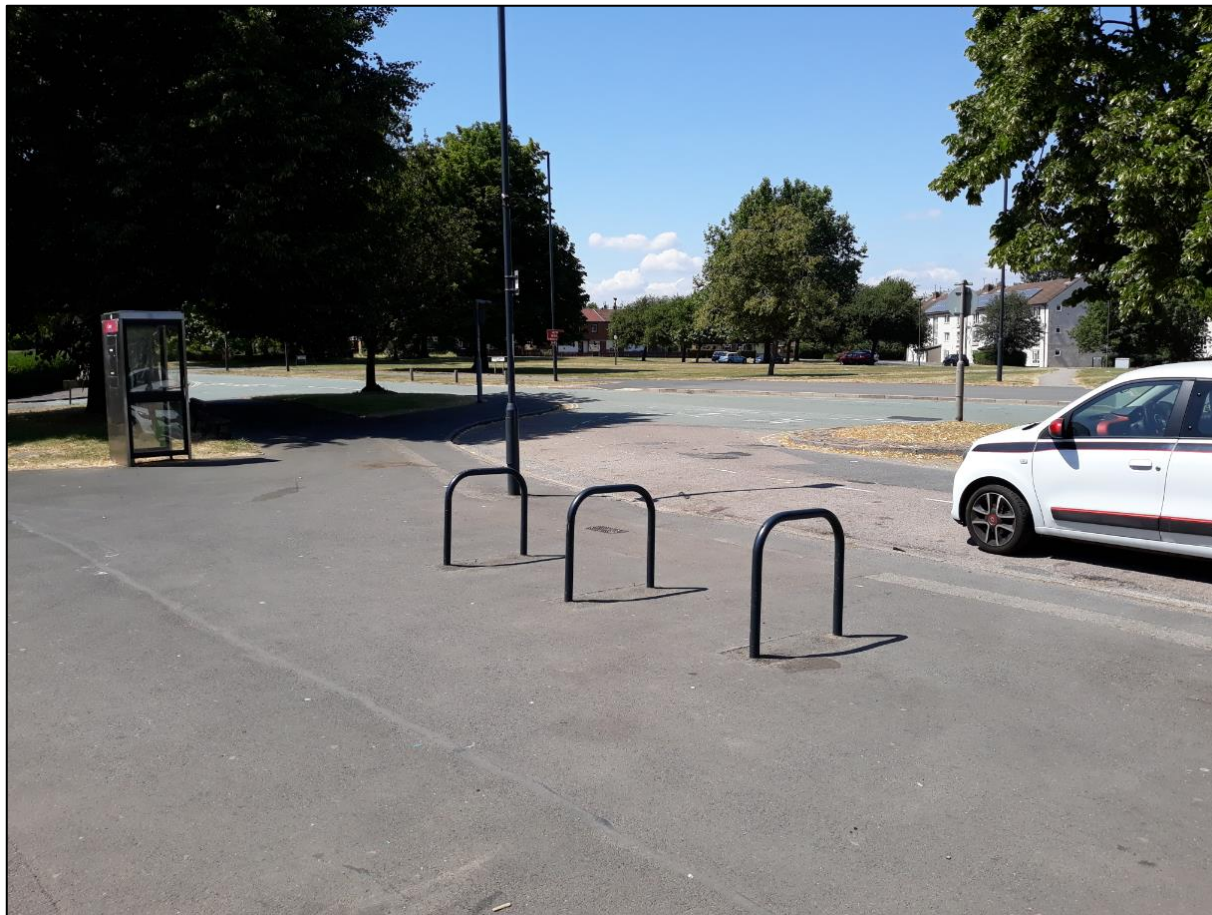
**Figure 3.2** Cycle Parking Facilities in Mackworth District Centre

- 3.4.4 There is cycle parking of up to 12 bikes on the pedestrian space outside the supermarket by way of modern design Sheffield stands and two further cycle parking areas are provided at the centre and to the western extent of the shopping precinct also provide Sheffield stands which accommodate 12 cycles in total, one of which is shown in **Figure 3.2**. The cycle parking location is in an appropriate position as it is both conveniently located and overlooked.

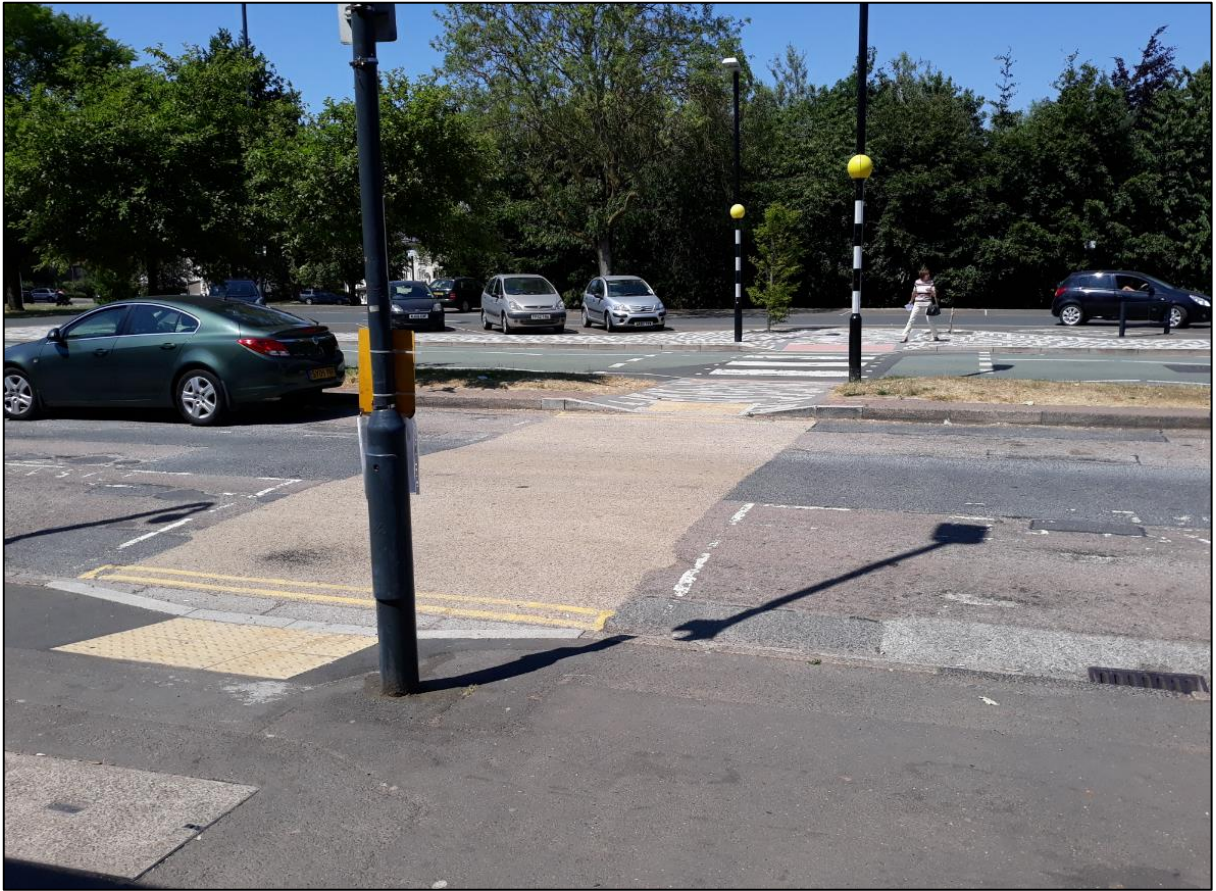
**Figure 3.3** Pedestrian Crossing Facility on Prince Charles Avenue

- 3.6.2 There is a zebra crossing facility with dropped kerbs and tactile paving, linking the bus stop central reservation to the north with the on street parking area adjacent to the shopping precinct frontage. The crossing facility over the on street parking area is noticeable by having different surfacing to the carriageway and has drop kerb provision with tactile paving. The crossing facility is shown in **Figure 3.2**. Surrounding the site there are appropriately located dropped kerbs which also enable pedestrian crossing of local roads and provide access to surrounding bus stops.

- 3.6.3 The streets surrounding the retail precinct provide good levels of pedestrian accessibility with dropped kerbs and tactile paving provided in appropriate locations. There is a zebra crossing on Prince Charles Avenue to the north of the shopping precinct which provides a safe crossing point linking the on street car parking area to the bus stop and car park on the north side of the carriageway. There is also a pedestrian crossing provided to connect the retail area to the zebra crossing to the north of the on street parking area. This pedestrian crossing is poorly marked with no signage to warn vehicles of the presence of pedestrians crossing. **Figure 3.3** shows the zebra and pedestrian crossing facilities.

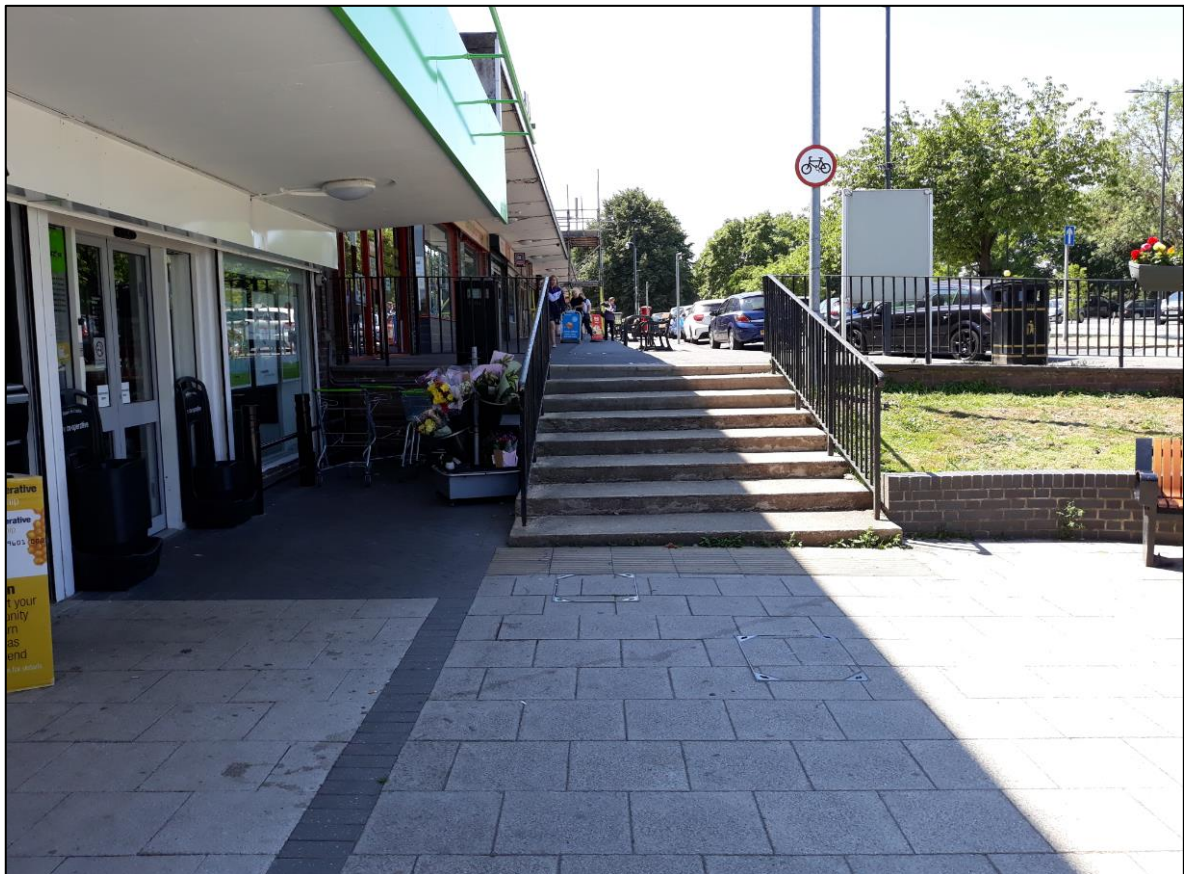
**Figure 3.4** Stepped Access Between Upper and Lower Retail Areas.

- 3.6.5 Internally there are steps which connect the smaller shops to the supermarket and library at the eastern extent of the precinct as there is a significant level difference at this location. Provision is available for those with mobility impairments by way of footpath that runs adjacent to the Prince Charles Avenue carriageway and connects the smaller shops on the upper section of the precinct to the pedestrian space to the front of the supermarket on the lower section.

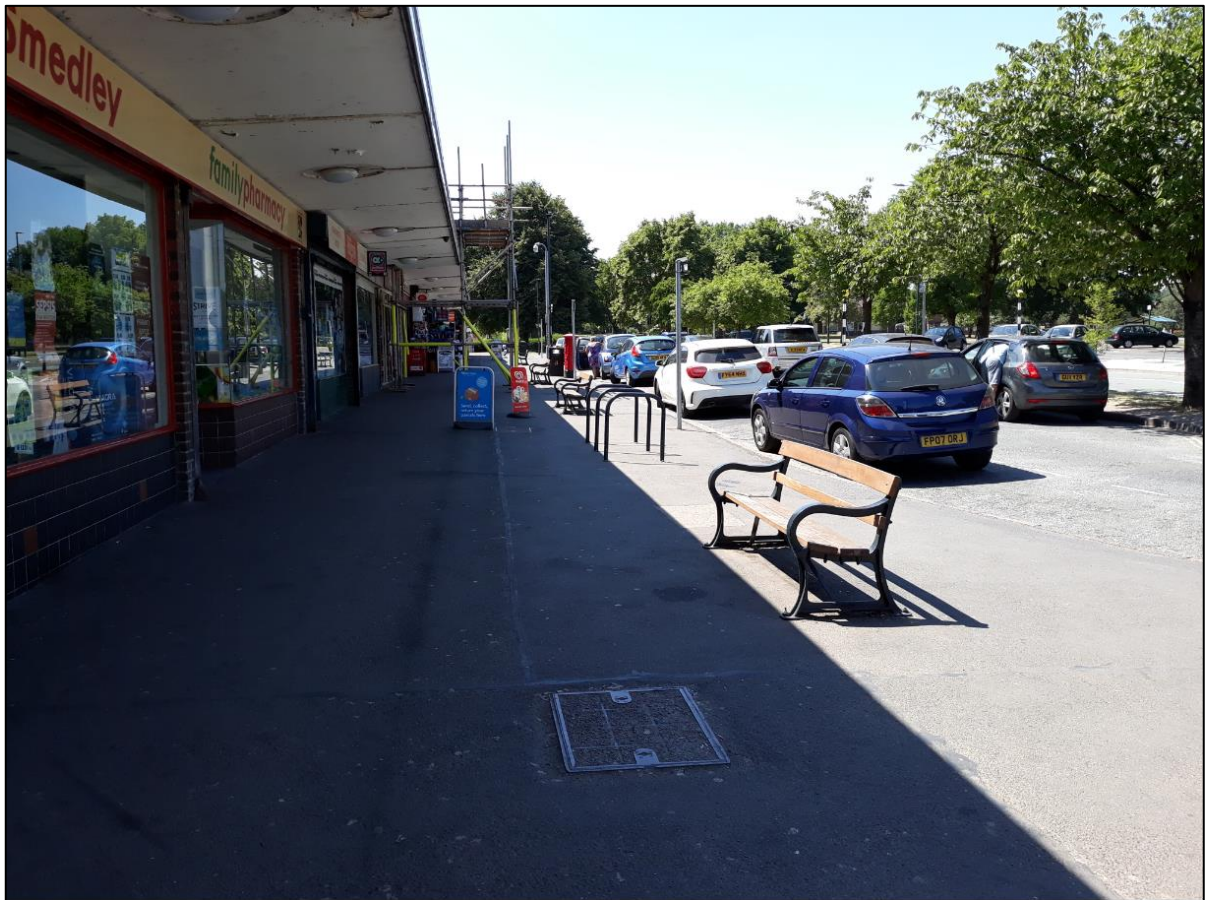
**Figure 3.5** Footway Facilities in Mackworth District Centre

- 3.6.8 Footways have been provided as described above and they are in good condition, with dropped kerbs provided at appropriate locations. **Figure 3.4** details the footways at the shopping precinct frontage and **Figure 3.5** shows the pedestrian area at the front of the supermarket. No cycleways are provided.

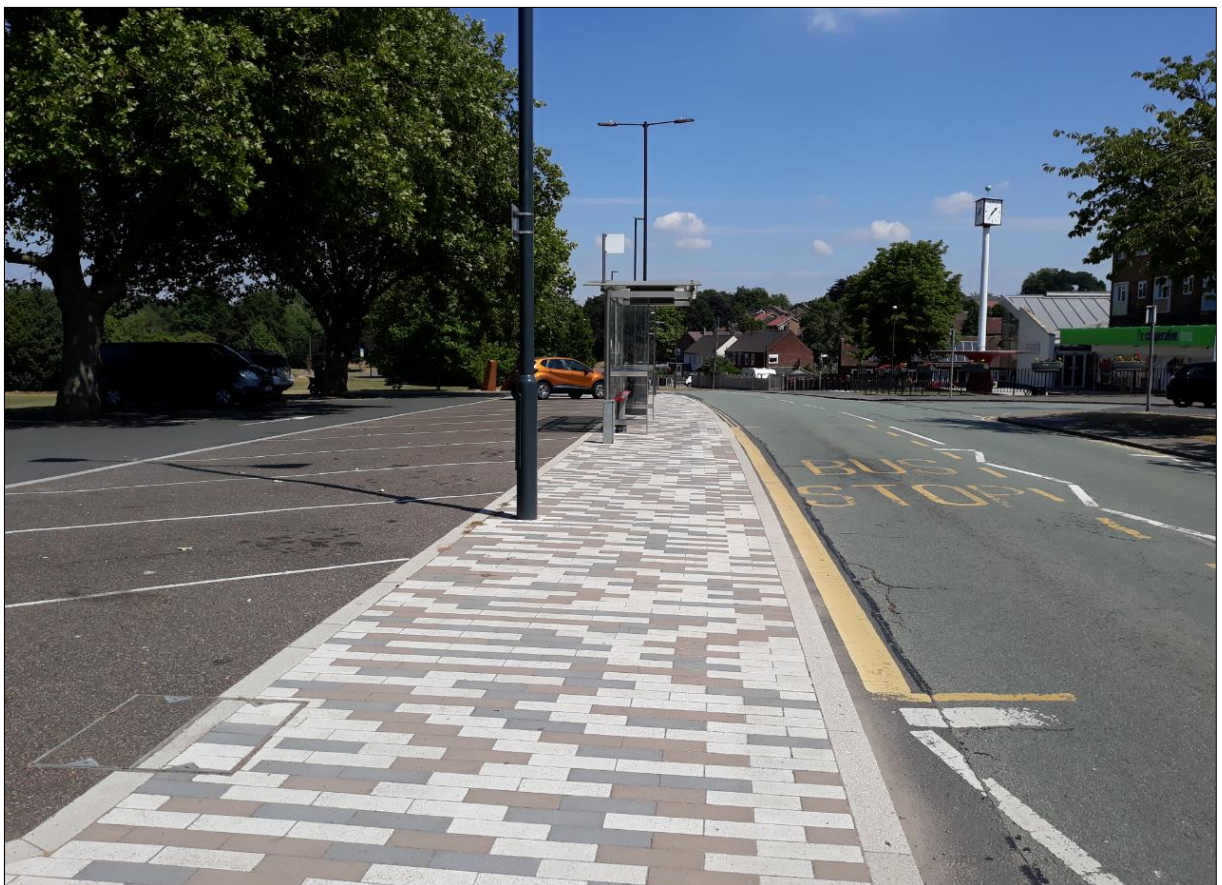
**Figure 4.1** Eastbound bus Stop on Prince Charles Avenue.

- 4.1.1 There is one bus stop on Prince Charles Avenue (opposite the shopping area) for east-bound services which has a shelter, lighting, real time information, seating, timetable, raised kerb and bus cage within the carriageway.
- 4.1.2 There are two westbound bus laybys on Prince Charles Road which are located 130m and 180m to the east and west of the shopping precinct which appear to be disused as there are not flags or timetable information provided.

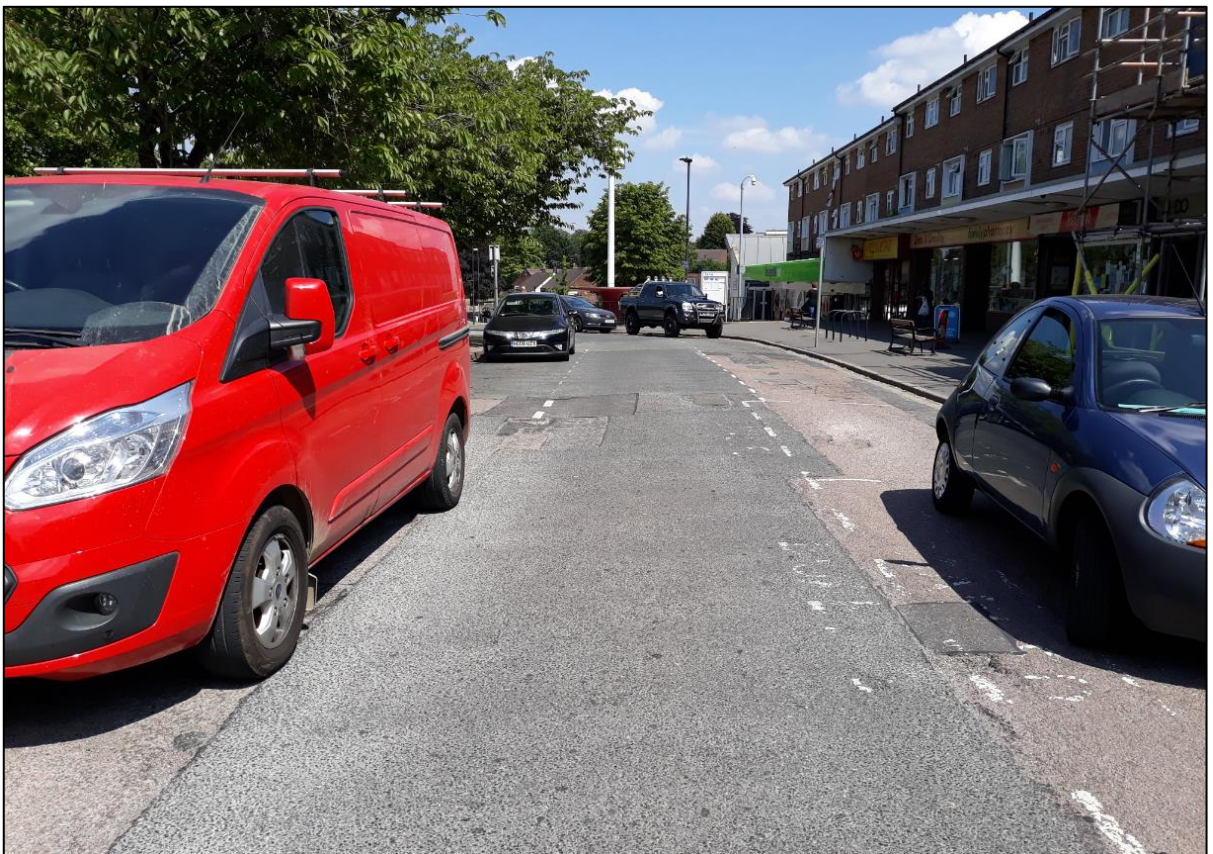
**Figure 5.1** On Street Parking Area off Prince Charles Avenue

- 5.1.1 There is an on-street parking area across the shop frontages to the southern boundary of Prince Charles Avenue. The parking area is accessed off the southern kerb line of Prince Charles Avenue to the east of the smaller shops in the shopping precinct and egress onto Prince Charles Avenue is to the western extent of the shopping precinct.

- 5.1.2 The parking area comprises parking bays on either side of a carriageway and operates a one way system. The parking bays to the southern side of the road extend for a length of 97m and to the north extend for 59m. Within this area there is provision for four disabled parking spaces although markings are barely visible, and therefore all vehicles were observed using these bays. A pedestrian crossing point is also located in the centre of the parking bays to assist in crossing of the one way on street parking area.

- 5.1.3 The on street parking area had a high turnover rate and was observed to average approximately 70% capacity at the time of survey (weekday afternoon).

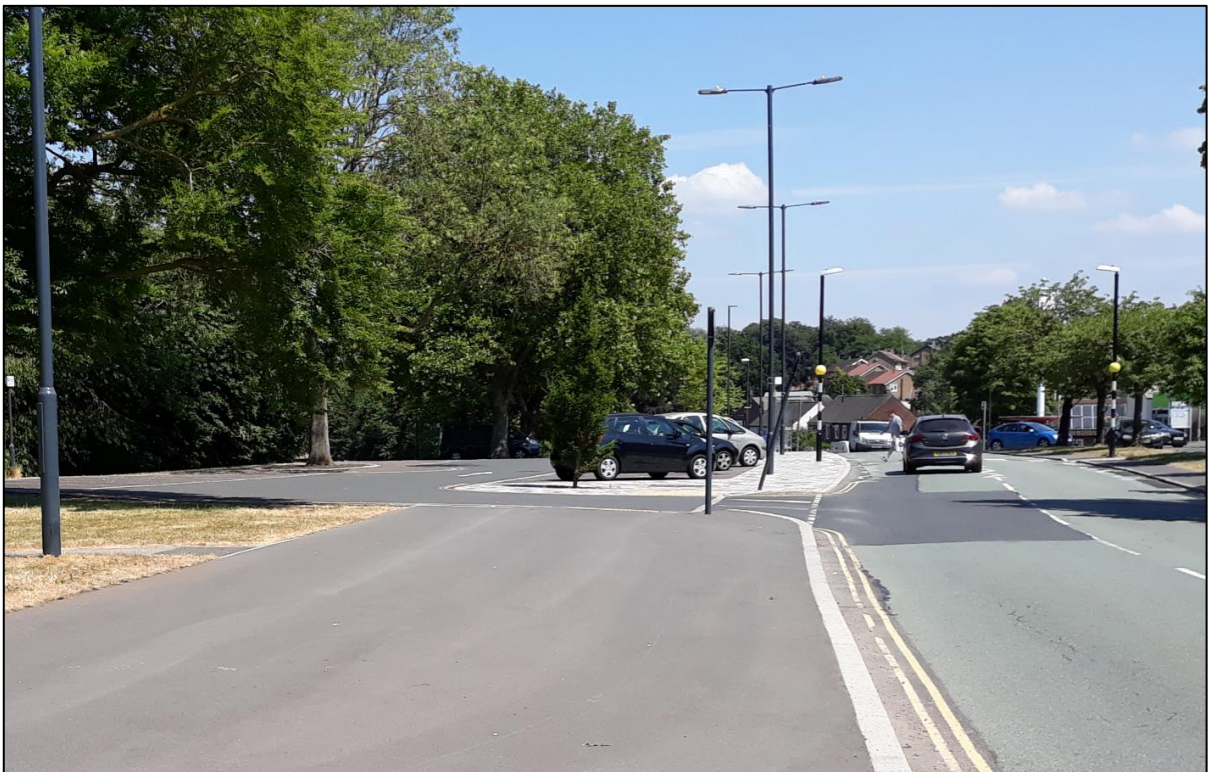
**Figure 5.2** Car Park off Prince Charles Avenue.

- 5.1.4 A car park is located off the northern boundary of Prince Charles Avenue opposite the shopping precinct. The car park operates a one way system and is accessed from the west and egress is to the east. There are 40 standard parking bays and two motorcycle parking bays provided within the car park. The car park is well maintained with clear parking bays demarcated. The parking area was observed to have an approximate 30% occupancy level at time of survey (weekday afternoon).

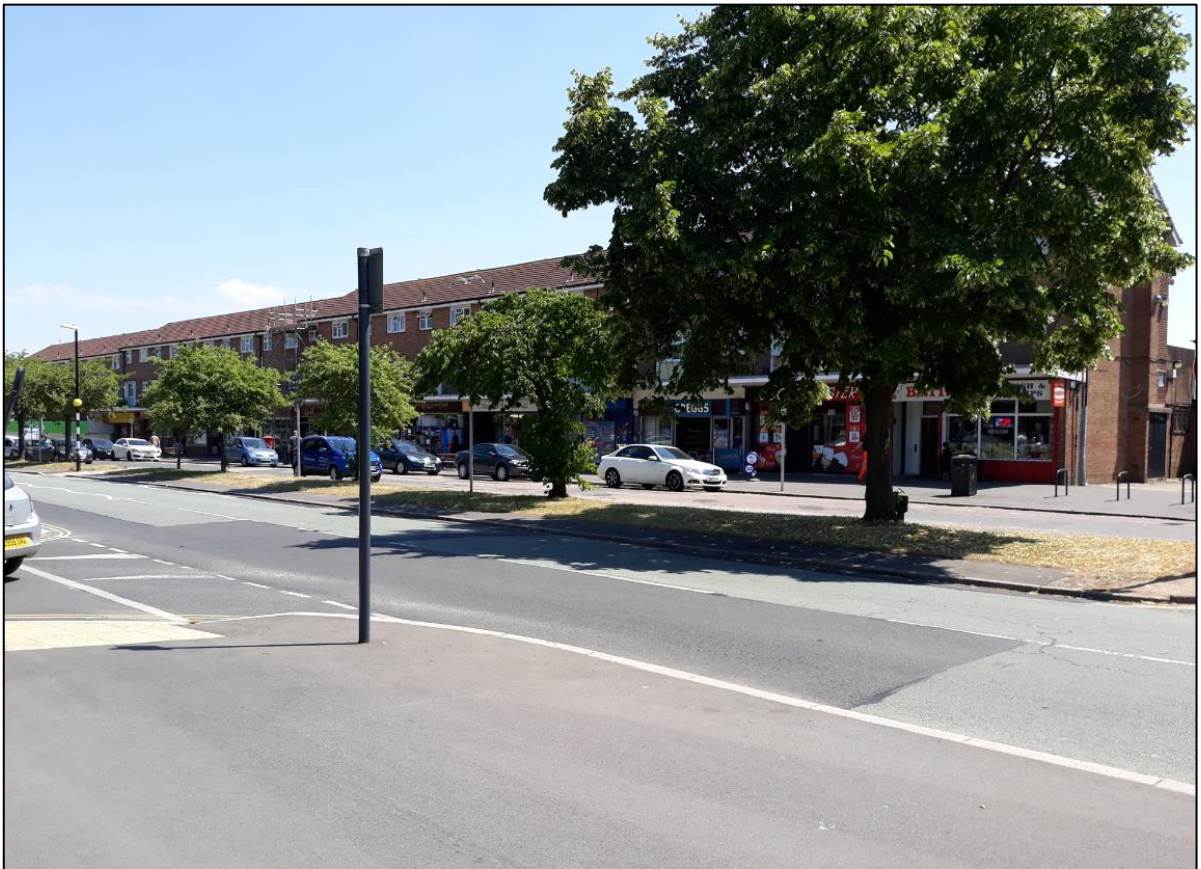
**Figure 6.1** Mackworth District Centre – Shopping Precinct

- 6.1.1 The shopping precinct is generally tidy, orderly and functional. Planting and trees make the appearance of the retail area pleasant as shown in **Figure 6.1**.

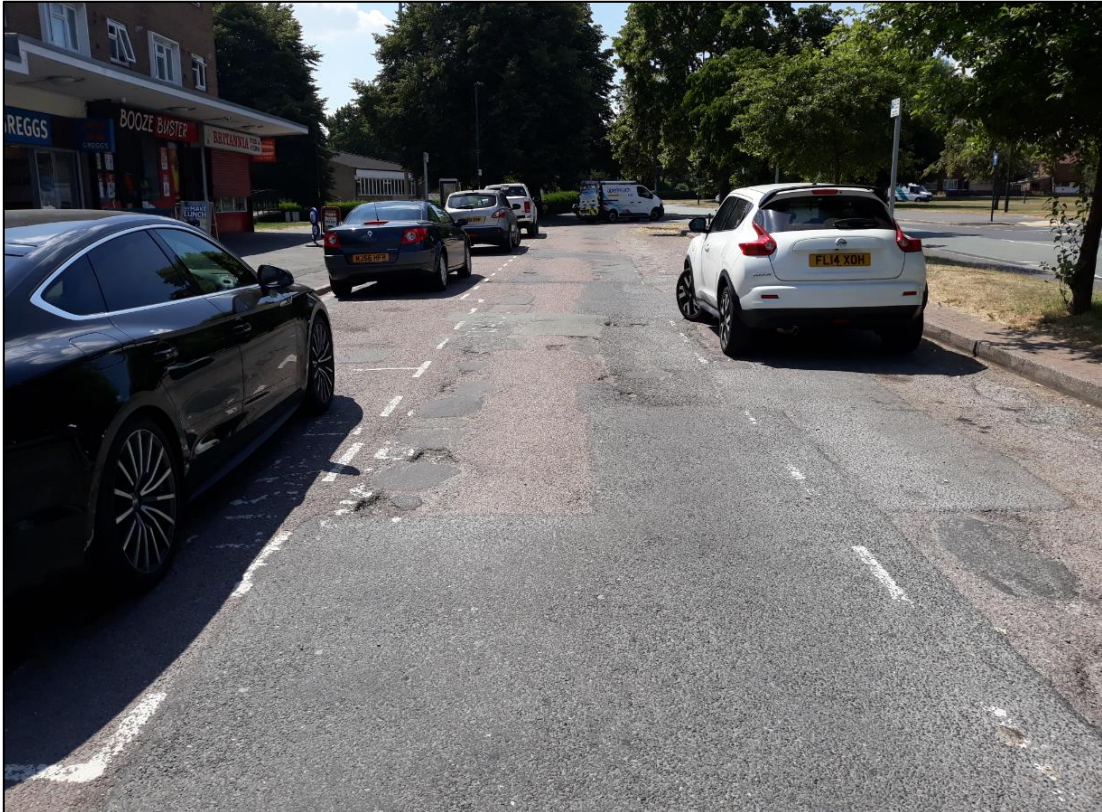
**Figure 6.2** On Street Parking Area Road Condition

- 3.2.6 Access and egress points to the opposing car parks are staggered and with the geometry designed so that the access of one car park is adjacent to the egress of another. This results in a lesser chance of confusion and therefore risk of collisions is reduced at these points.
- 3.2.7 The condition of the on street parking bays are poor with potholes, patching, and cracking and are not appropriate for those with mobility impairments who utilise the parking area. **Figure 6.2** shows the condition of the parking area.

- 6.8.1 The general condition and maintenance of the car park and shopping precinct is good. The condition of the on street parking is poor and is not appropriate for those with mobility impairments who utilise the parking area. **Figure 6.2** shows the condition of the parking area.
