Derby Retail Study

Zone 5 – Allenton Accessibility & Infrastructure Appraisal

Curtins Ref: TPNO66625-CUR-00-XX-RP-TP-00005

Issue Date: 13 May 2019

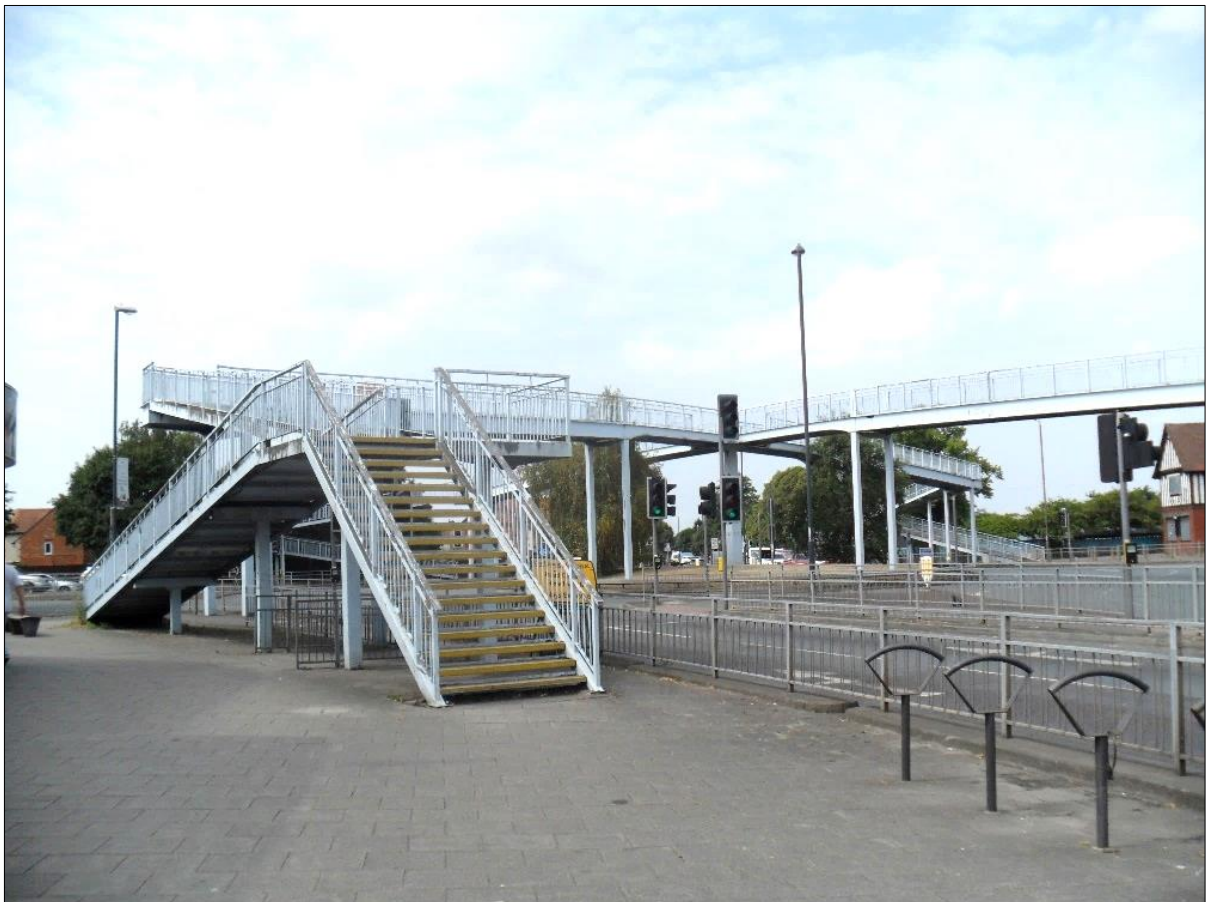
Figure 3.1 Spider Island Bridge at the junction of Osmaston Rd & Harvey Rd

- 3.1.3 Additional pedestrian access can also be taken directly from the Spider Island Bridge where pedestrian footbridges are provided at the A5111 Harvey Road junction with A514 Osmaston Road and A514 Osmaston Park Road / Lord Street signalised roundabout junction, which lies to the north of the retail area. Pelican crossings are provided across three arms of the roundabout, to link pedestrians to the retail area from the roundabout.

- 3.6.2 The main signalised crossing facility in the retail area is the A514 Osmaston Rd roundabout junction with A5111 Harvey Road and A5111 Osmaston Park Rd, located north of the retail area. This junction provides pedestrian crossings on three arms, linking the residential areas surrounding the roundabout to the retail area. Above this roundabout junction is a spider island bridge, where a pedestrian footbridge has been provided, which leads onto the shopping area. The Spider Island Bridge is shown in **Figure 3.1**.

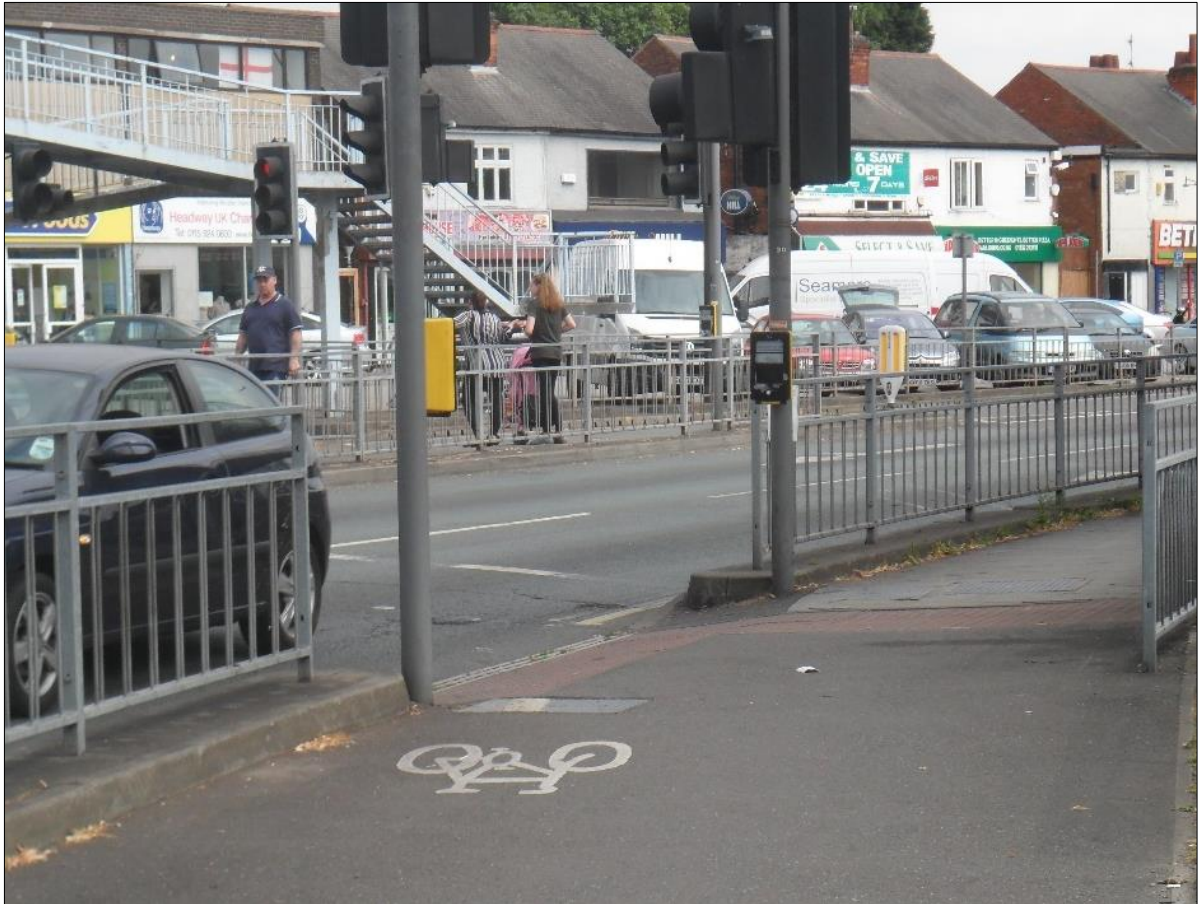
Figure 3.2 Shared Pedestrian & Cycleway on A514 Osmaston Road

- 3.4.1 There are no marked or segregated cycle routes within the shopping area itself. However, the surrounding residential roads are suitable for cyclists to cycle within the carriageway.
- 3.4.2 There is a shared pedestrian and cyclist route north of A514 Osmaston Road, leading towards the Pelican Crossing at the junction of A514 Osmaston Road with A5111 Harvey Road, as shown in **Figure 3.2**.

- 3.6.10 There is provision for shared footways and cycleways in appropriate locations as described above and they are in good condition, with dropped kerbs, shown in **Figure 3.2**.

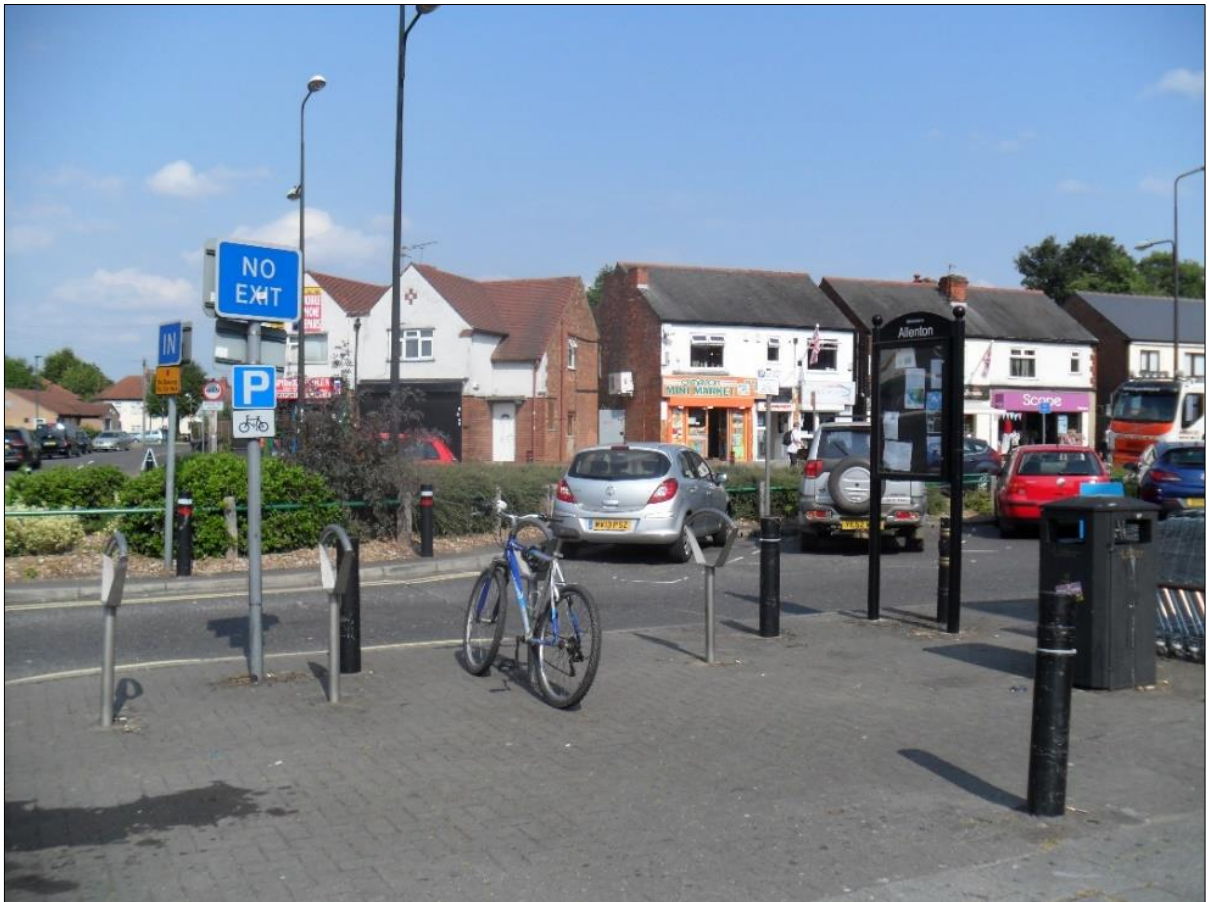
Figure 3.4 Cycle Parking within the Shopping Area

- 3.4.4 There is cycle parking for up to 44 bikes within the shopping area. The cycle parking location is in a convenient position as it is located along the main frontage of the shops and is overlooked by residential properties. **Figure 3.5** shows some of cycle parking within the shopping area.

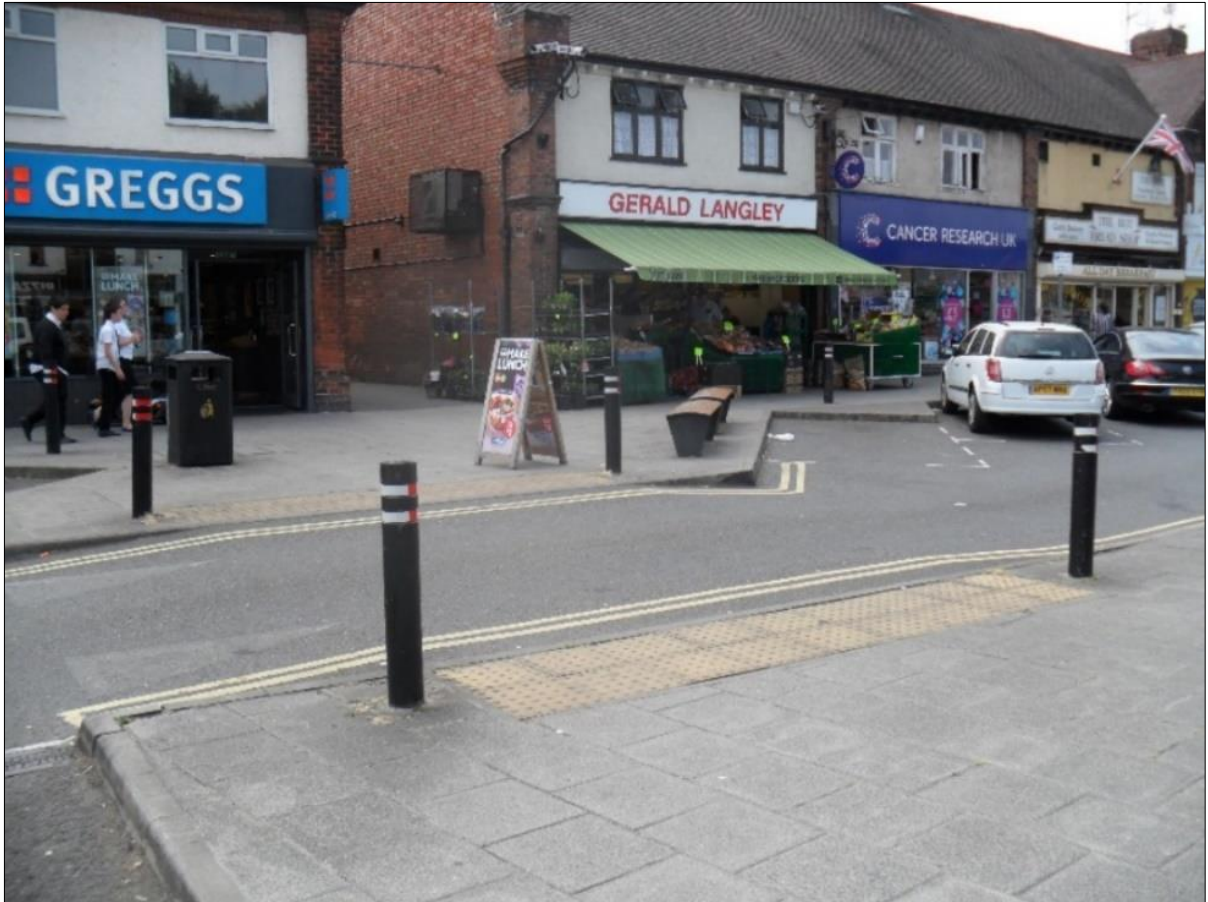
Figure 3.5 Raised Speed Table within the Shopping Area - Osmaston Rd

- 3.6.7 There are two raised speed table crossing facilities with dropped kerbs and tactile paving within the shopping area, which serve as an access point for pedestrians and those with a mobility impairment between the northbound bus stop on A514 Osmaston Road and the shopping area.
- 3.6.8 As there is no priority for pedestrians at these raised speed tables, they could potentially pose a danger for pedestrians and those with a mobility impairment as they cross, while vehicles also drive within the parking area.
- 3.6.9 One of the raised speed tables is shown in **Figure 3.4**.

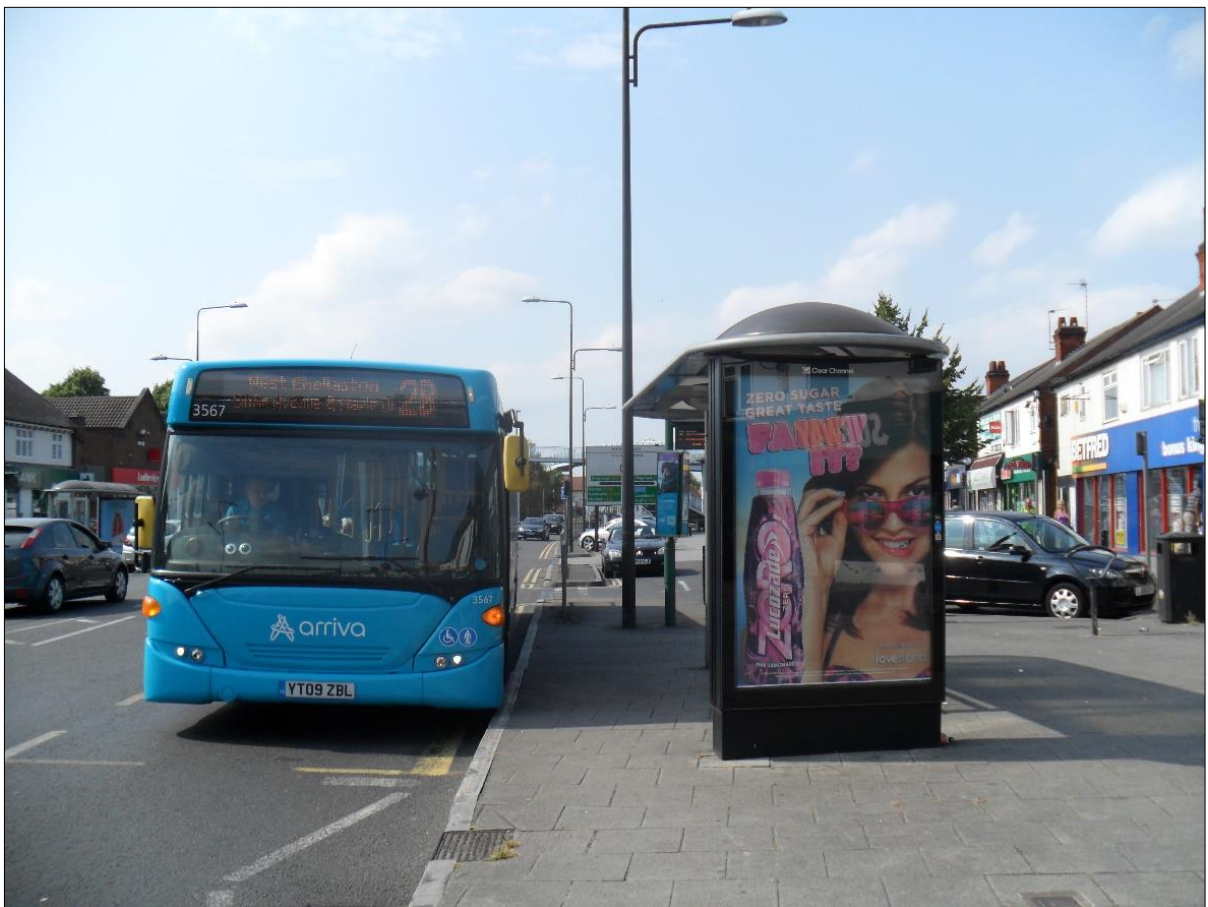
Figure 4.1 South-bound bus stop on Osmaston Rd

- 4.1.1 There are two bus stops on A514 Osmaston Road (within close proximity to the shopping area), which provide shelters, seating, lighting, a timetable, raised kerb, bus cage and real time bus information.

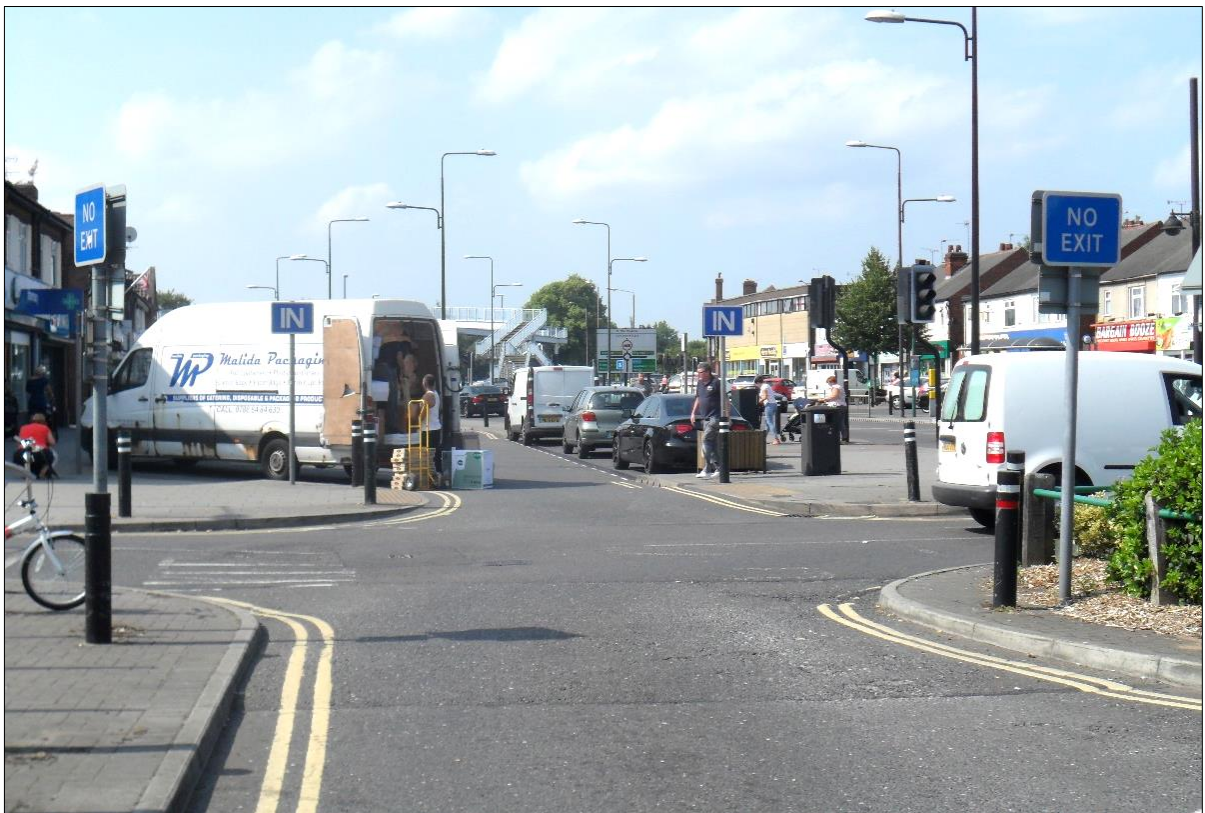
Figure 5.1 In & No Exit Signs in Parking Area on A514 Osmaston Road

- 5.1.2 There are approximately 98 standard parking bays and 23 disabled bays provided within the shopping area along the main frontage of the shops. **Figure 5.1** shows the “In” & “No Exit” signs in the parking bay along the shop front, which facilitate a one-way system in the parking area. The parking areas are accessed via A514 Osmaston Rd and also egressed via A514 Osmaston Rd.
- 5.1.3 Disabled parking bays are demarcated and comply with modern design standards as they are provided with dropped kerbs around to enable wheelchair access, as shown in **Figure 5.2**.
- 5.1.4 The car parking area along A514 Osmaston Rd comprises on street parallel parking bays while some bays are at a 45-degree angle.

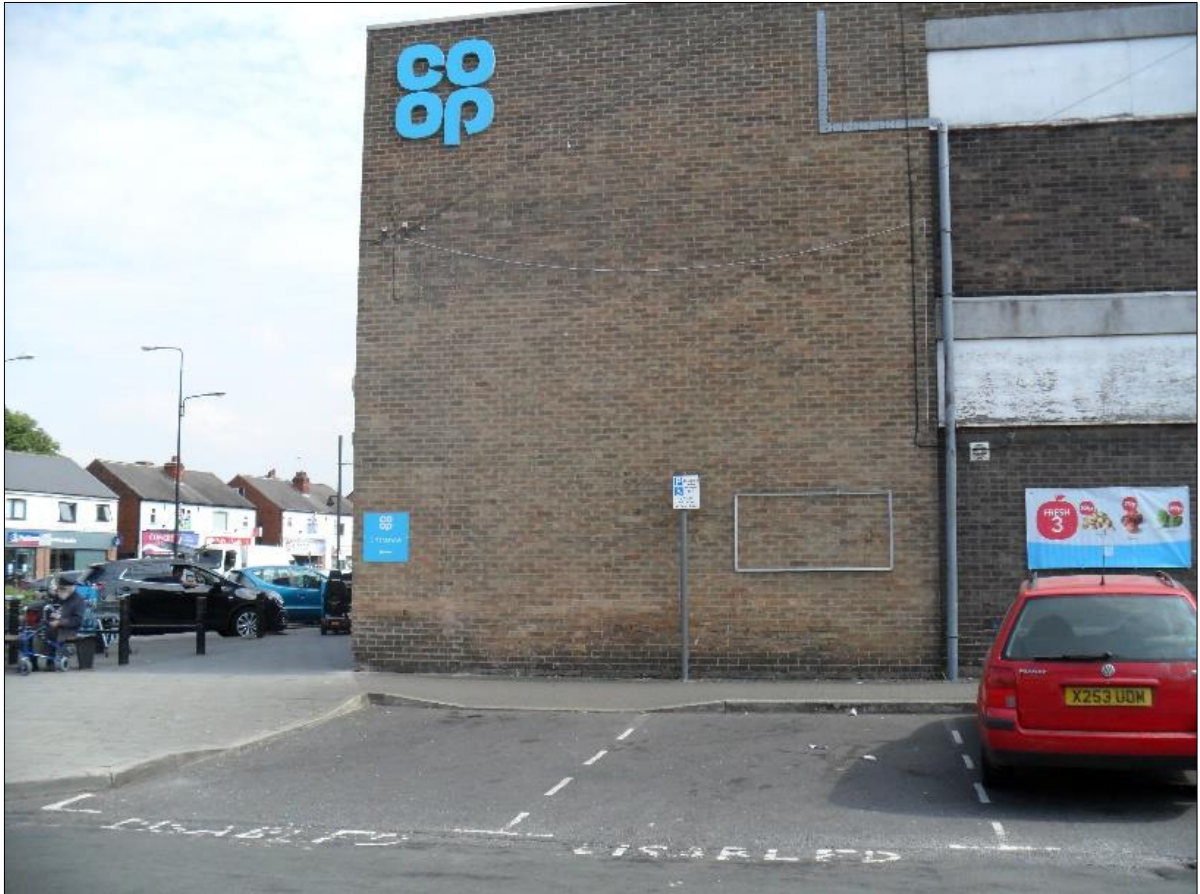
Figure 5.2 Disabled Parking Bays outside Co-op

- 5.1.5 **Figure 5.2** shows the disabled parking bays, ideally located outside Co-op near the entrance to the store. The bays have dropped kerbs which makes it convenient for people with a mobility impairment.

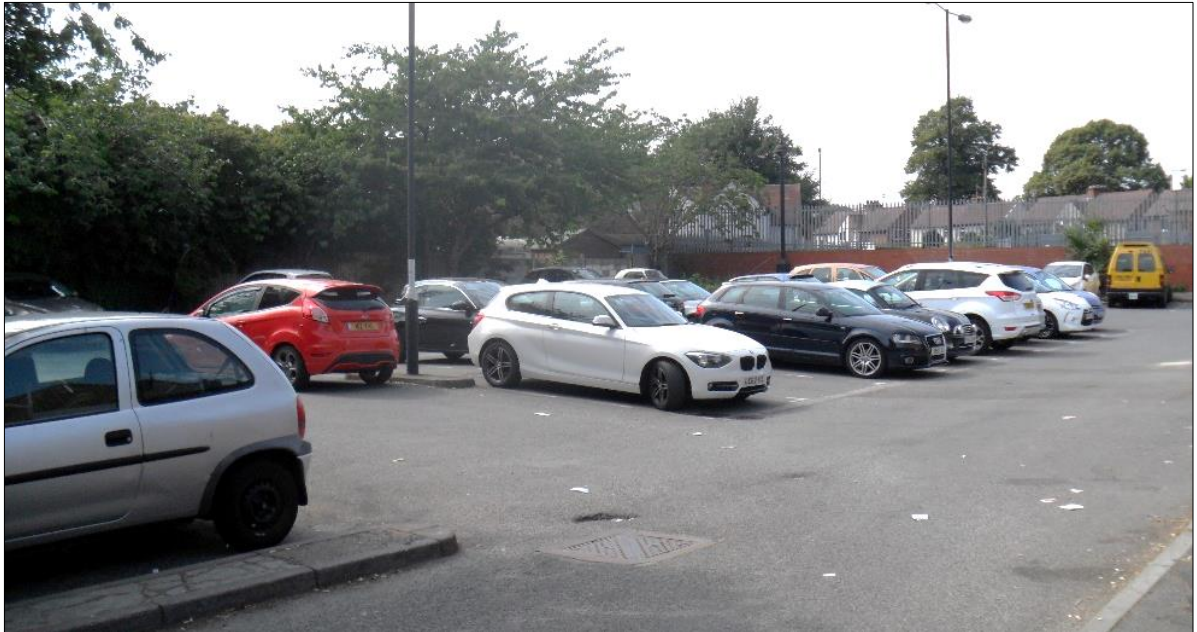
Figure 5.3 Long-Stay Parking off Stamford Street

- 5.1.6 Long-stay off-street parking is provided in a public car park located off Stamford Street, behind the shopping area, shown in **Figure 5.3**. The car park is accessed via Stamford Street, via the junction of A514 Osmaston Rd with Stamford Street. The car park is at the rear of the shopping area and can accommodate approximately 44 vehicles. The car park is open 24 hours and is monitored by CCTV coverage.

- 6.8.1 The condition and maintenance of the car park and shopping area is generally good with slight fretting, patching and potholes identified in the long-stay car park on Stamford Street, shown in **Figure 5.3**. Lighting and CCTV are provided and the area provides the impression of a well maintained very busy retail centre.

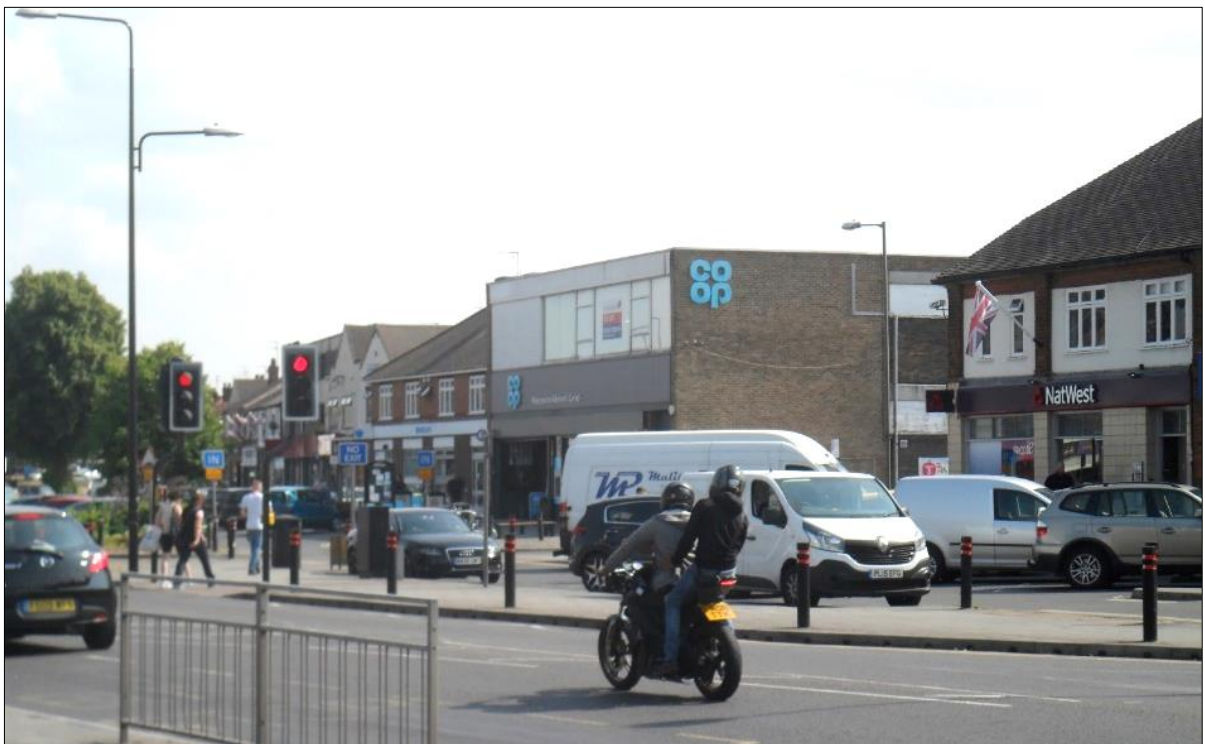
Figure 6.1 Allenton Retail Area

- 6.1.1 The shopping area is generally busy, orderly, functional with high volumes of activity from pedestrians and other road users, shown in **Figure 6.1**. There is a high demand for parking within the shopping area evidenced by **Figure 6.2**. The majority, if not all available parking bays are occupied.
