# Investigation Report into November 2019 Derwent Floods in Derby City

Derby City Council

Project number: 60675186

15th September 2022

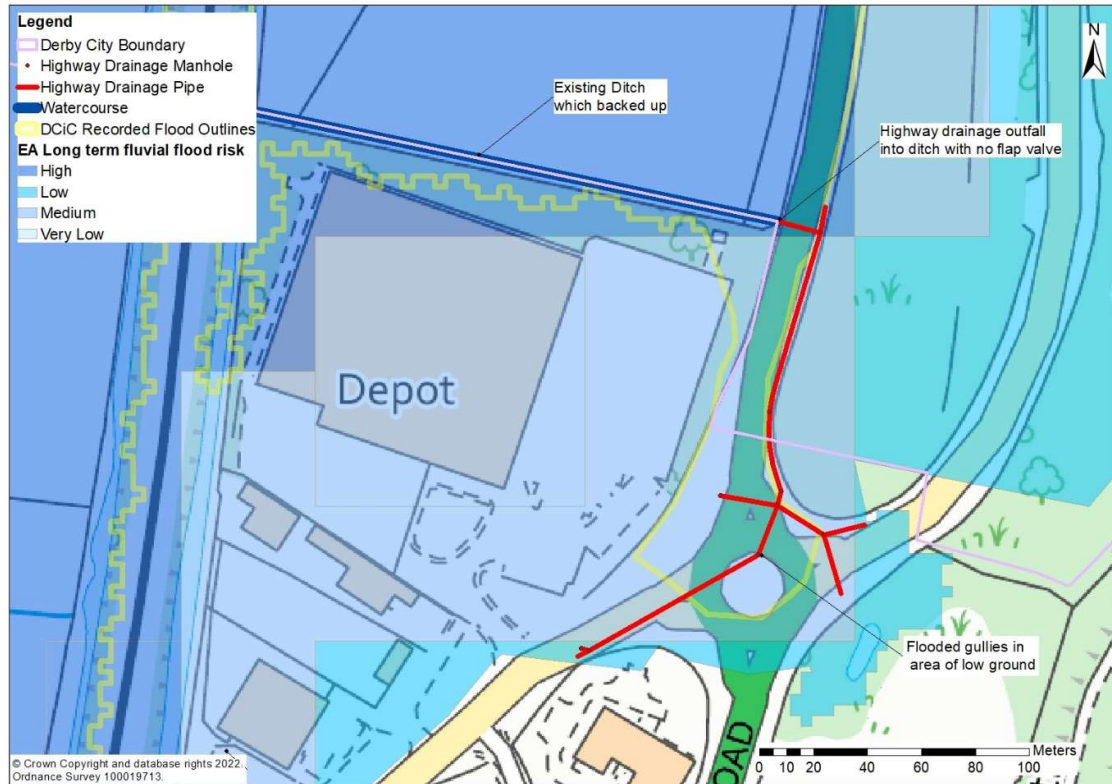
**Figure 5-10: November 2019 Recorded flood outlines at A61 North of Pektron Roundabout**

During the flood event Pektron Island Roundabout on the A61 experienced significant flooding with water depths of approximately 500mm, resulting in the need to close the roundabout for a period of time. Pektron Island was underwater by 21:45 on 8<sup>th</sup> of November. The flooding was reported as being caused by fluvial water flooding from the gullies of the highway drainage network.

Figure 5-10 shows the drainage system within the area including the highway drainage network and the outfall of this network into an existing ditch that ultimately discharges into the River Derwent. The ditch is privately owned, through third-party riparian ownership and is split between DCiC bounds and Derbyshire County Council bounds. Based on observations on site, the ditch has very little fall along its length and is poorly maintained. Due to the high water levels in the river during the flood event and the lack of fall along the length of the ditch, fluvial flows from the river are believed to have entered the ditch causing the water levels in the ditch to exceed the height of the highway drainage outfall. The outfall does not have a non-return valve on it, therefore as water levels in the ditch rose above the outfall, fluvial water entered the highway drainage system, eventually emerging through the gullies around the roundabout which are at a lower level than the ditch, causing flooding of the highway even without significant rainfall occurring in Derby on the day of the flooding. Figure 5-10 also shows that the area that flooded is an area known to be at risk of surface water flooding with areas of low, medium and high risk.

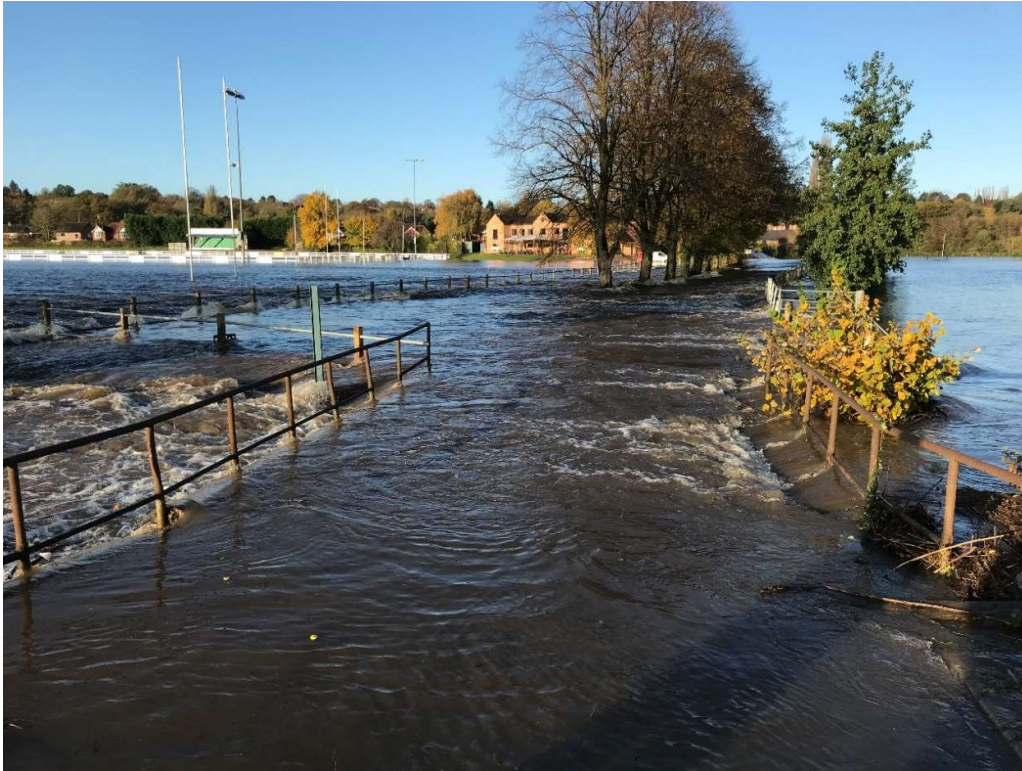
Figure 5-13: Photo taken looking towards Derby Rugby Football Grounds (8:53 8<sup>th</sup> November 2019)

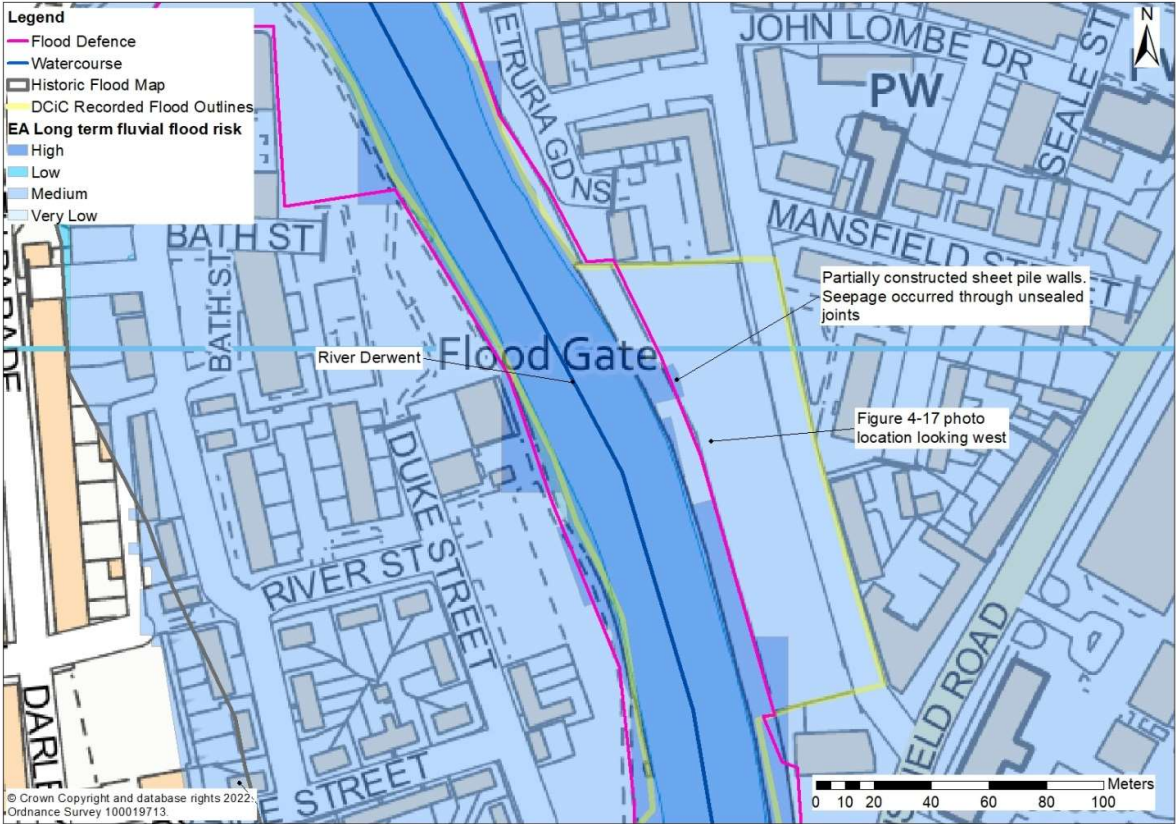
Figure 5-17: City Road flood defences

As part of the 'OCOR scheme'<sup>12</sup>, new sheet piling flood defences (see Figure 5-17) were in the process of being constructed along the riverbank behind Old Tomlinson Yard at the time of the flood event. At the time of the flooding event, the sheet piles had been installed however, the precast brick walls and concrete had not been installed and the sheet piles had not been sealed, resulting in seepage through the sheet piles (see Figure 5-18). includes the recorded flood outlines from DCiC however, there is some uncertainty with the outlines at this location as they appear to show there was no flooding from the river which does not match with the observed event.

To manage the seepage two pumps were used, a 4" and a 6", to pump the water out of the construction site and back to the River Derwent. During the flood event, the 6" pump failed resulting in flood water flowing onto City Road. Sandbags were then employed along City Road to protect the residential and commercial properties and as a result no internal flooding was reported. The reported flooding within the construction site and along City Road was of depths up to 50mm.

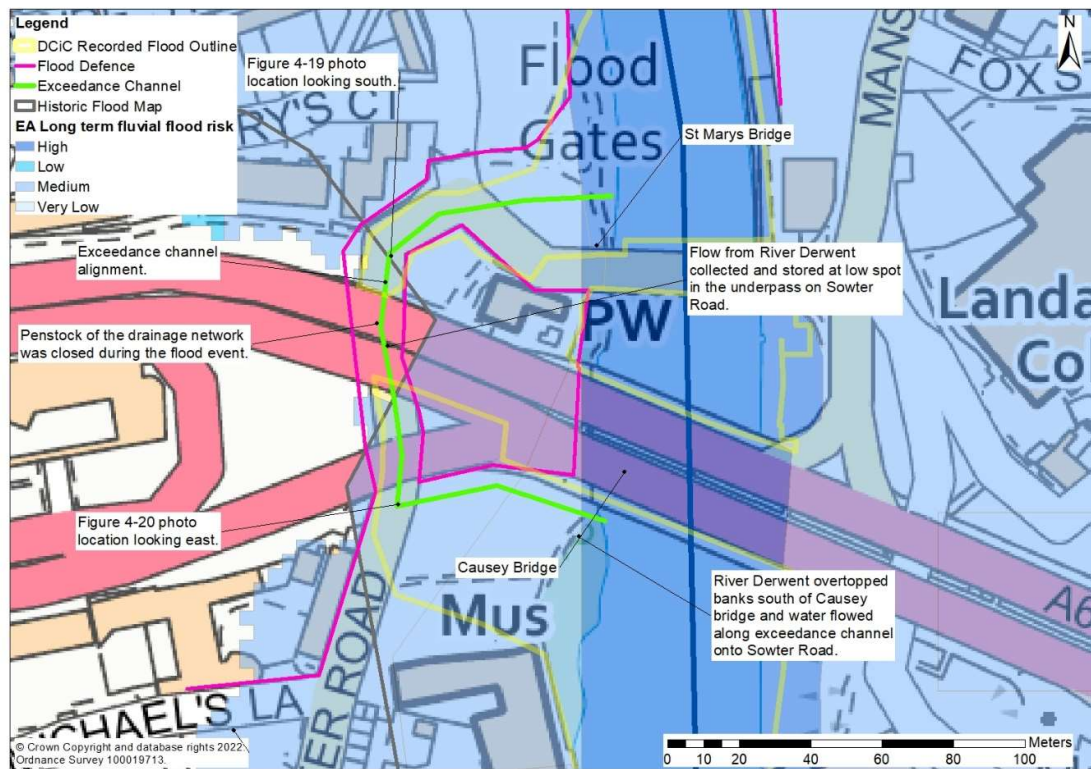
Figure 5-19: Recorded flood outlines at Sowter Road

Prior to this flood event as part of the OCOR scheme<sup>12</sup> to reduce the impact of St Marys bridge on river flow, an exceedance channel along Sowter Road was created, see Figure 5-19. The exceedance channel was designed to have flood waters overtop the bank and enter the channel north of the bridge allowing flows to bypass the constriction of St Marys Bridge and re-enter the channel south of the bridge, with flood water being stored under the underpass on Sowter Road. However, due to the levels of the constructed exceedance channel south of the bridge, the flood waters entered the exceedance channel from the south before collecting in the underpass, Figure 5-20 and Figure 5-21.

The manhole under the Sowter Road underpass (see Figure 5-19), is connected to a penstock which was shut to stop the flows entering the sewer system and allowing them to attenuate on the road. Due to the attenuation under the underpass and the flood walls and gates functioning as designed, no internal property flooding was reported in this area. After the river levels had reduced, the penstock was gradually reopened to allow the attenuated water to gradually enter the drainage system.

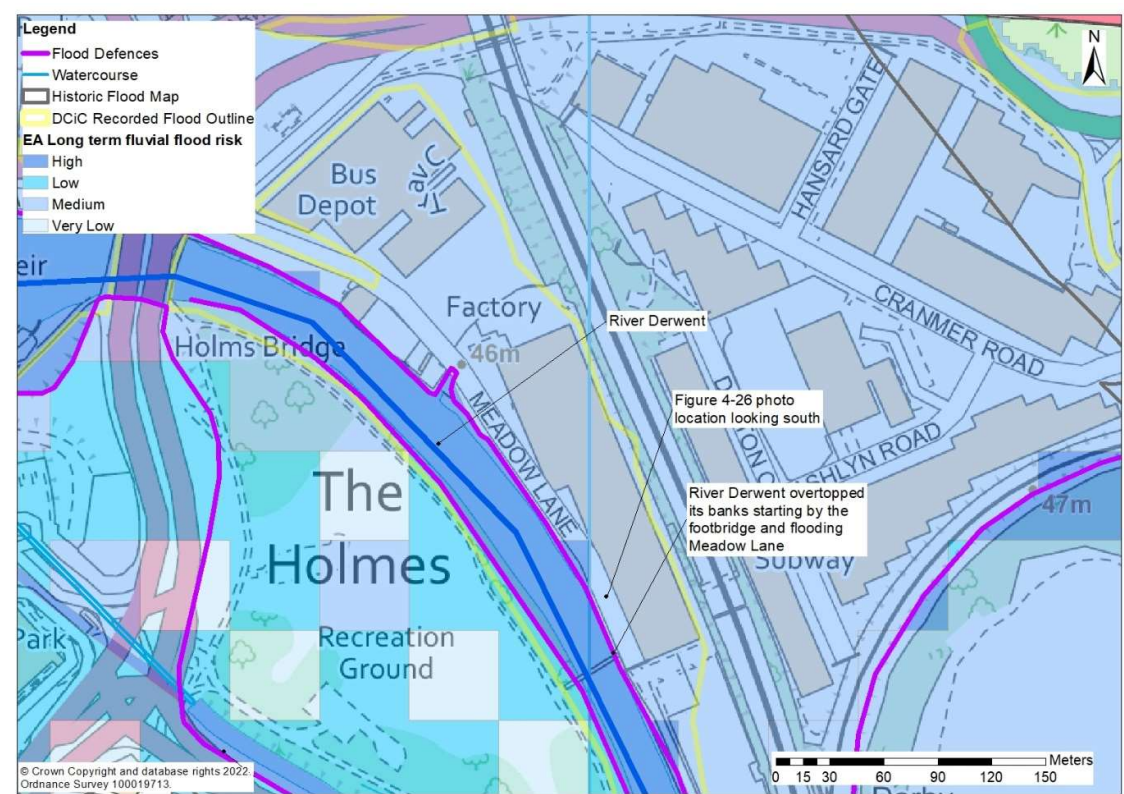
Figure 5-26: November 2019 Recorded flood outlines at Meadow Lane

The flooding that occurred along the industrial area of Meadow Lane was likely caused by the river overtopping its banks, starting by the footbridge, which acted as a constriction on the river flows. As identified by the EA's fluvial flood map, this area has a high risk of fluvial flooding (see Figure 5-26). As a result of the flooding one of the commercial properties was evacuated. The overtopping of the riverbank likely resulted in flooding of the road (see Figure 5-27).with flood depths of approximately 150mm to 200mm near the bridge by 2:30pm on 8<sup>th</sup> of November, 2019. From the site walkover it is understood that internal flooding at four of the commercial properties was experienced during the same event at this location.

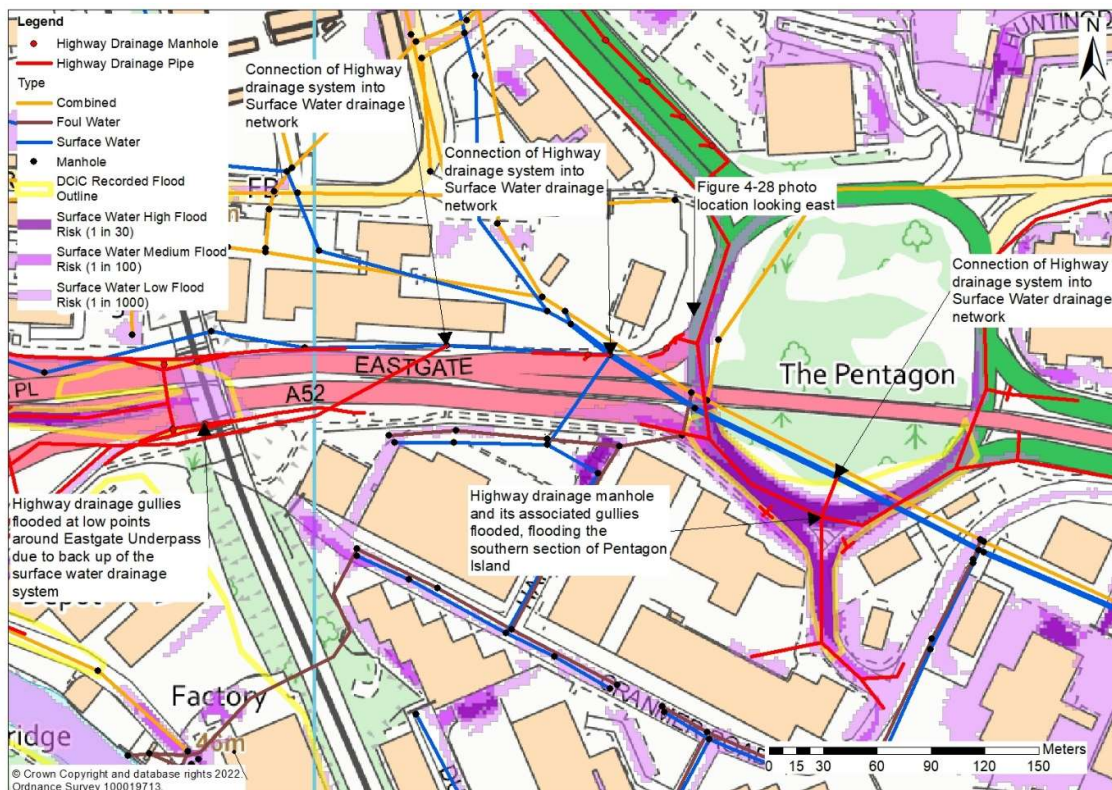
**Figure 5-28: November 2019 Recorded flood outlines at Pentagon Island and Eastgate Underpass**

Figure 5-28 shows the highway and surface water drainage system around the Eastgate Underpass and Pentagon Island and the connection between the two systems. The highway drainage system discharges into the STW surface water drainage system at a number of locations, which in turn discharges into the River Derwent near Chequers Road. The outfall of this system does not have a non-return valve fitted at the discharge point into the River Derwent. Consequently, the high river levels during the flood event reportedly caused flows to back up within the surface water sewer. Due to the connection of the highway drainage system and surface water system (see Figure 5-28) this caused high water levels within the highway drainage system as well, even without significant rainfall within the city. This resulted in water flooding out of the highway drainage manholes and gullies at low spots away from the river, flooding the southside of Pentagon Island roundabout.

It can be seen from Figure 5-28, that the Pentagon Island and the Eastgate underpass highway drainage systems are both connected into the same surface water network. Therefore, similarly to Pentagon Island the gullies at the lowest points along Eastgate Road also flooded as a result of water backing up throughout the surface water drainage network. The underpass at Eastgate was flooded by 14:40 on 8<sup>th</sup> November.

Figure 5-28 also shows that the area that flooded both around Pentagon Island and Eastgate Underpass are the area's most at risk from surface water flooding as identified by EA maps. This is because these areas are at low points in the topography and so are the area's most likely to flood, with the cover levels of the manholes around Eastgate underpass being between 41.22 m AOD (Location SK353695AG) and 42.67 m AOD (Location SK35369AD) (above ordnance datum).

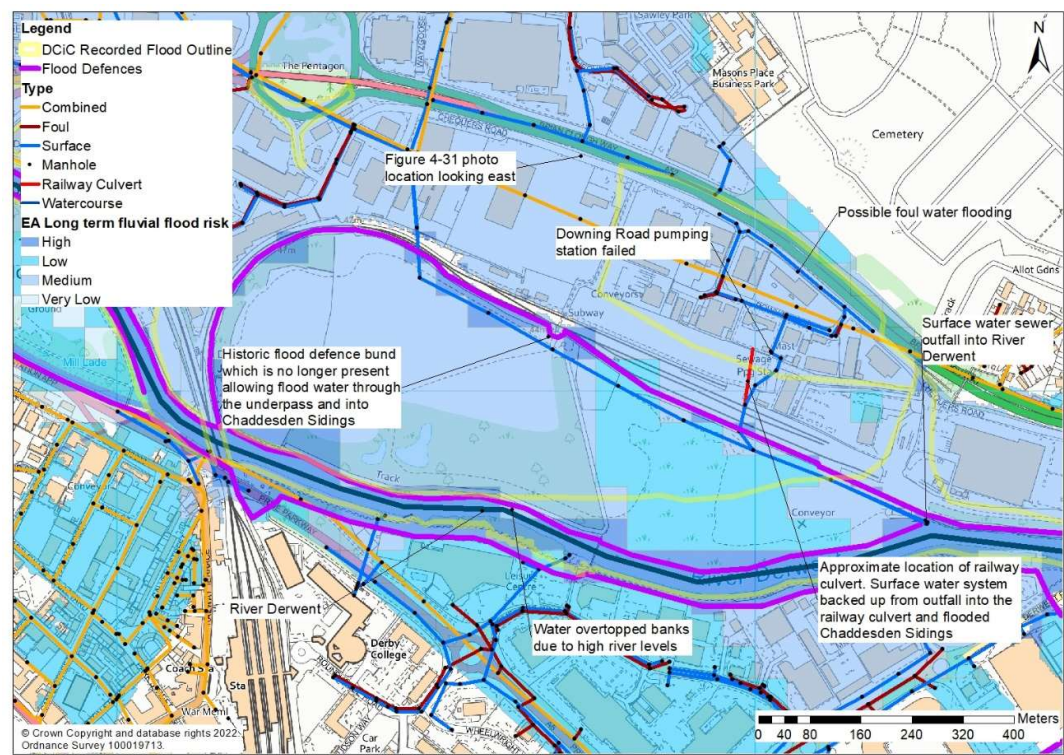
Figure 5-33: November 2019 Recorded flood outlines at Chaddesden Sidings

During the flood event, flooding occurred across the flood plain, with the River Derwent overtopping its banks and flooding the area to the south of the railway tracks. Although the railway lines act as a flood embankment, preventing water from flowing further north, there is an underpass which allowed flood water to flow into Chaddesden Sidings, see Figure 5-33. A flood defence bund was previously constructed to maintain the defences and protect the underpass from fluvial flooding, see Figure 5-34. The EA are in charge of maintaining the flood defence bund. However, prior to the November 2019 event the bund was either removed or eroded, leaving a gap within the flood defences. This allowed flooding from the flood plain into Chaddesden Sidings.

In addition to the mechanism above, it became evident during the flood investigation that flooding also occurred north of the railway due to flows from the river backing up through the STW surface water sewer and an existing culvert underneath the railway, shown in Figure 5-33 and Figure 5-35. The figures shows that the railway culvert is connected into the surface water drainage system, this is the same system referred to in Sections 5.2.9 and 5.2.10. Prior to this flood event the existence of the railway culvert was unknown, and it is believed that the railway culvert may have previously been blocked. Due to the open nature of the upstream end of the culvert, water was able to flow back from the river into the culvert and flood into Chaddesden Sidings, contributing to the flooding.

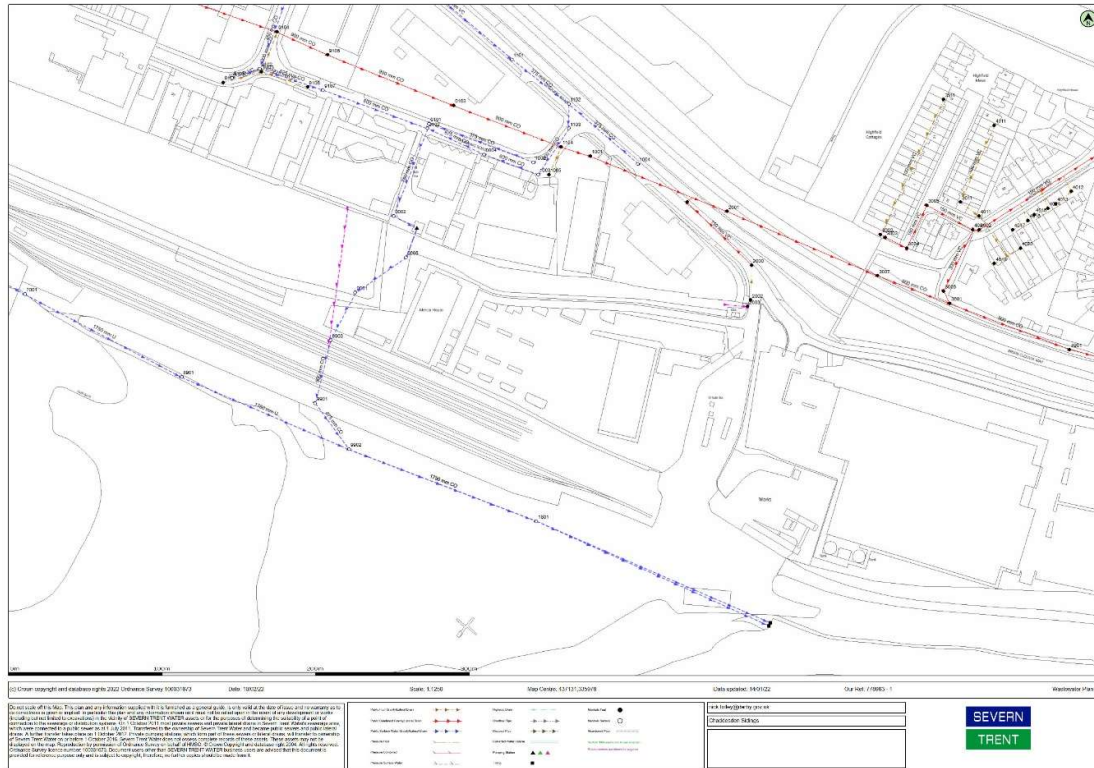
Figure 5-35: STW Sewer records within the Chaddesden Sidings Area

STW has reported that during the flood event the pumping station became flooded due to the significant flooding in area which led to the failure of the pump, which probably exacerbated the flooding in the area.
