Darley Abbey Bridge

Heritage Statement Baseline Understanding & Geoarchaeological Assessment

authors: Mel Morris & Kristina Krawiec (dated 14/10/2025 – v6)

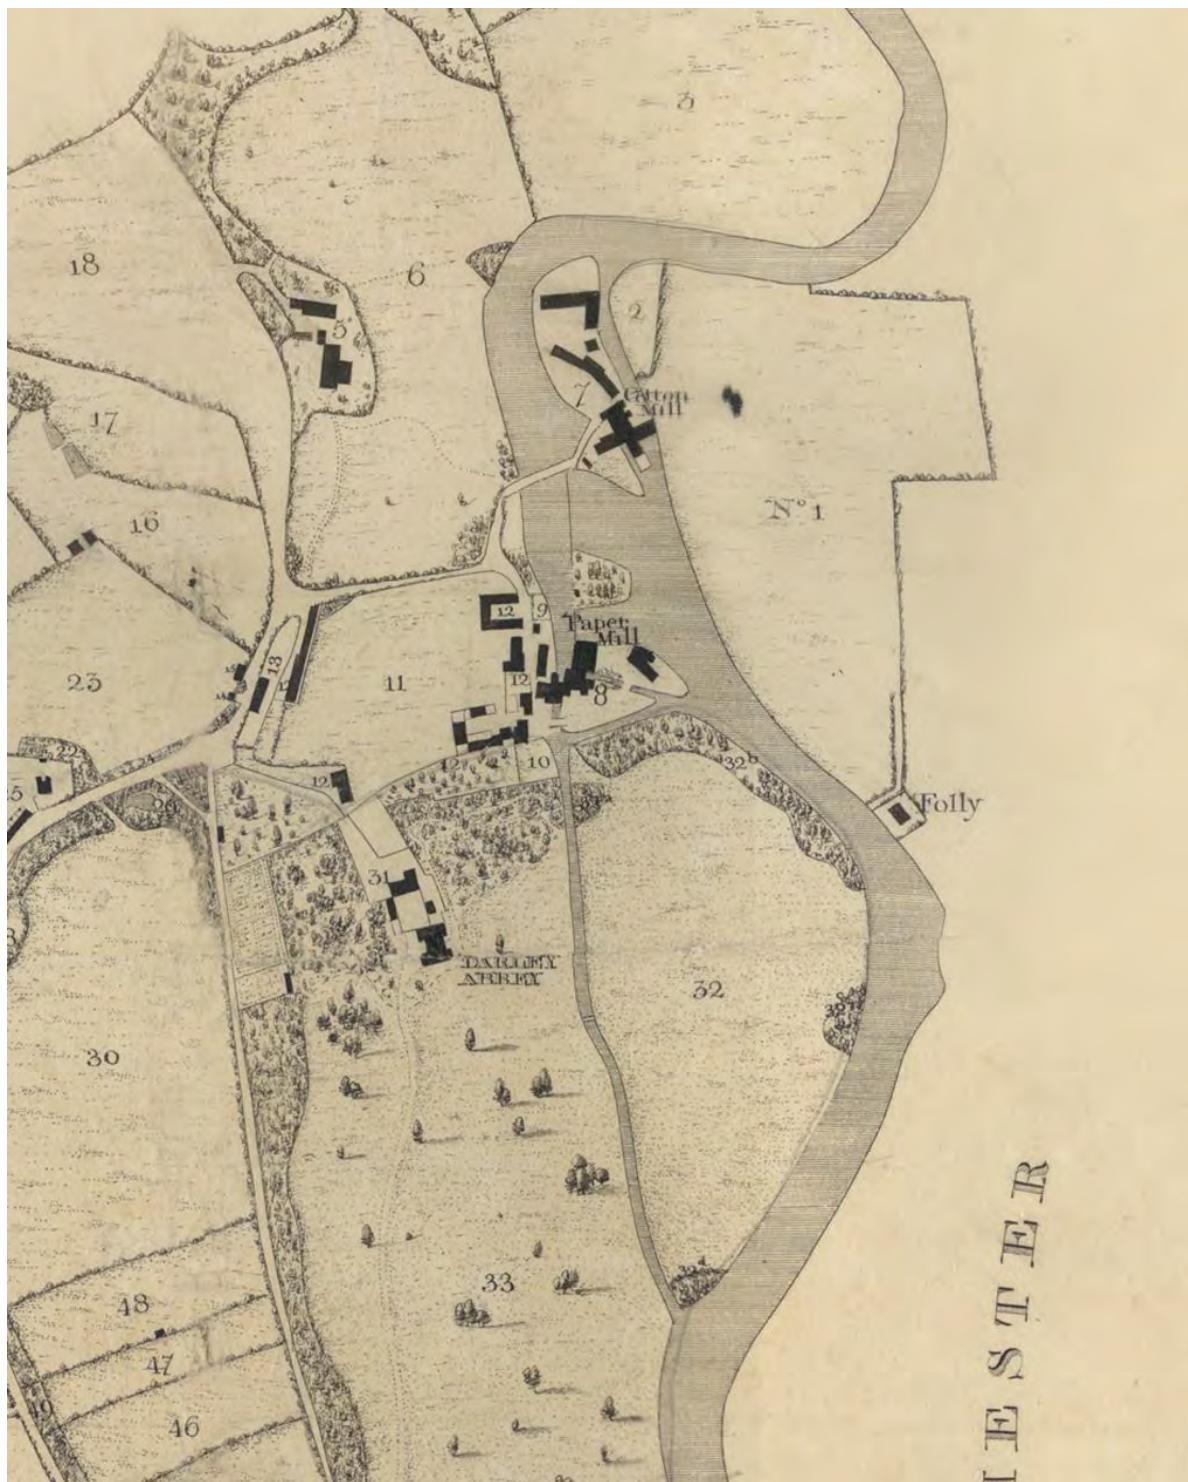
Fig.17 1811 Derby Liberty Map (DRO – D769/B/11/3)

The 1798 'new cut' is illustrated on this map, which appears to be a highly accurate survey, based on an overlay of the first edition OS map. Could the earlier 'cut' have followed the boundary alignment shown close to plot number 2? This appears closer to that illustrated in 1792.

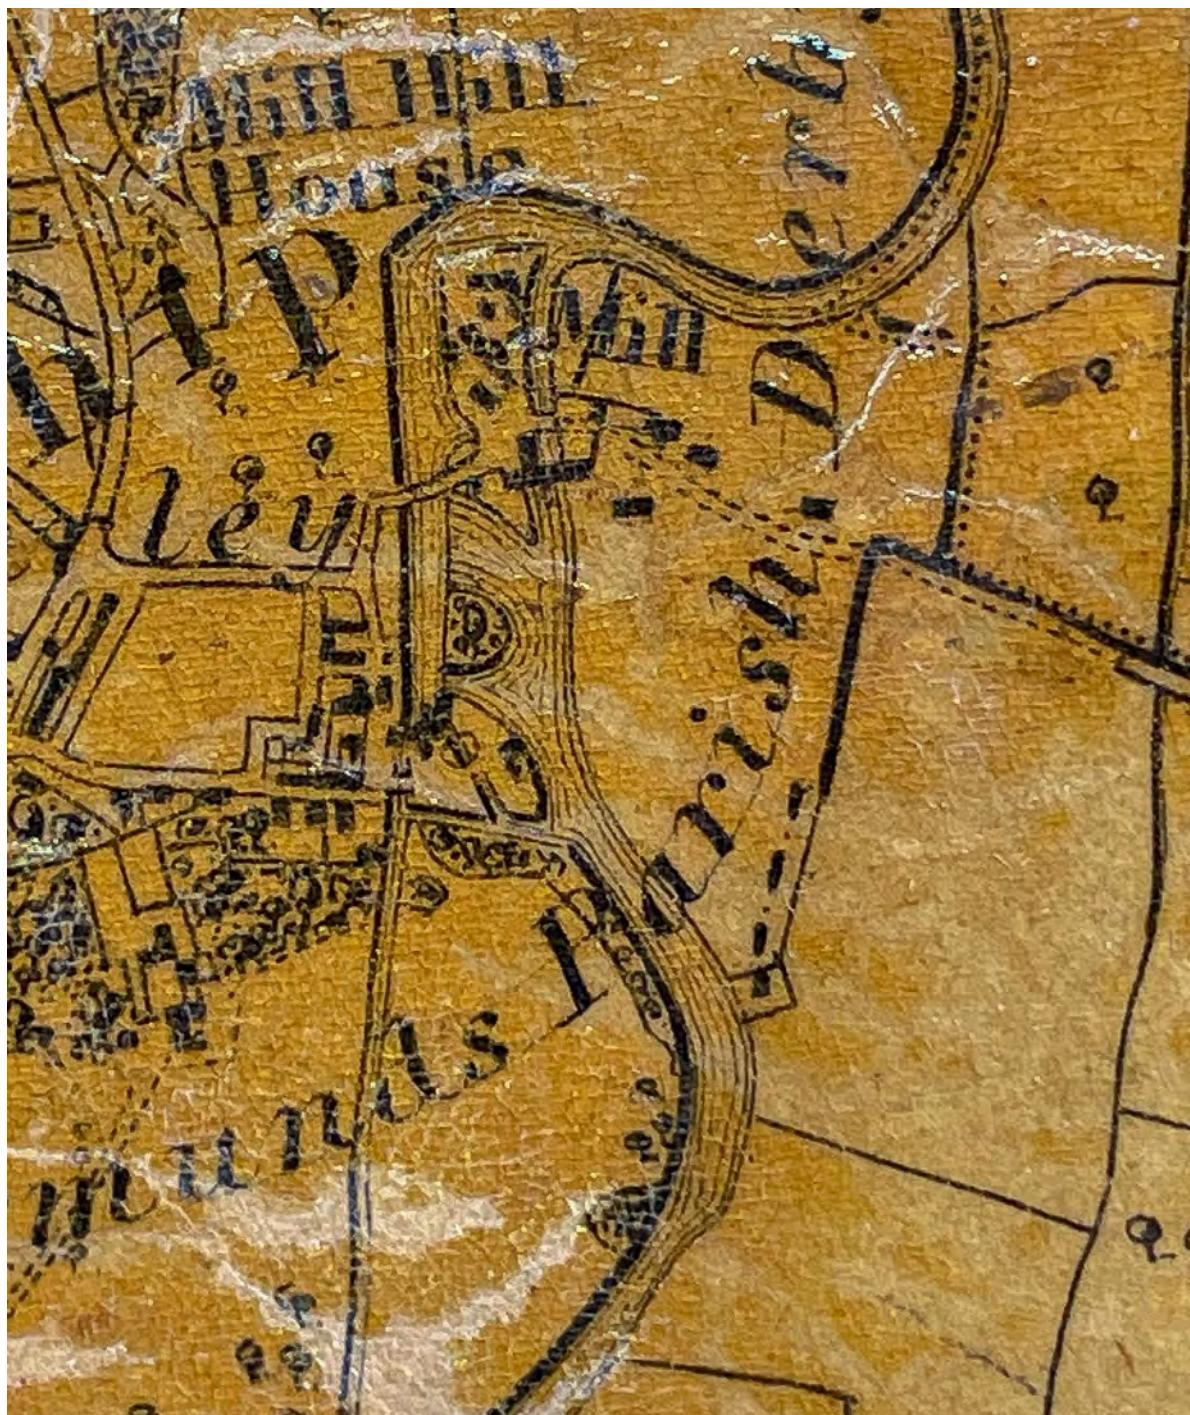
Fig.18 1835 Sanderson map – extract (DRO – D6572/1). The water is clearly marked and illustrated with contour lines flowing through sluices on the left bank above the bridge and the bank above the bridge is clearly built-out where it adjoins the sluices. The weir is not illustrated with its distinct curved shape for the northern straight-drop section.

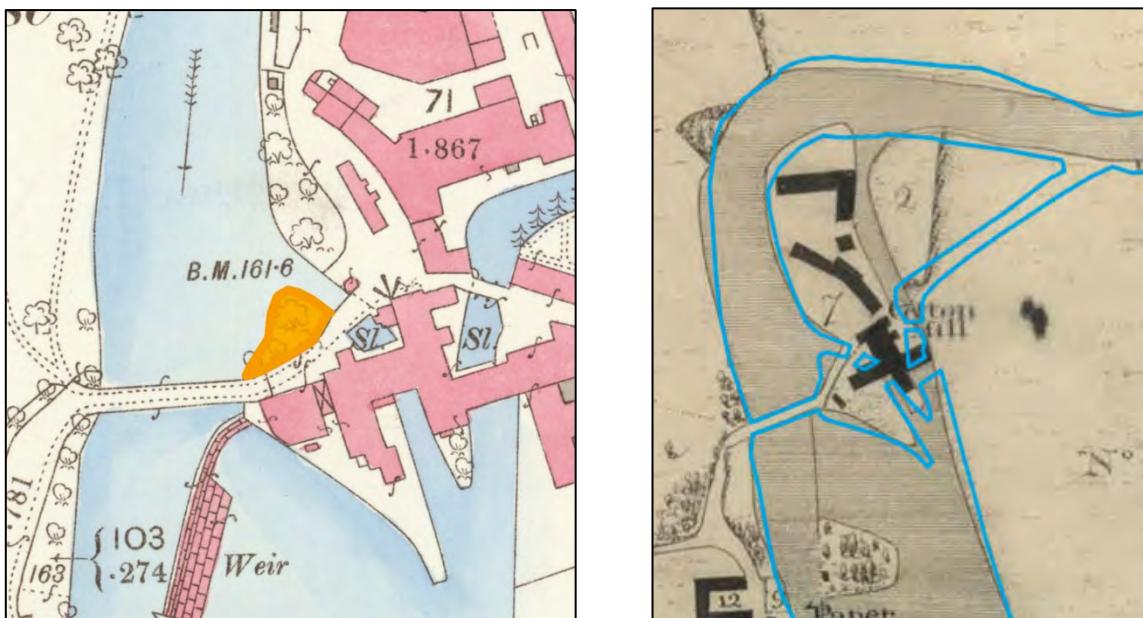
- The alignment of the weir by 1882 has a distinct curve where it meets the left bank but is straight in 1811. Is this remodelling associated with an encroachment of the mill site into the bed of the river at this point, as they searched for more space to accommodate more structures / and / or changed water management?

Fig.20 Comparison of the 1882 OS map (left) with the Liberty map of 1811 (right). The area in orange marked on the 1882 map appears to be built out in order to create the paired sluices to feed the west side of the Long Mill / Middle Mill after 1811.

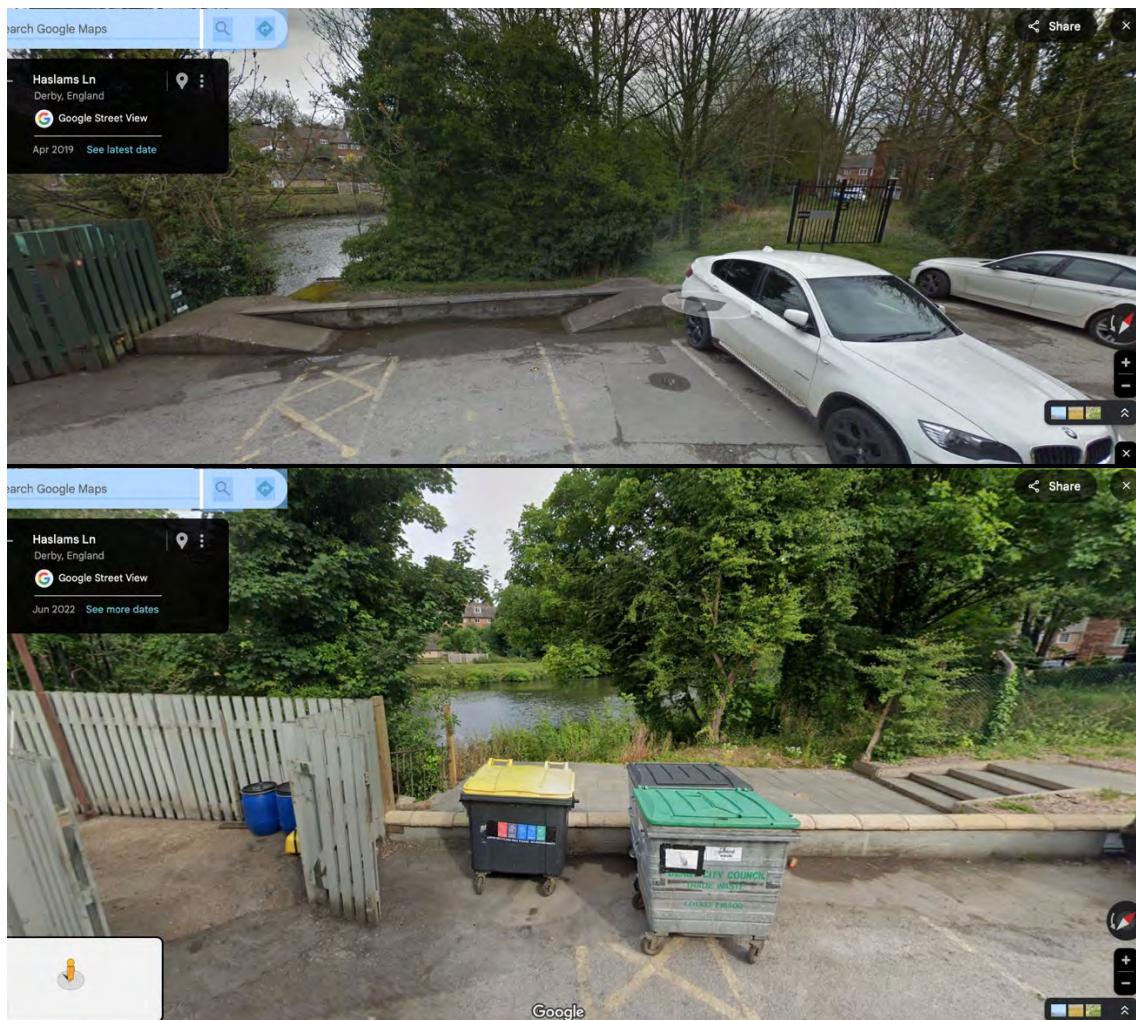
Fig.26 Google Streetview images from 2019 and 2022 show incremental changes to the left bank.

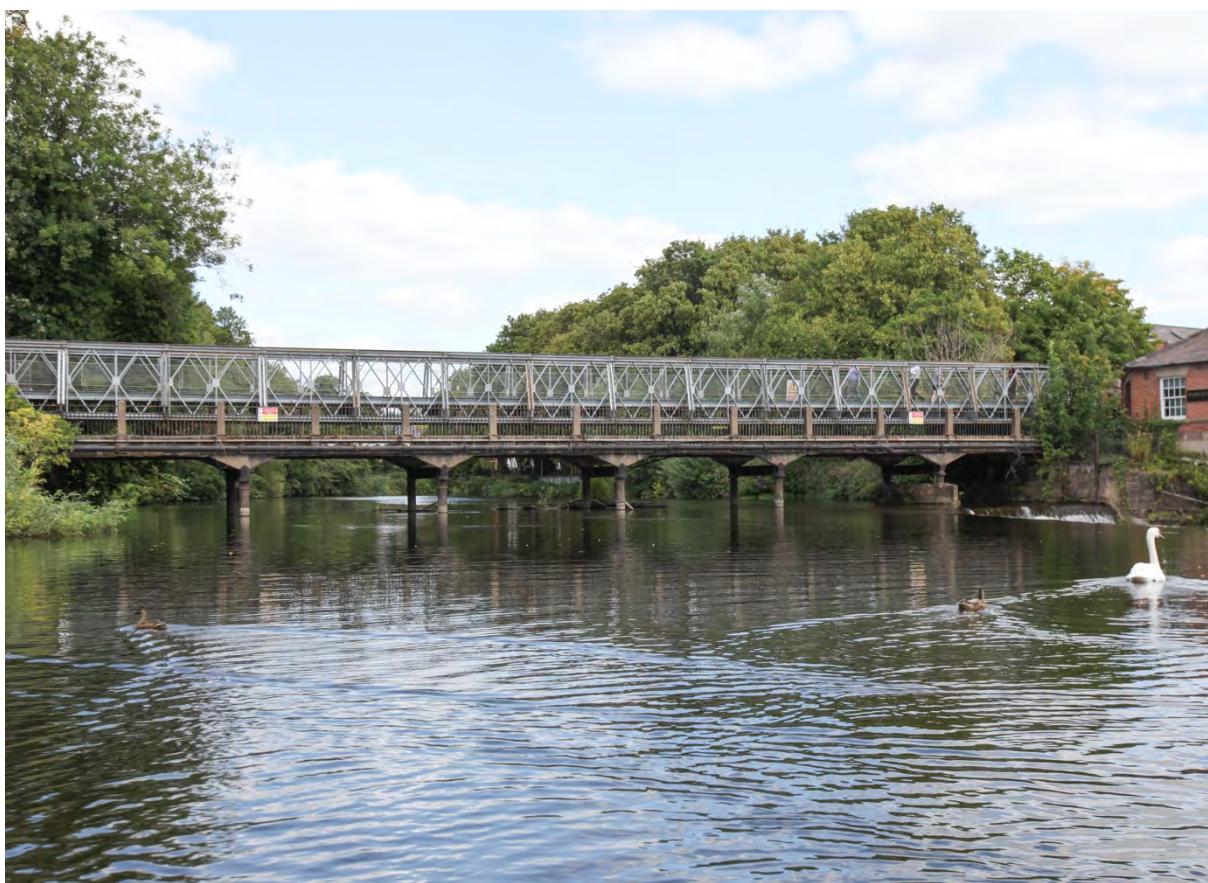
Fig.27 View of Darley Abbey bridge from the weir (8.8.2025)

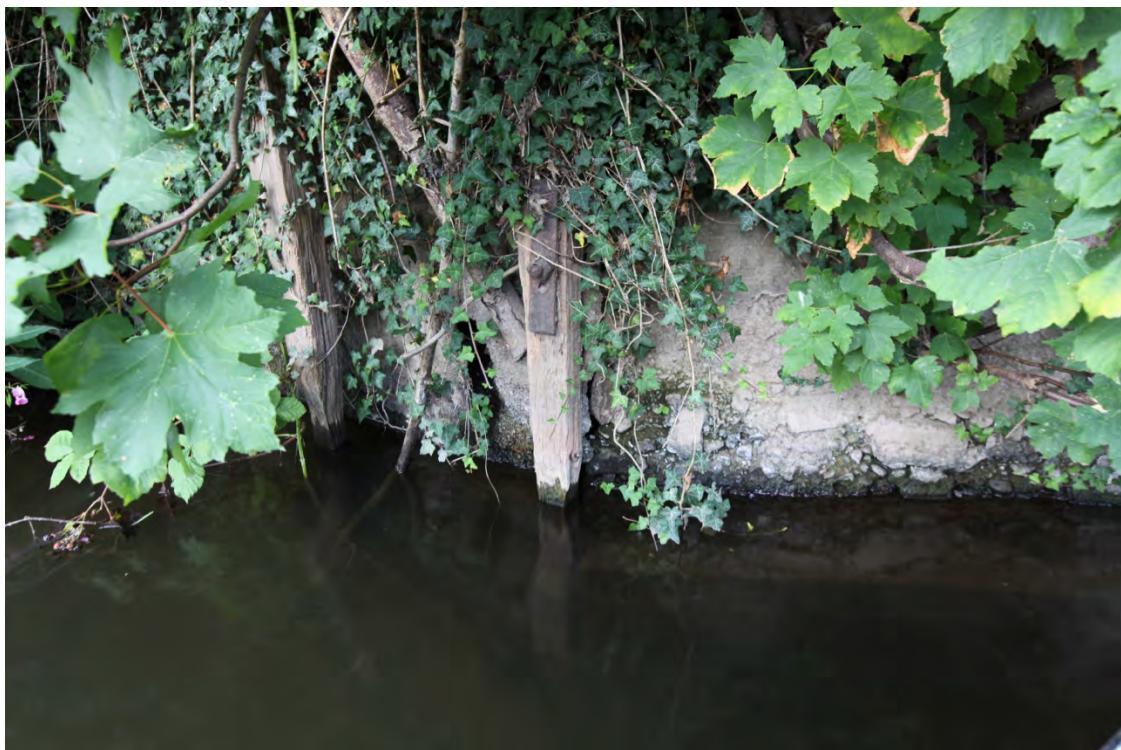
5.14 The bridge was examined at close quarters from an open boat on 8th August 2025, when the river was at a particularly low level. The height gauge was not visible as a result of the temporary bridge structure and access restrictions. However, the water level from the river bed under pier 1 was measured at 510mm (see figure). Following a prolonged hot spell and low water levels, increases in the concentration of algae and silts does not enhance the clarity of the water; visibility through the water was therefore still limited. Vegetation along the riverbanks was heavy and as a result it was not possible to examine the left bank above the bridge. This is where the greatest concentration of works associated with the water management of the mills site are likely to survive. Revetment walls could not be seen, although they are visible in early photos. A single area of revetment wall with some timbers which may be related to repairs could be seen (see image below).

Fig.35 Left bank upstream of the bridge 2025.

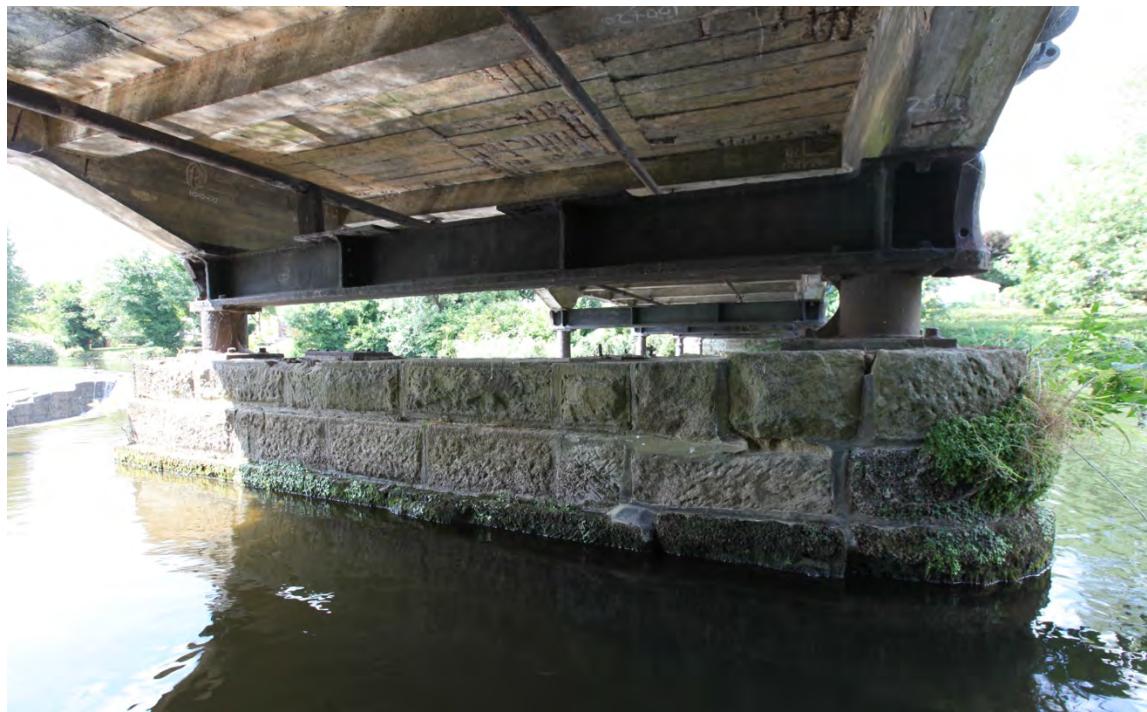
5.21 The stonework is heavily tooled with draughted margins and a raised / rock-face pitched face. The detail is not particularly decorative and does not show great consistency. The top course of the pier is 'rougher' in execution and may be later and a replacement. There are some cementitious repairs to the more heavily weathered upstream cutwater.

5.22 The upper face of this structure has a series of wrought iron cramps at the masonry joints²⁵. The visible corrosion makes it clear that these iron cramps, which are a common way of connecting ashlar masonry wall caps, are wrought iron²⁶.

Fig. 37 Stone pier with short cast-iron posts, transverse cast I-beam, and rounded cutwater - 2025

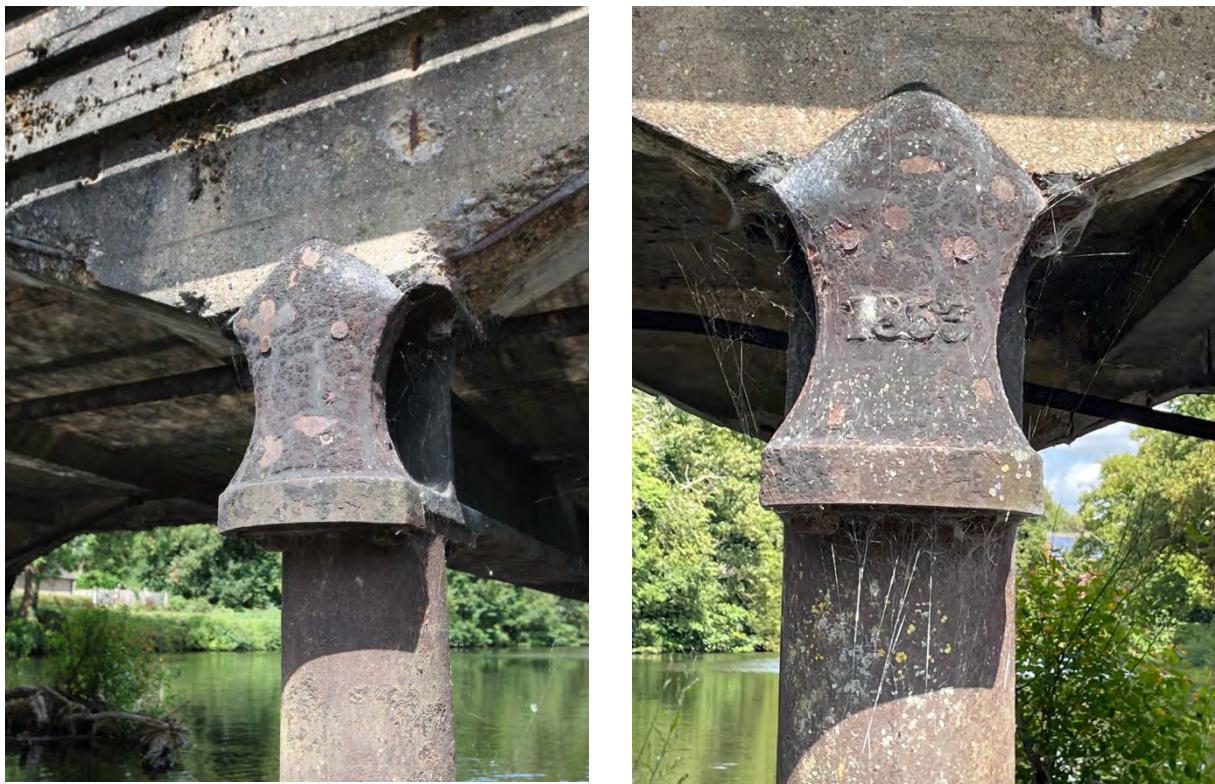
Figs.43 & 44 End caps with visible dowels to upper face (left – plain, right – with 1853 date in the casting) – 8.8.25.

5.26 The cast-iron end caps are curved to the face and have a slight bell-shape and skirt. Only the two central caps have cast datestones of 1853. The end caps are missing on two of the beams. Each end cap sits above the end of each cast-iron beam shaped at the upper part in such a way to mask the junction with the beam and any longitudinal beam. The tapered shape reflects that of a jack-arch, and the concrete structure also hints at this, but there is no surviving evidence that there was any brickwork in the construction, although T Swailes²⁷ states that 'many short span road bridges with cast-iron girders to brickwork jack arches are still in use'.

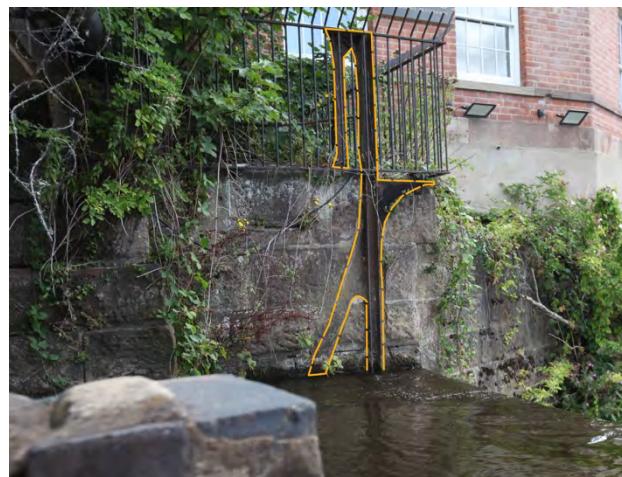
5.27 Downstream of the left bank abutment, there is a casting for one of the historic rack-and-pinion mechanisms for the sluices which is fixed within the 'wing wall'. The metal slot is still visible where the sluice boards have been removed. Behind this, bedded in the wall and partially hidden by modern railings, is the remains of the casting for the rack-and-pinion mechanism.

Fig.45 Left bank at the weir crest. Marked in yellow dashes is the casting for sluice gate, rack-and-pinion and grooves for raising the gate within the 'wing wall' - 8.8.2025. The outer spur carried a narrow boardwalk.
